Asset #M0177(Routine, Underwater type 2)

SH 7 S-6 LM 2.81 over MILL CR.

Location: 2.81 MI W DALLAS CO

Team Lead: Lee Swan, Inspection Date: 05/11/2022

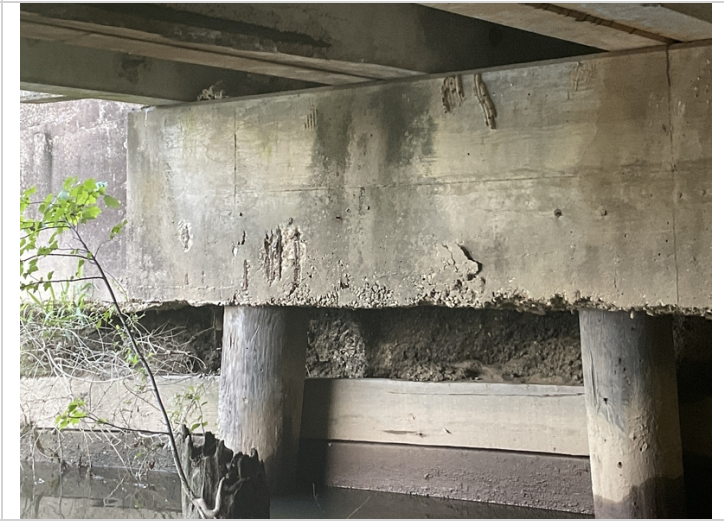
(234) Bent 1 has cracks and delamination. Bents 2 and 3 have exposed rebar.							
330	Metal Bridge Railing	LF	76	76	0	0	0
515	Steel Protective Coating	SF	243	243	0	0	0

Bent 3 left side, exposed rebar in the face of the cap.

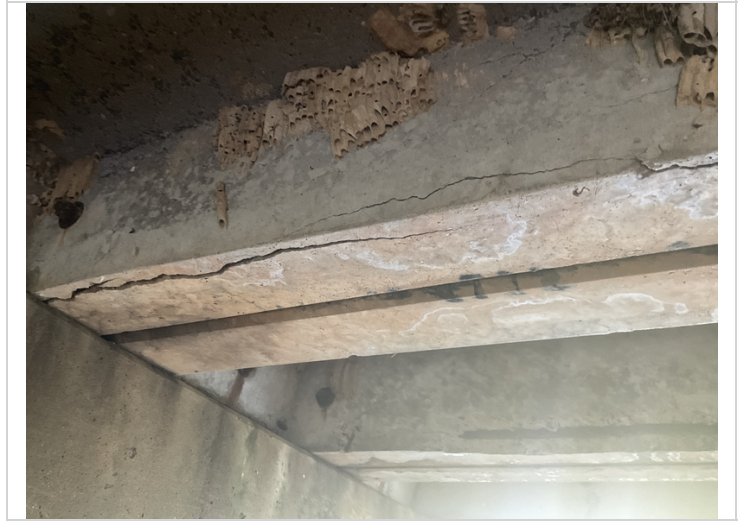
(110) Span 1, unit 2, exposed rebar Span 2 unit 2, exposed rebar Large cracks on the bottom of the unit legs. Scattered spalls and delamination.							
C							
216	Timber Abutment	LF	51	22	25	4	0
1140	Decay/Section Loss	LF	25	0	25	0	0
6000	Scour	LF	4	0	0	4	0

Unit 3 span 2, large longitudinal cracks on the bottom of the unit leg.

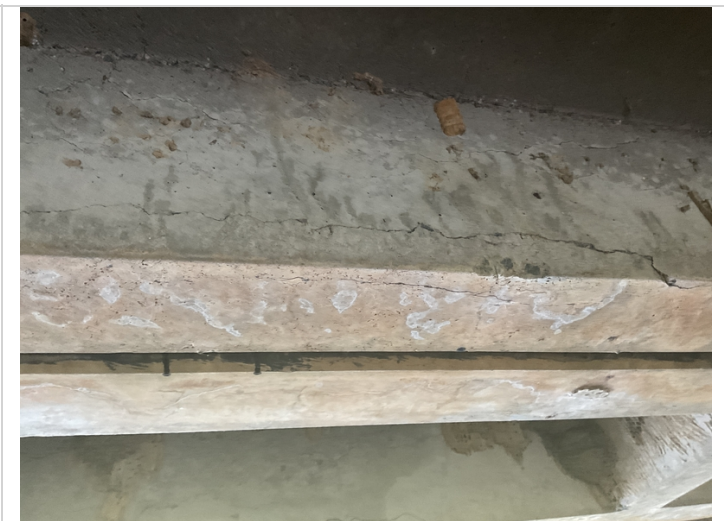
Unit 4 span 2, large cracks on the bottom of the unit leg.

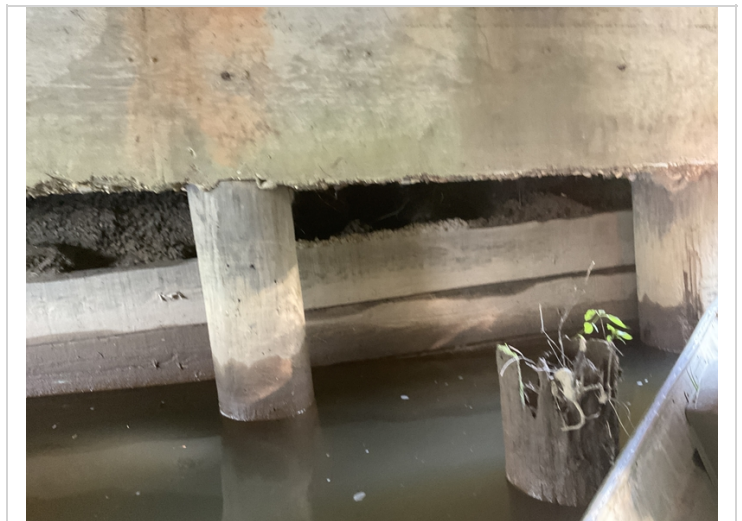
(216) Missing boards abutment 2. Left side wing walls washed out. Deep void behind the timber cribbing at abutment 2.							
228	Timber Pile	EA	15	14	1	0	0
1140	Decay/Section Loss	EA	1	0	1	0	0

Bent 3, large void behind the timber cribbing.

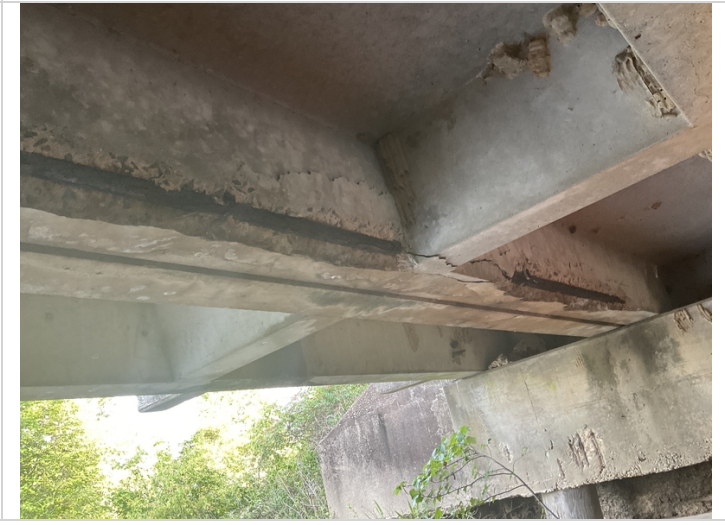
Most inside units have some horizontal cracking along stems. (noted as "bottom of channel" in a previous inspection. Span 2 Unit 2 has a 12' spalled area with exposed steel, minor section loss. Unit 6 span one has cracks that are beginning to spall. 2' .

Span 2 unit 2, exposed rebar in the channel leg.

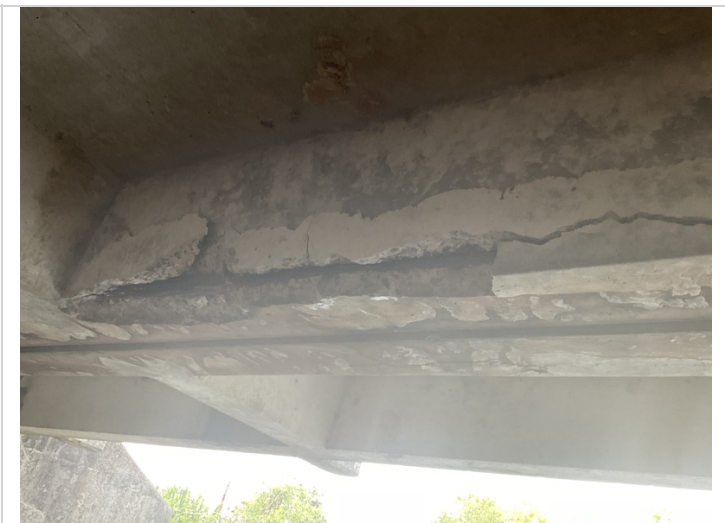
Span 1, unit 2, exposed rebar and large delaminated area in the unit leg.

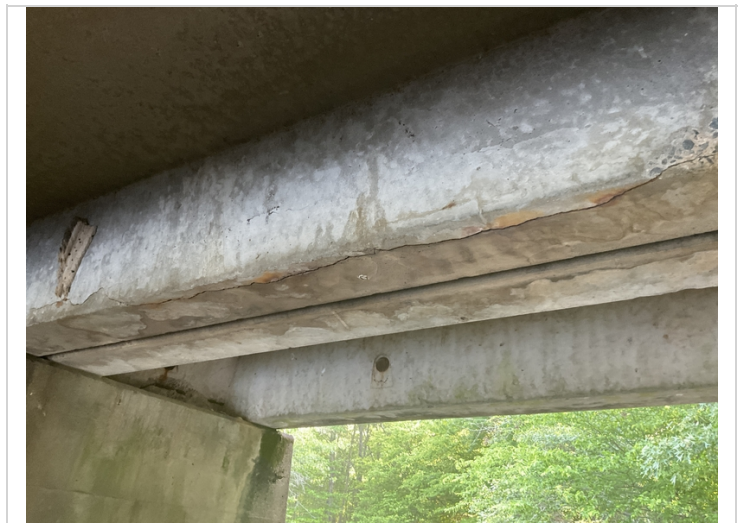
Span 1 unit 6, large crack in the leg of the channel unit.

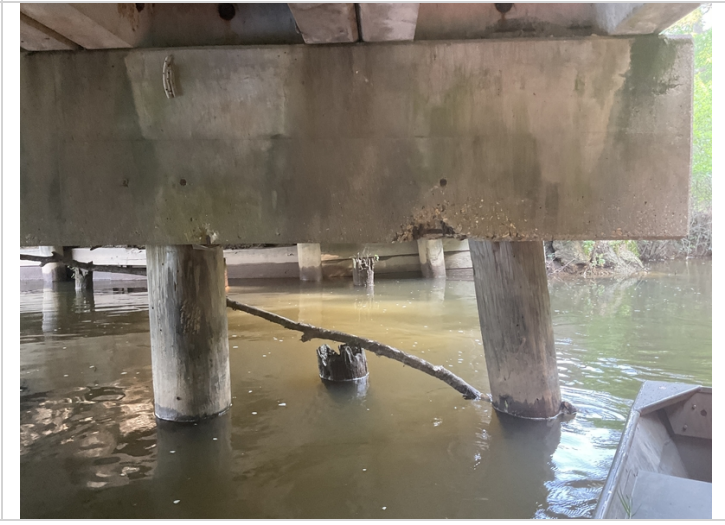
Bent 2, exposed rebar in the bottom of the cap.
