Asset #M0178(Routine, Underwater type 2)

SH 7 S-6 LM 6.53 over L'EAU FRAIS RELIEF

Team Lead: Rickie Bratton, Inspection Date: 03/06/2023

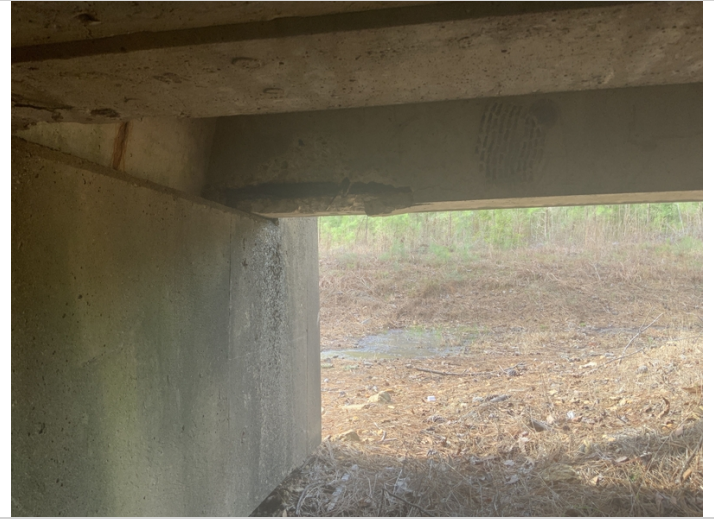
Span 11 unit 1, left leg, exposed rebar at bent 11 bearing area.

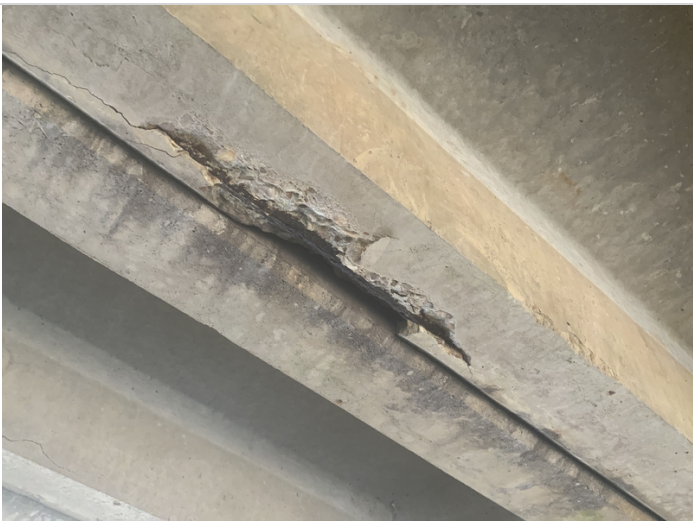
Span 8 unit 5 left leg 5' from bent 8 has exposed rebar.

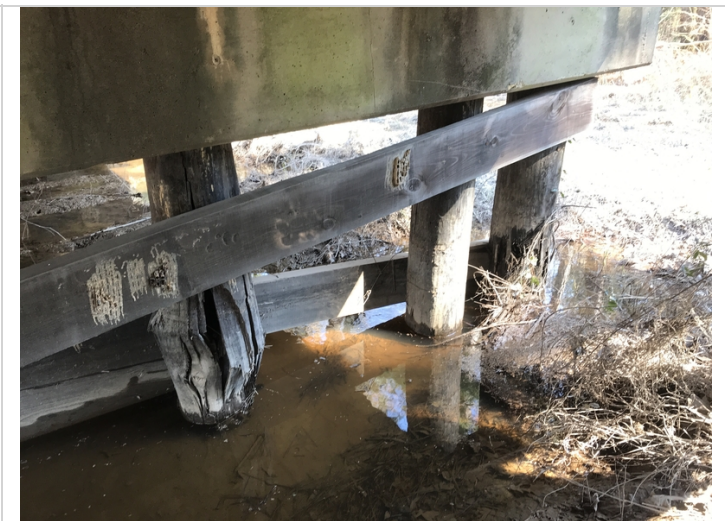
BT#2-11 maintance forces added conc. ftgs & @ least 4 pile per bent(see drawings dated 1-31-01 &2-10-05 REV BT#8) =90 pile 03-23-2011 most original pile are rotten several are crushed. Maint has added helper piles as needed. Bt 8 pile 7 crushed. 3/30/2009 JPR Bent 3 pile 3 rotten, Bent 4 Piles 1 & 5 rotten, Bent 6 pile 1 rotten. 03/14/2013 JPR Bent 2 pile 6 rotten below splice. Bent 8 piles 5 & 7 are crushing. Bent 10 piles 4, 6, & 8 have no bearing with cap.

Bent 8 piles 7 and 9 typical of old rotten piles.

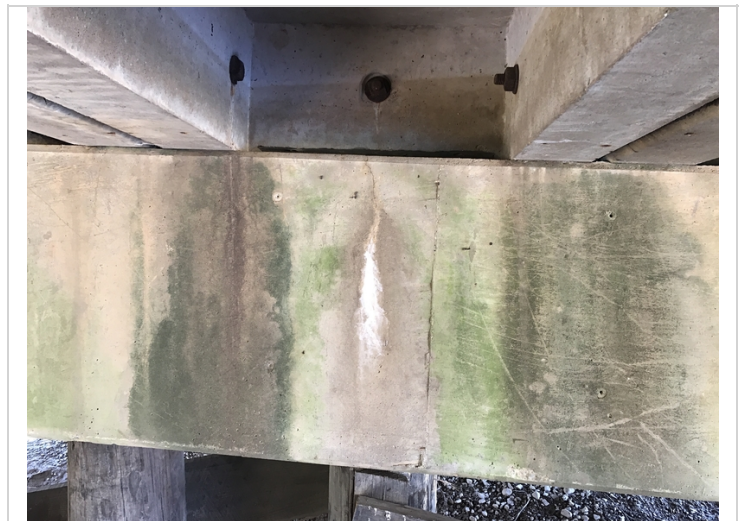
Bent 6 crack in cap over pile 5

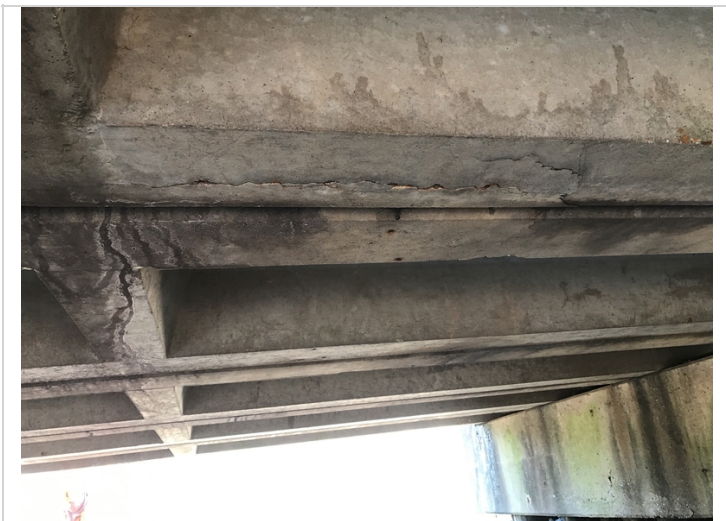
ELEMENTS	DESCRIPTION	UNITS	TOTAL	CS1	CS2	CS3	CS4
110	Reinforced Concrete Open Girder/Beam	LF	1463	1454	7	2	0
1090	Exposed Rebar	LF	2	0	0	2	0
1130	Cracking (RC and Other)	LF	7	0	7	0	0
(110) Reinforced Concrete Open Girder/Beam = (209' x 7 PC Units) = 1463 Lf. per plans. Span 9 units 4&5 cracks along bottom legs. Span 10 unit 5, crack in bottom leg.

Span 10, unit 5, crack in bottom left leg.

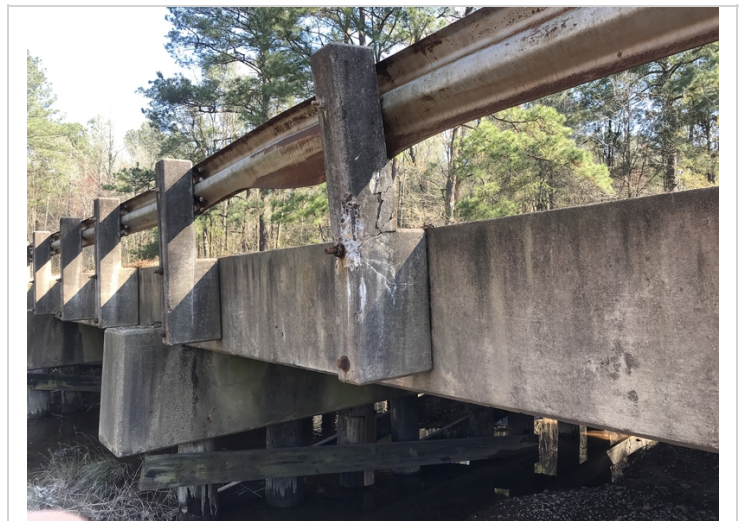
(301) Pourable Joint Seal = (25.0' x 10 bents) = 250 Lf. per plans.							
330	Metal Bridge Railing	LF	418	104	314	0	0
1000	Corrosion	LF	314	0	314	0	0
(330) Span 5, rail damage and middle post, left side. 03/15/2021 JPR -- rail damage has been repaired, there is no maintenance need for this item now.

Span 5 left side post and rail damage

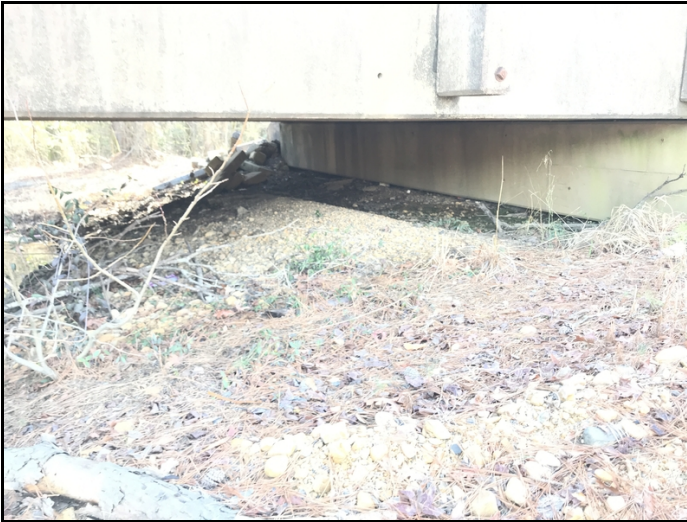
Local scour below bottom of cap @ Abutment 1 with minor roadway settlement.

Minor scour abutment 1
