Asset #M1079(Routine)

SH 60 over Branch

Location: 2.0 M E OF SH 9

Team Lead: Kevin Milligan, Inspection Date: 12/05/2022

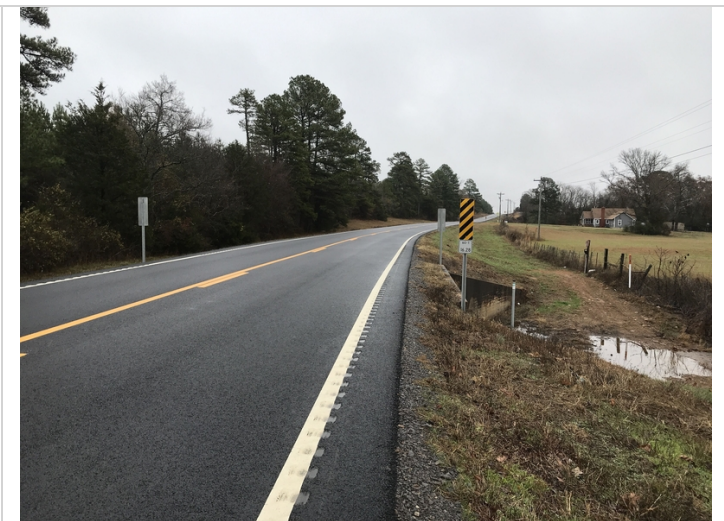
East bound log mile sign is incorrect, the west bound log mile sign is missing.

East bound log mile marker sign is incorrect, the west bound log mile marker sign is missing.

The correct log mile is 16.0 - route 60 - section 1

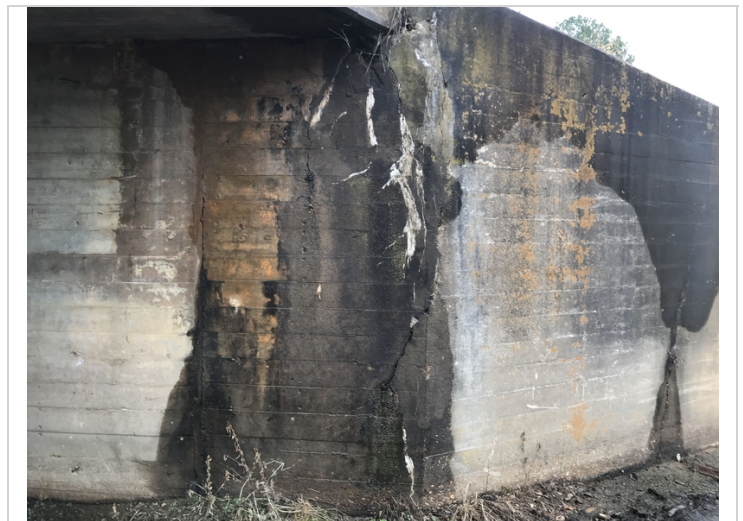
Barrel #1 left end has moderate vertical cracks with minor efflorescence at the connection.

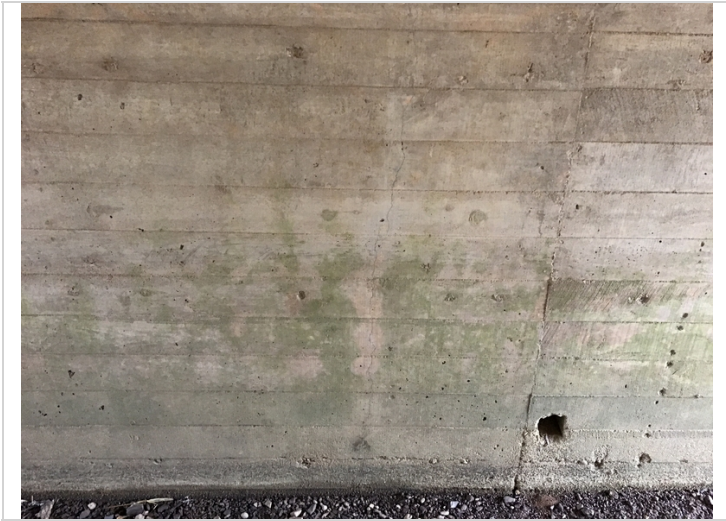
Few minor vertical cracks in the walls of barrels.

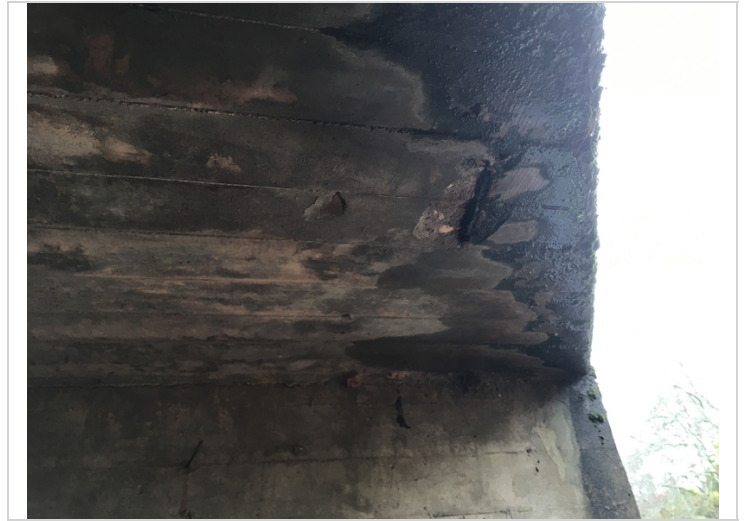
Right end of barrel #1 has exposed rebar in the top of the barrel.

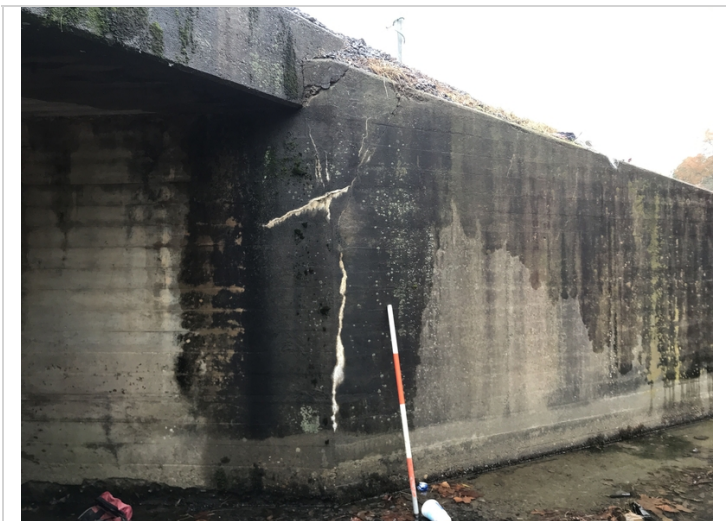
Right end of barrel #1 has minor to moderate vertical cracks with moderate efflorescence.

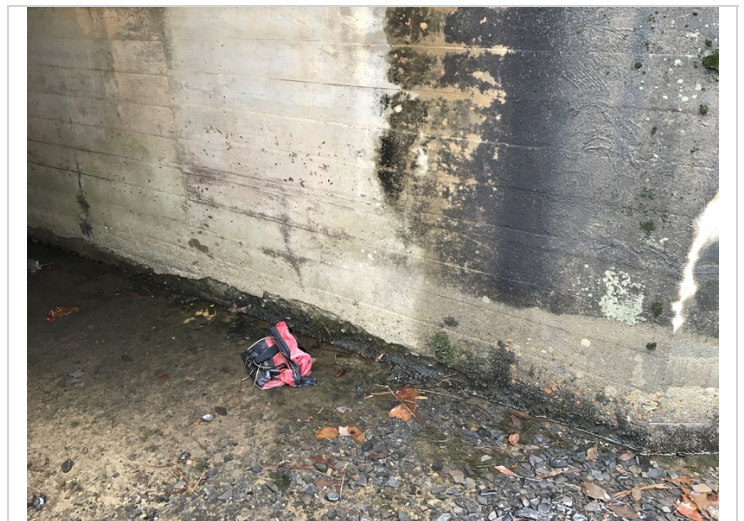
Bottom of the walls in barrels 2 & 3 near the right end have minor abrasion.

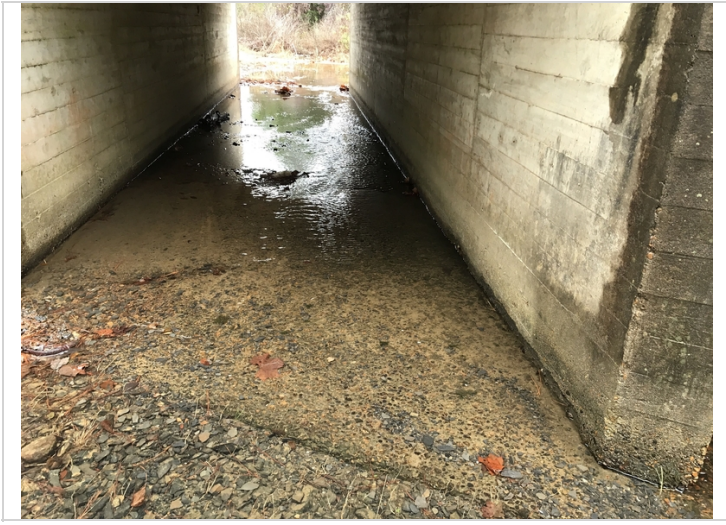
Barrels 2 & 3 have minor abrasion throughout the full length of the floor.

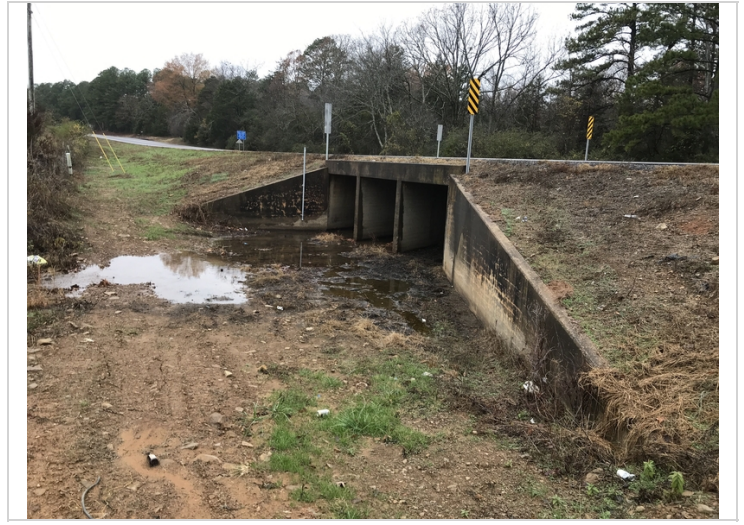
No scour

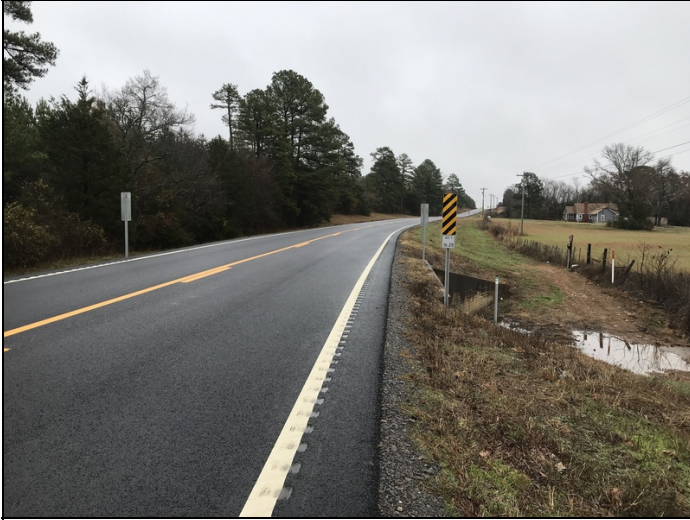
East bound log mile marker sign is incorrect, the west bound log mile marker sign is missing.

East bound log mile sign is incorrect, the west bound log mile sign is missing.  
The correct log mile is 16.0 - route 60 - section 1
