Asset #M0180(Routine)

SH 7 S-6 LM 8.66 over TUPELO CR.

Location: 2.5 MI SE JCT SH 51

Team Lead: Rickie Bratton, Inspection Date: 01/10/2024

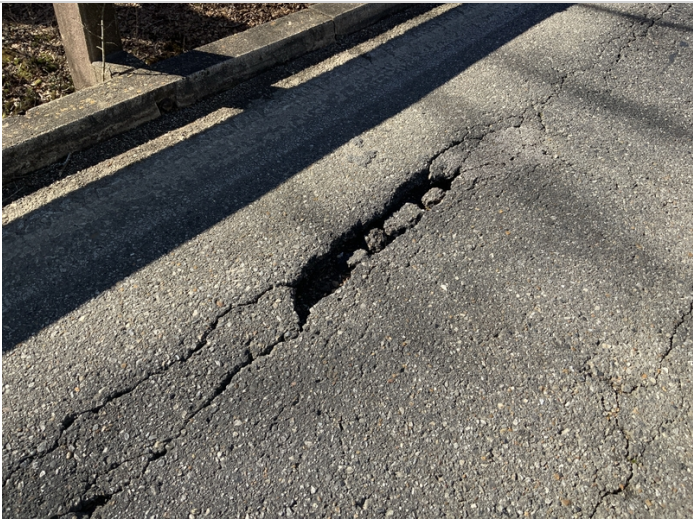
Spall in asphalt wearing surface

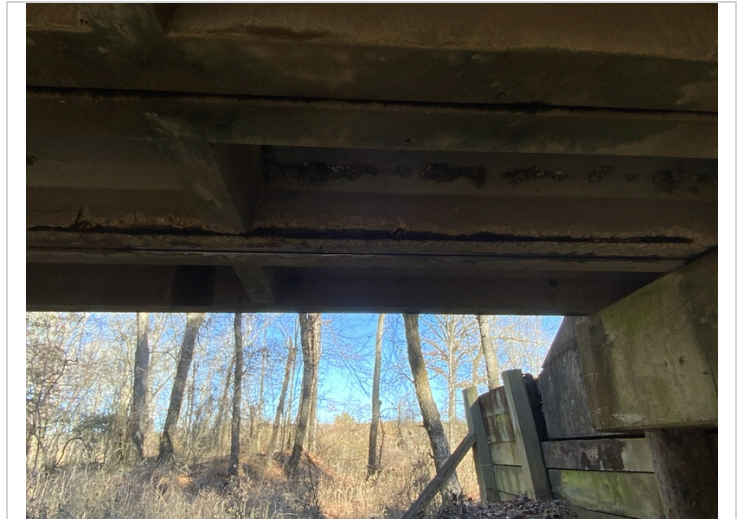
Span 1 units 2,6 exposed rebar.

Span 1 unit 6 exposed rebar right leg.

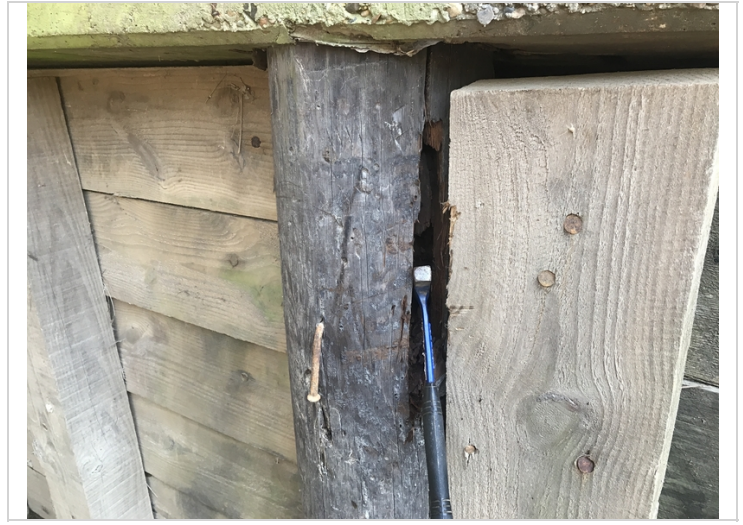
Abutment 1 pile 1

(228) Pile 1 at bents 1 and 5 are hollow with inside decay.							
234	Reinforced Concrete Pier Cap	LF	151	125	0	26	0
1080	Delamination/Spall/Patched Area	LF	2	0	0	2	0
1090	Exposed Rebar	LF	24	0	0	24	0

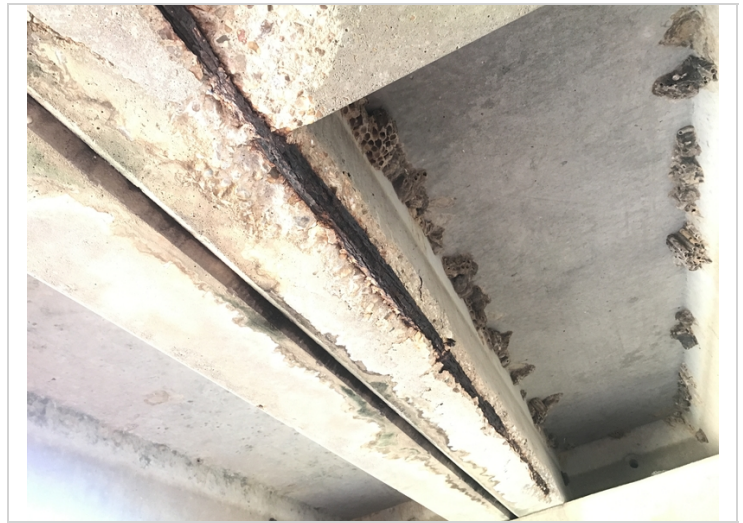
Span 1, unit 6, left leg, section loss to rebar.

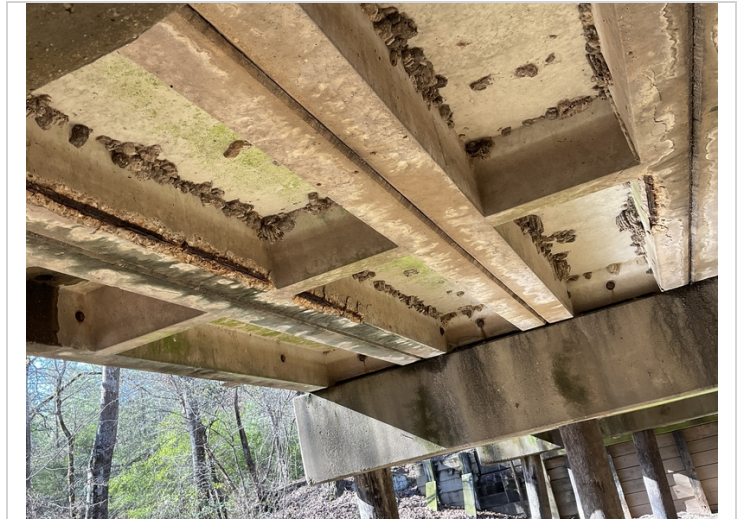
Span 3 units 2,3 exposed rebar.

Span 3 units 2 and 3 legs have spalls with exposed rebar.

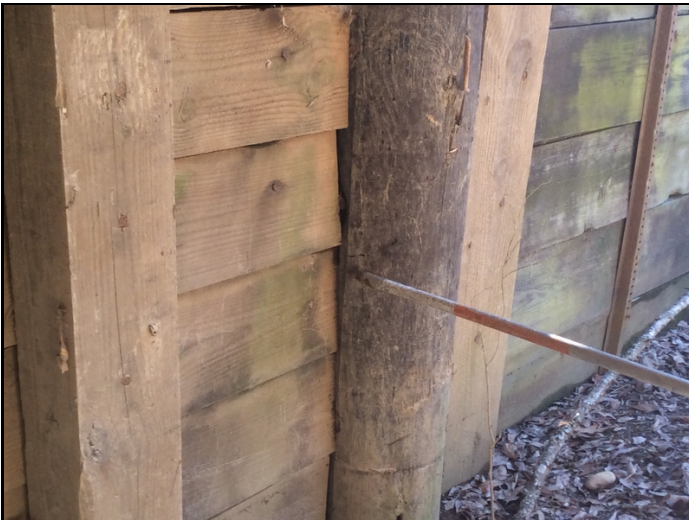
Bent 1 Pile 1 hollow & outer shell has split vertically @ the backwall, & the section of shell behind the backwall has slid inside the section outside the backwall. There is about 1 1/2" of shell at this point, this is a 5 pile bent.

Bent 1 Pile 1 hollow & outer shell has split vertically @ the backwall.

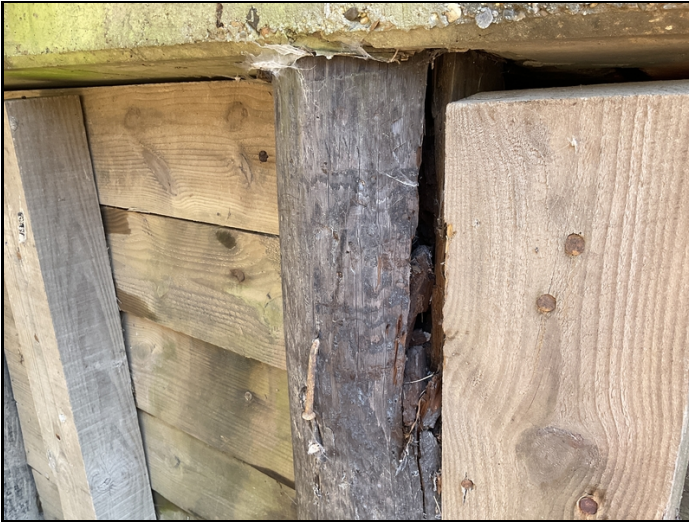
Bent 1 pile 1 and bent 5 pile 1 hollow with inside decay,

Bent 1 pile 1 is hollow.

Type of Work: Replace (General)

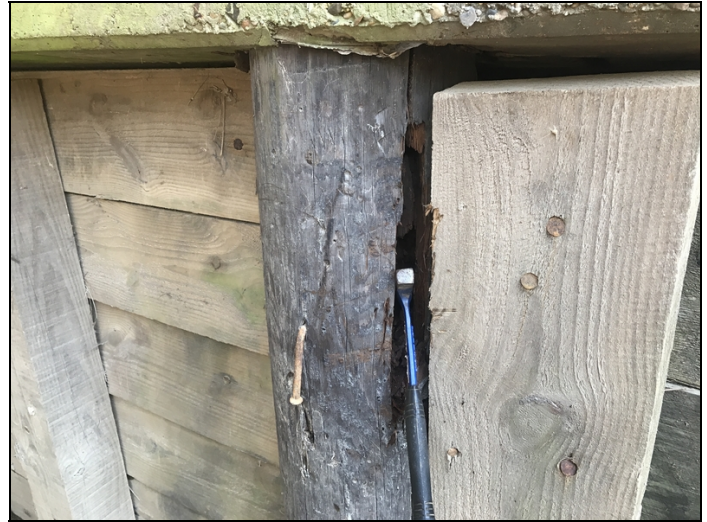
Abutment 1 pile 1 inside decay

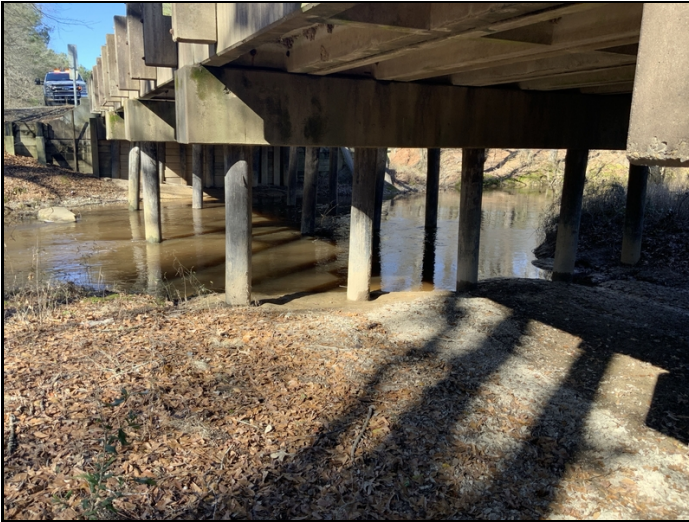
Log and drift against pile 5 bents 4&5 restricting flow of water.

Debris has been removed
