Asset #X1069(Routine)

SH 7 S-5 LM 8.94 over Cypress&amp;Bever Cr. Relief

Team Lead: Rickie Bratton, Inspection Date: 01/03/2024

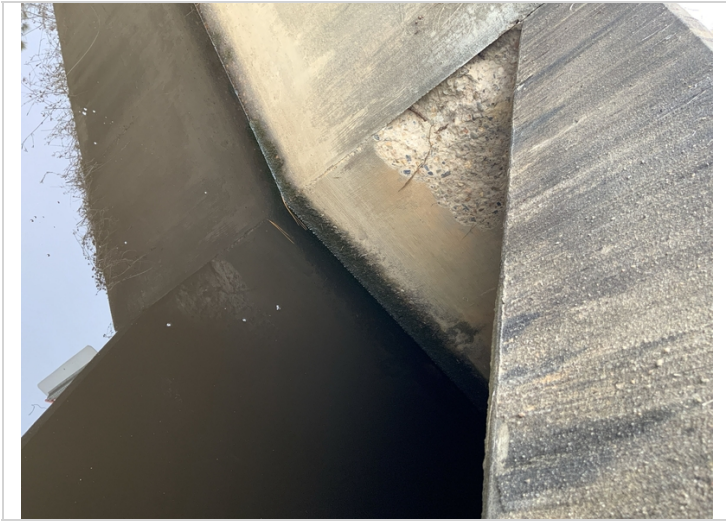
ELEMENTS	DESCRIPTION	UNITS	TOTAL	CS1	CS2	CS3	CS4
241	Reinforced Concrete Culvert	LF	228	214	11	3	0
1080	Delamination/Spall/Patched Area	LF	3	0	0	3	0
1090	Exposed Rebar	LF	1	0	1	0	0
1130	Cracking (RC and Other)	LF	10	0	10	0	0
(241) 02/05/2018 JPR -- Barrel #1 Lt. there is a 1' spall @ top of barrel on the wingwall, and barrel #4 Lt. there is a 2' spall @ top of the culvert wall just inside the box culvert, neither of the 2 spalls have any exposed steel at this time. Barrel #4 Rt. side there is a vertical crack about 1' inside the box barrel on the outside wall, that is full height of the box barrel, there is also a horizontal crack that starts at the vertical crack and runs back up in the box culvert about 2'. Spall with exposed rebar outer wall.							
(1090-241) Barrel 4 left end outside wall exposed rebar.							
(1130-241) All barrels have cracking.

Comment: Good Condition - Minor efflorescent cracks, with one exposed rebar

Barrel 4 spall with exposed rebar.
