Asset #X1103(Routine)

SH 7 S-5 LM 9.24 over Beaver Relief

Team Lead: Rickie Bratton, Inspection Date: 01/03/2024

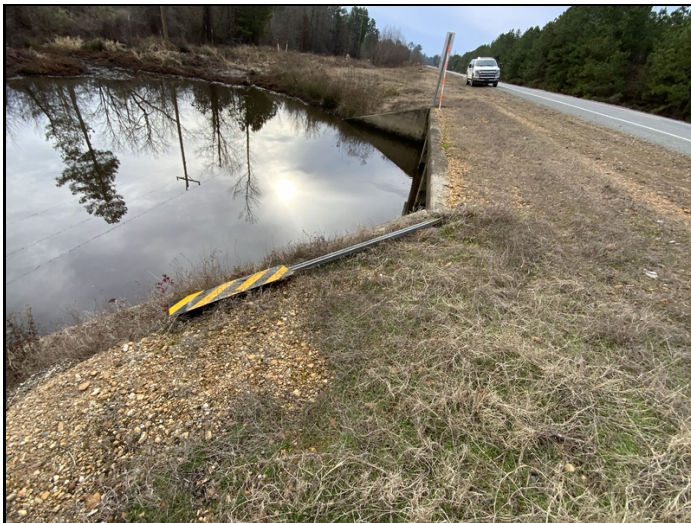
Northeast flare board sign is down.

Type of Work: Repair (General)
