Asset #X1104(Routine)

SH 7 S-5 LM 9.45 over Beaver Relief

Team Lead: Rickie Bratton, Inspection Date: 01/03/2024

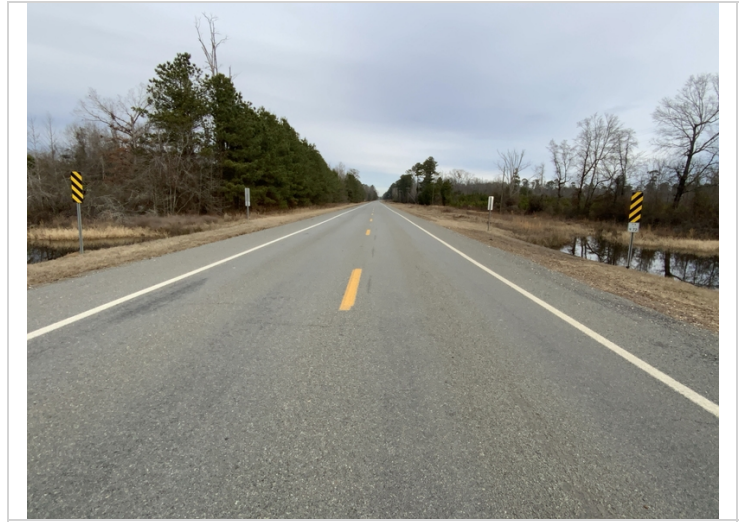
Approach roadway Northbound

ELEMENTS	DESCRIPTION	UNITS	TOTAL	CS1	CS2	CS3	CS4
241	Reinforced Concrete Culvert	LF	224	168	56	0	0
4000	Settlement	LF	56	0	56	0	0
(241) 02/05/2018 North bound lane @ both sides of the box culvert there is roadway settlement, see pictures.

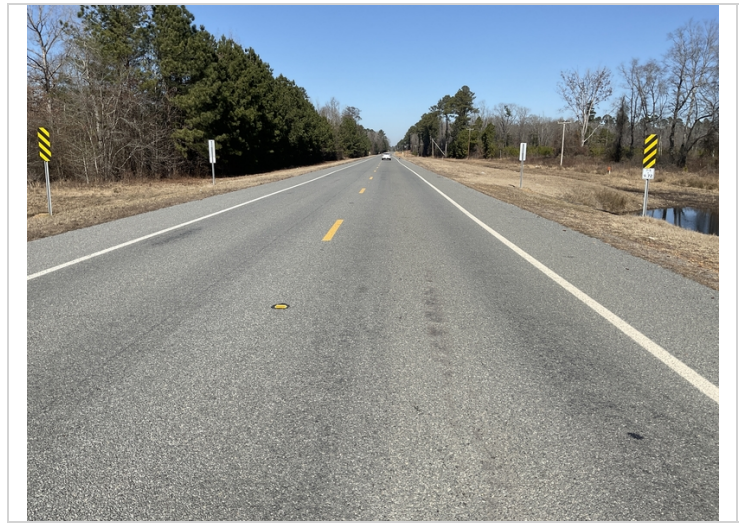
Roadway

New chip seal overlay has been added since last inspection, RHB 2-19-2020.
