Asset #X1105(Routine)

SH 7 S-5 LM 9.64 over Beaver Creek

Team Lead: Rickie Bratton, Inspection Date: 01/03/2024

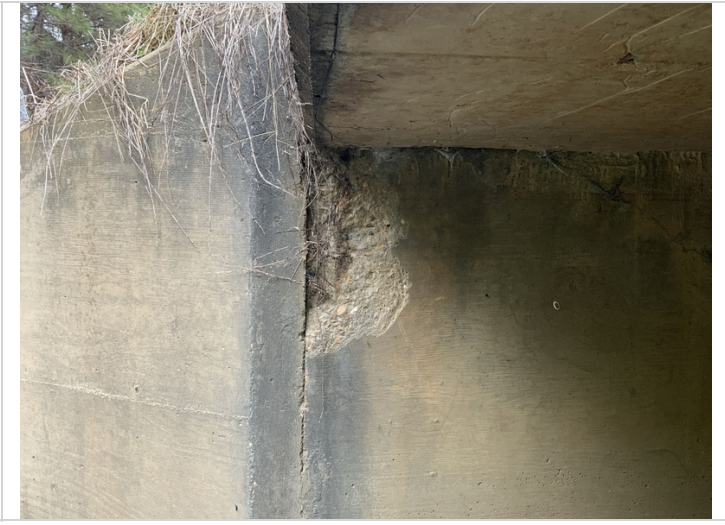
ELEMENTS	DESCRIPTION	UNITS	TOTAL	CS1	CS2	CS3	CS4
241	Reinforced Concrete Culvert	LF	252	242	10	0	0
1090	Exposed Rebar	LF	1	0	1	0	0
1120	Efflorescence/Rust Staining	LF	7	0	7	0	0
1130	Cracking (RC and Other)	LF	2	0	2	0	0
(1090-241) Barrel 4 left end outside wall, exposed rebar.							
(1120-241) Small cracks with light efflorescence, in barrels							
(1130-241) Small cracks in various spots in barrels.

Barrel 4 left end, exposed rebar

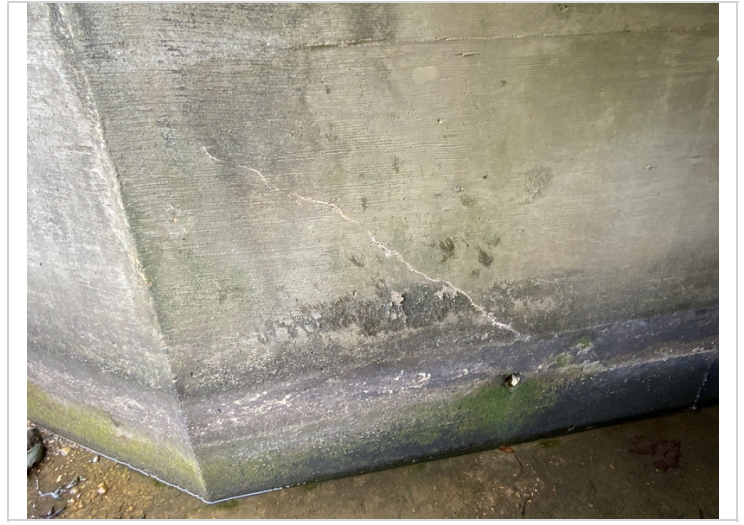
Barrel 1 crack with efflorescence outer wall

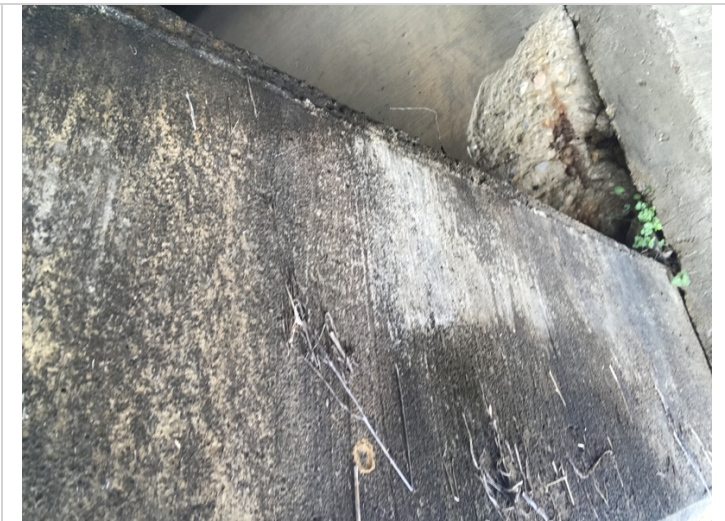
Barrel 4 left side, outside wall, spall with exposed rebar.

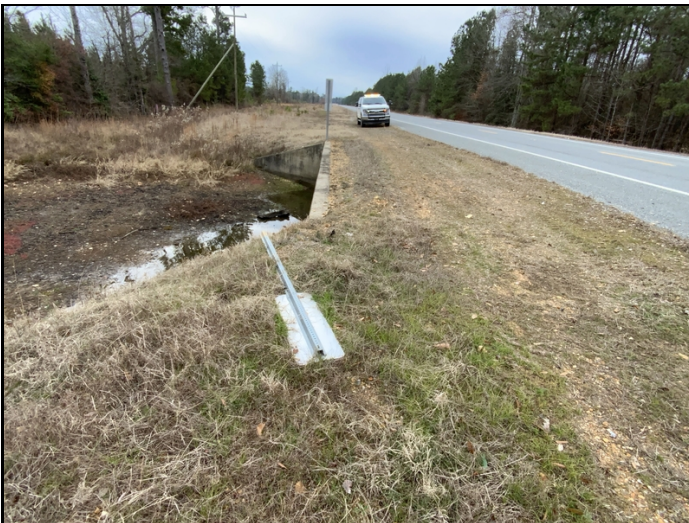
Northeast flare board is down.

Type of Work: Repair (General)
