Asset #X1106(Routine)

SH 7 S-5 LM 9.82 over Cypress Creek

Location: 10.09 Mi. No. Oua. Co.

Team Lead: Rickie Bratton, Inspection Date: 01/03/2024

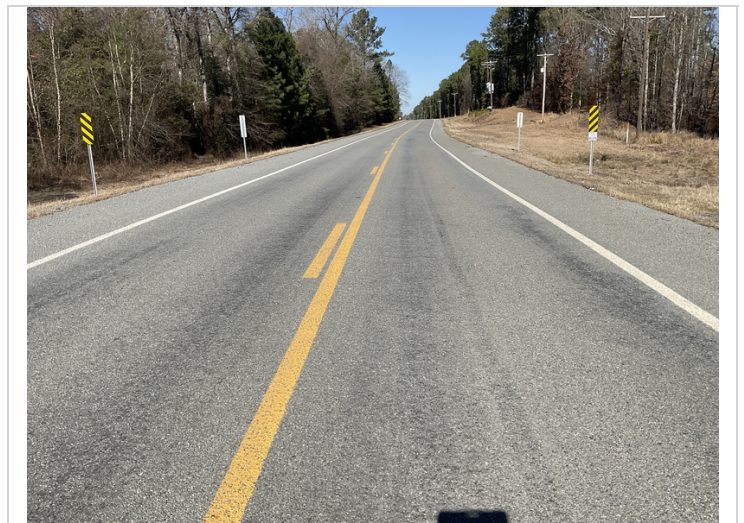
Roadway

ELEMENTS	DESCRIPTION	UNITS	TOTAL	CS1	CS2	CS3	CS4
241	Reinforced Concrete Culvert	LF	228	228	0	0	0
(241) ACHM surface is rough over this box culvert. See picture file.

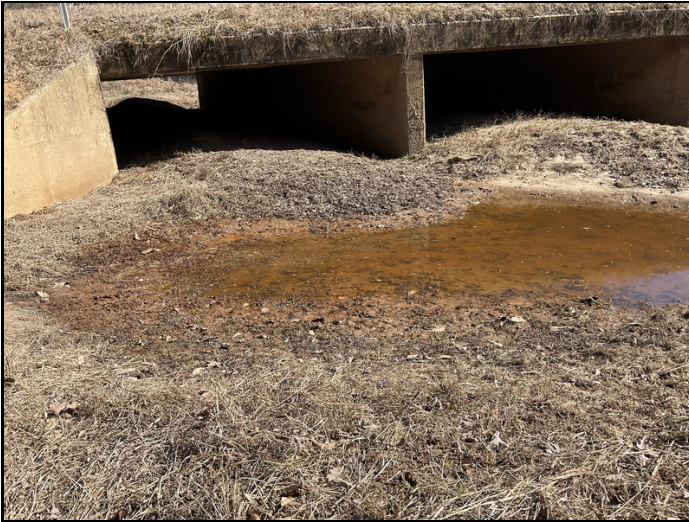
Barrels 3 and 4 silted in up to 3/4 entire length of barrels.

Silt barrels 3 and 4 outlet end.

Type of Work: (Inactive) (Inactive) 1 - Clean

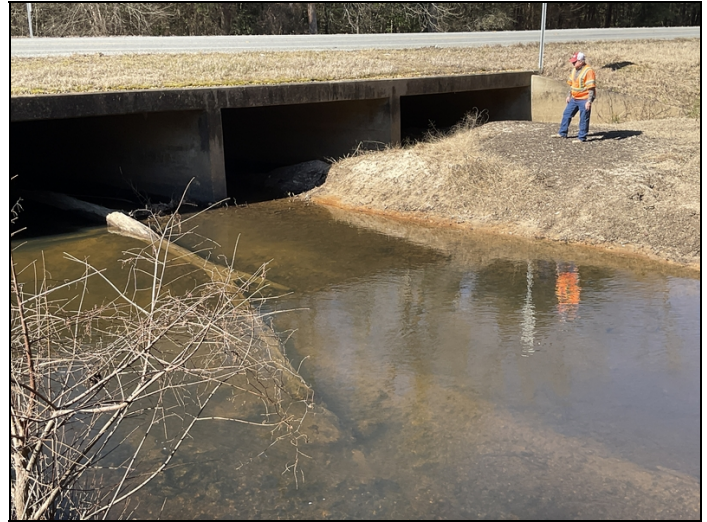
Barrels 3 and 4 silted in on inlet end.

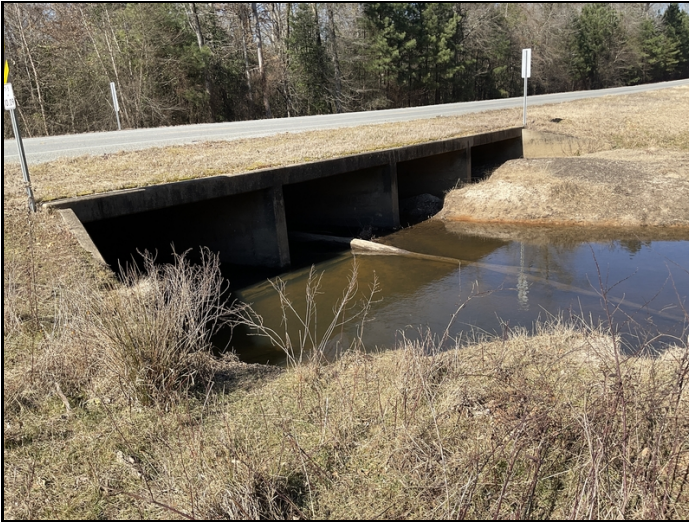
Drift in barrel 2 inlet end.

Drift barrel 2

Type of Work: (Inactive) (Inactive) 1 - Clean
