Asset #06147(Routine)

SH 273 S-1 LM 5.76 over WEST FK FREEO CREEK

Team Lead: John Parks, Inspection Date: 09/13/2022

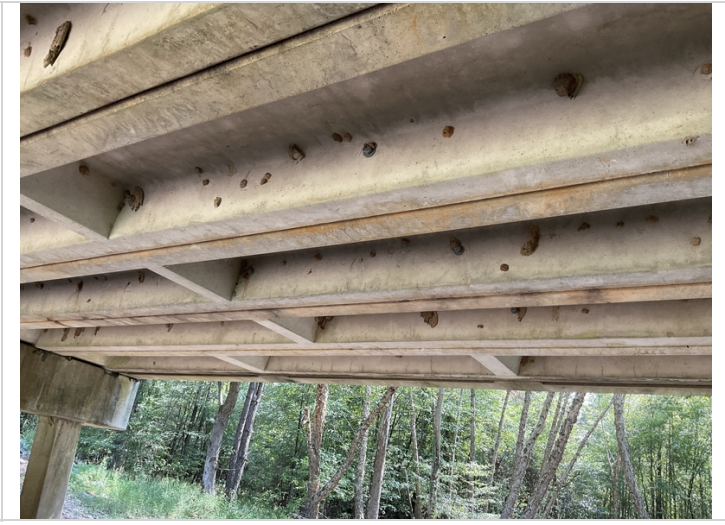
Typical view of the girders.

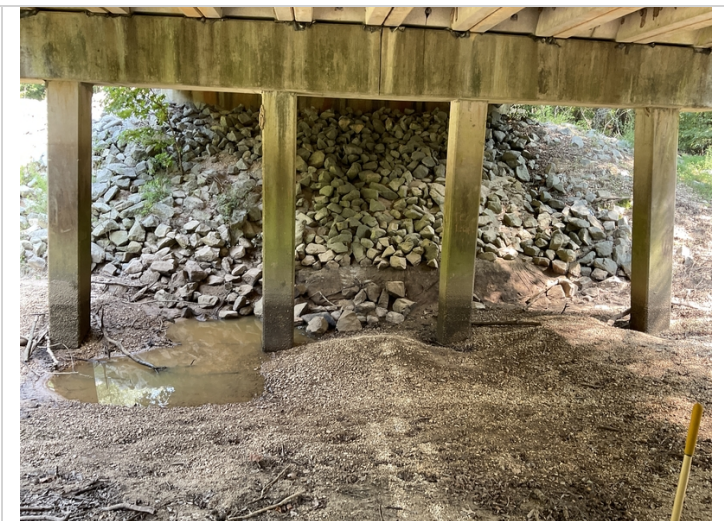
Bt. 3 pile have abrasion

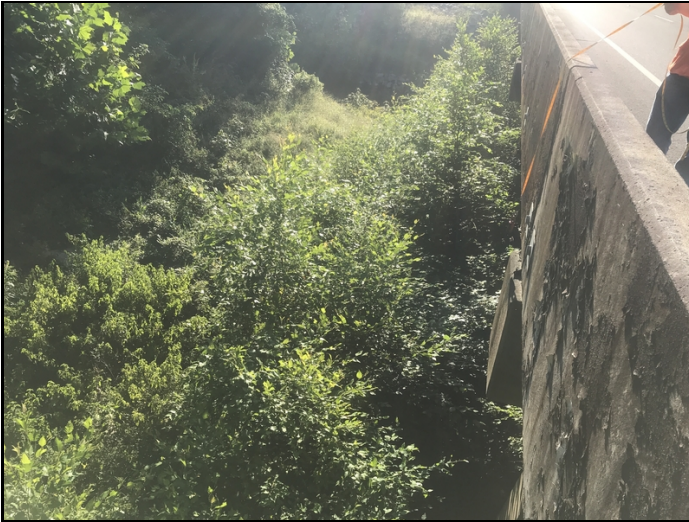
Vegetation left side

A-64 - Vegetation Removal Requested
