Asset #06148(Routine, Underwater type 2)

SH 273 S-1 LM 7.55 over FREEO CREEK

Location: 7.56 MI E JCT SH 9

Team Lead: John Parks, Inspection Date: 09/13/2022

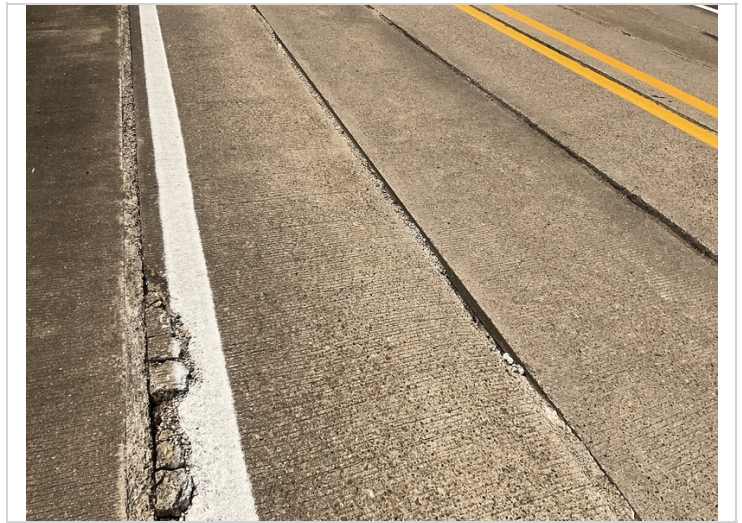
Small chips along keyways, unit 3 span 1 has large chips with loose concrete. Keyway grout is missing for a large portion of the structure.

Spalls in the keyways and keyway grout.

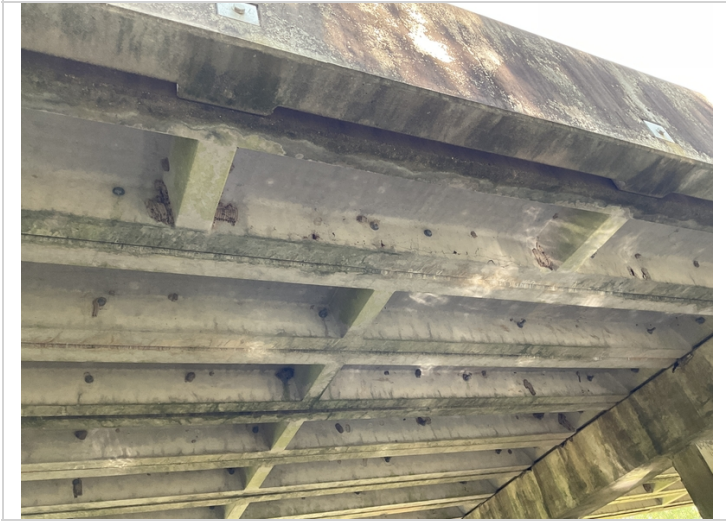
(110) Some water staining, all joints leaking, transverse and longitudinal.							
215	Reinforced Concrete Abutment	LF	62	62	0	0	0
(215) Slope areas are heavily eroded below the rip rap zone.							
227	Reinforced Concrete Pile	EA	12	8	4	0	0
1190	Abrasion/Wear (PSC/RC)	EA	4	0	4	0	0
234	Reinforced Concrete Pier Cap	LF	92	90	0	2	0
1080	Delamination/Spall/Patched Area	LF	2	0	0	2	0

Span 2 girder 8, cracks & exposed rebar.

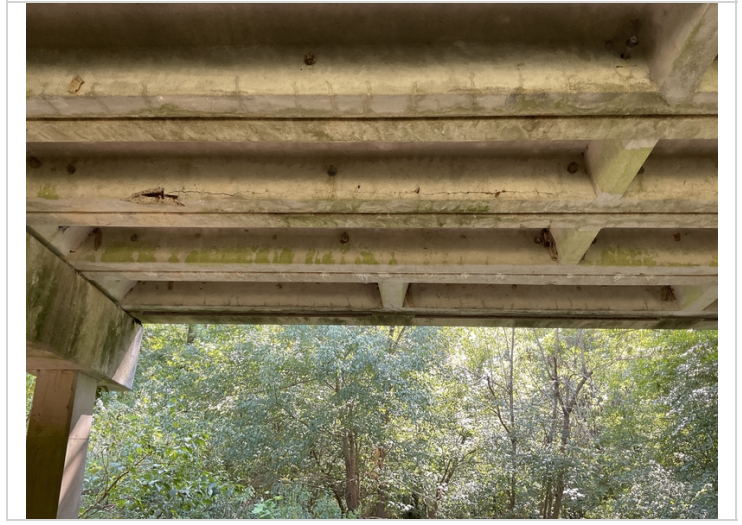
Span 3, girder 7, cracks & spalls with exposed rebar.

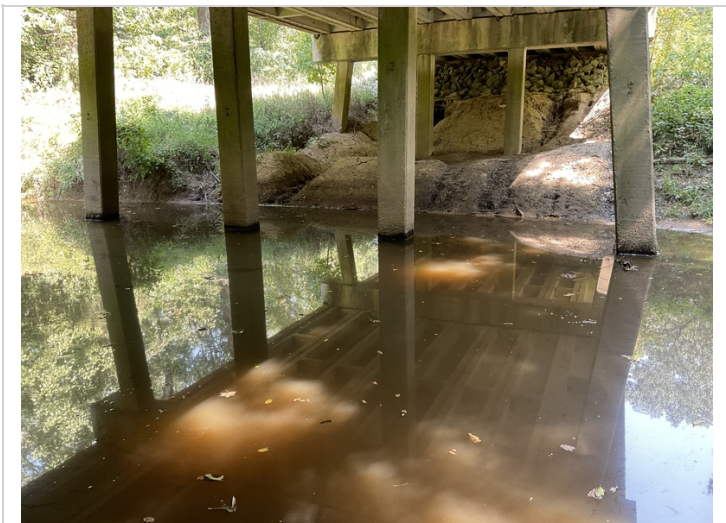
Bt. 3 pile have abrasion

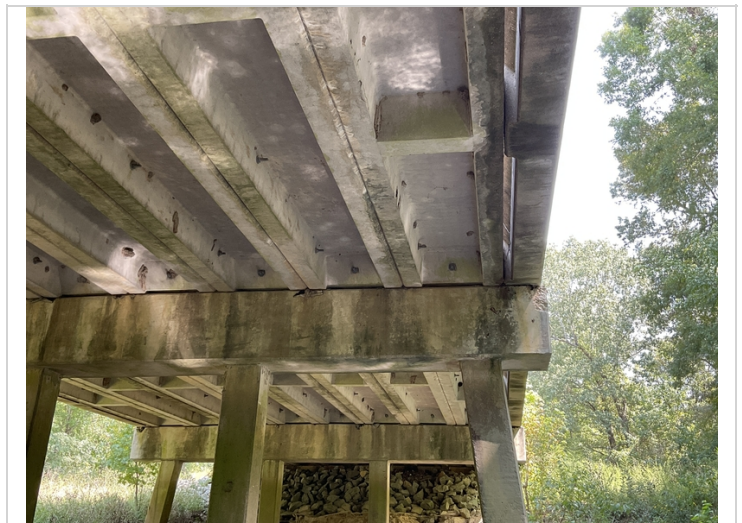
(234) Spall bent 3 cap spalled right side							
304	Open Expansion Joint	LF	92	0	0	92	0
2350	Debris Impaction	LF	92	0	0	92	0
331	Reinforced Concrete Bridge Railing	LF	248	248	0	0	0

Bt. 3, right end of the cap.

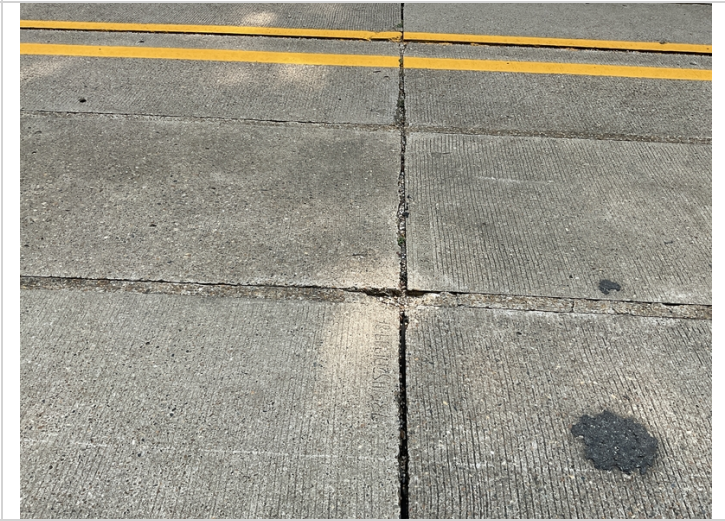
Joint material is gone and joints are full of debris.

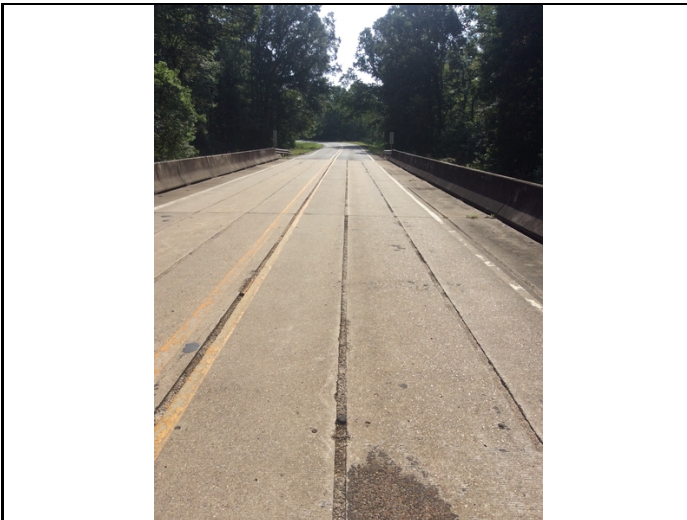
PC units are spalled and chipped . Grout is missing along several key ways. 08/06/2018 JPR -- There has been some minor changes as can be seen in the pictures below from 2012 till 2016 & 2018.

06148 grout missing from key ways

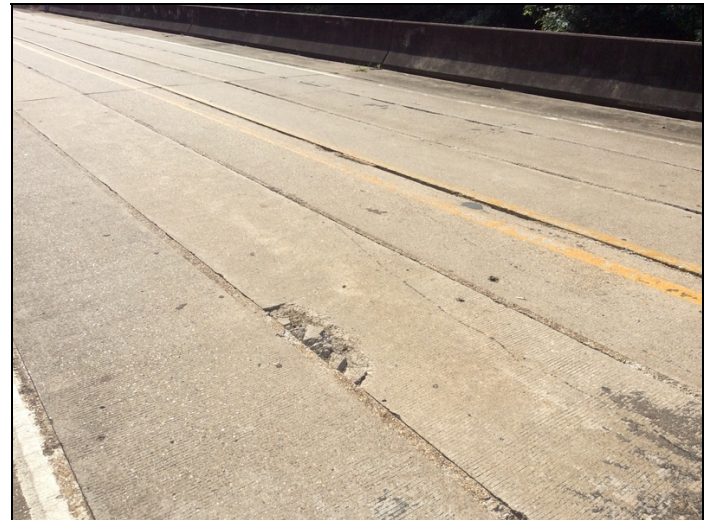
06148 span 1 unit 3

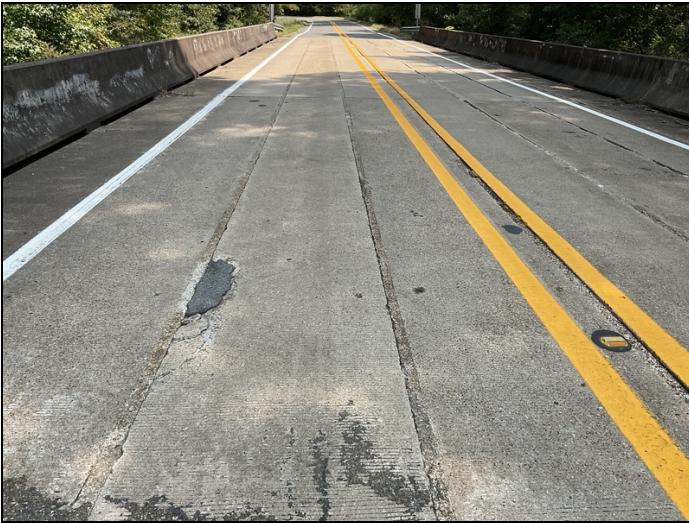
Spalls along the keyways and missing grout.

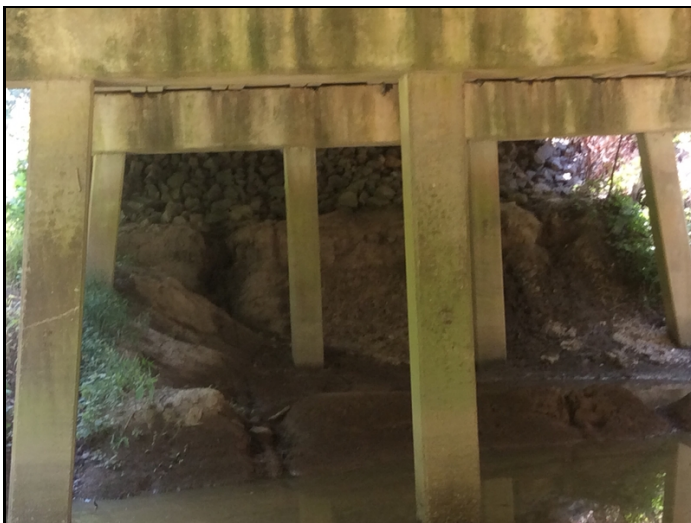
Abutment 2 slope erosion, this is caused by the missing keyway grout.

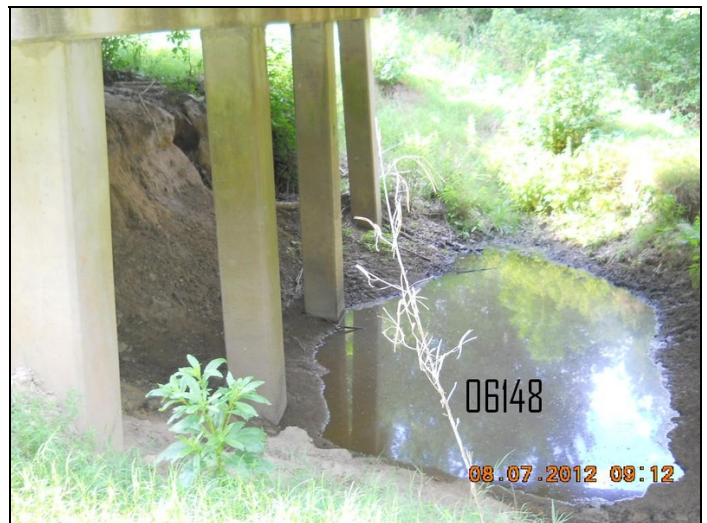
Slope areas are heavily eroded below the rip rap zone. Bank lines are eroded also. Most rip rap is in place but will eventually erode. Scour hole under span 2 and along bent 2.

Large hole scoured under span 2 @ Bt. 2.

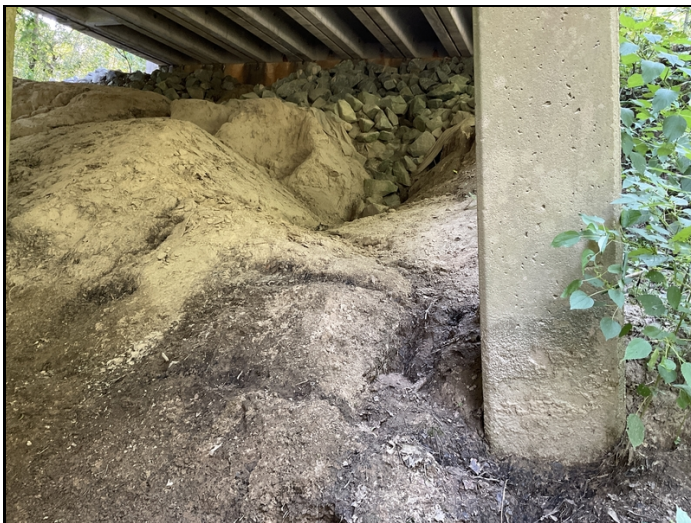
Span 1, embankment has been scoured.

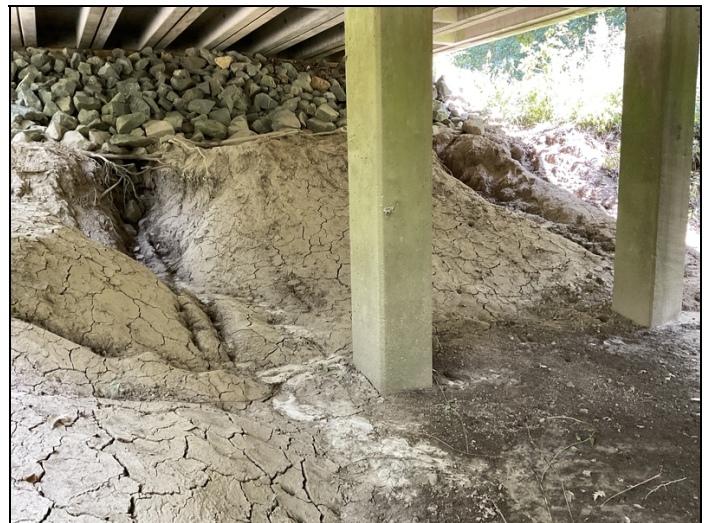
Channel scour. Bent 4. Large hole scoured under spans 1 & 4. 08/06/2018 JPR -- Little or no change since 2012 inspection.

Scour in span 4.

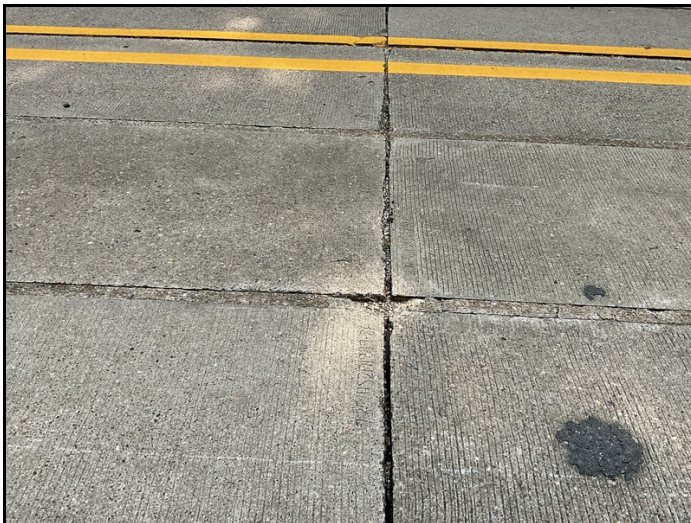
Joint material is gone and joints are impacted with debris.

Joint material is gone and joints are full of debris.
