Asset #X0645(Routine)

SH 273 S-1 LM 4.15 over MARSHALL CREEK

Location: 4.15 MI EAST JCT SH 9

Team Lead: John Parks, Inspection Date: 08/25/2022

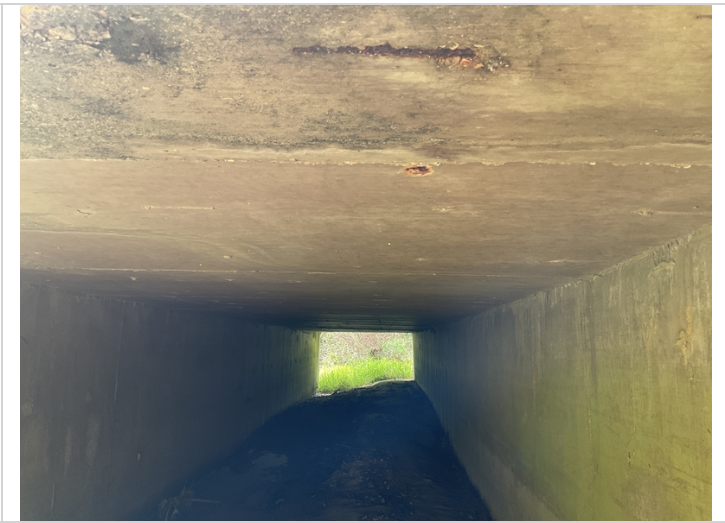
Barrels 1, 2, & 3 have exposed rebar in the tops due to insufficient concrete cover.

Barrel 3, typical view of the barrels.

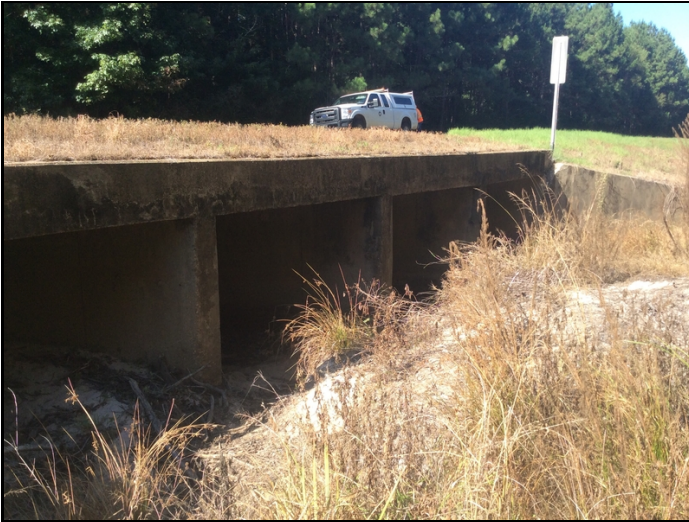
Left of the culvert side has silt built up @ outlet end of all barrels for 3/4 of the openings.

Outlet end, Lt. side has silt built up @ outlet end of all barrels for 3/4 of the openings.

Type of Work: (Inactive) (Inactive) 1 - Clean

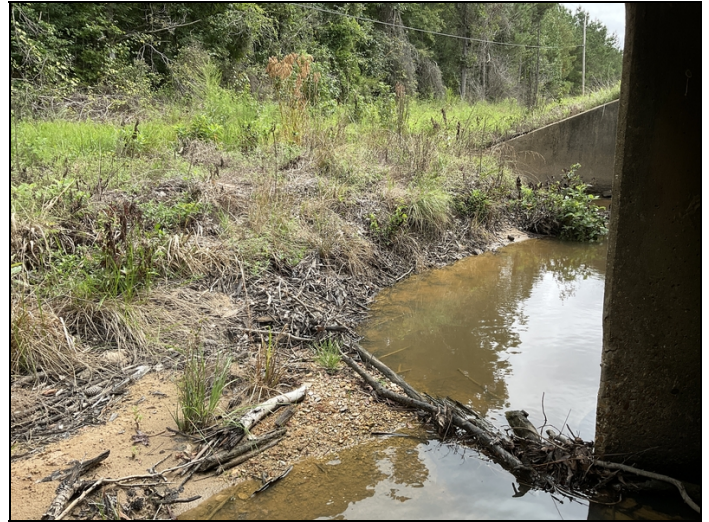
Left of the culvert side has silt built up @ outlet end of all barrels for 3/4 of the openings.

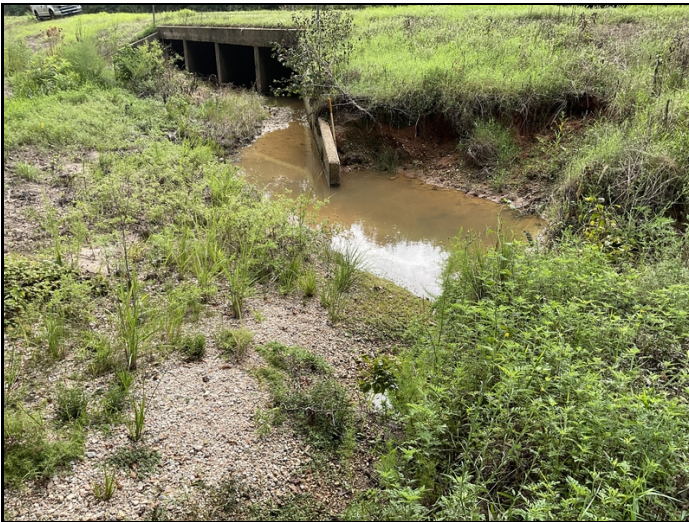
61 - Channel/Channel Protection (6 - Bank is beginning to slump. River control devices and embankment protection have widespread minor damage. There is minor stream bed movement evident. Debris is restricting the channel slightly.) The channel at the upstream end of the culvert is has moved due to sediment build up at the mouth of the culvert and is scouring the embankment behind barrel 1 wing wall.

The channel at the upstream end of the culvert is has moved due to sediment build up at the mouth of the culvert and is scouring the embankment behind barrel 1 wing wall.

Type of Work: Repair (General)

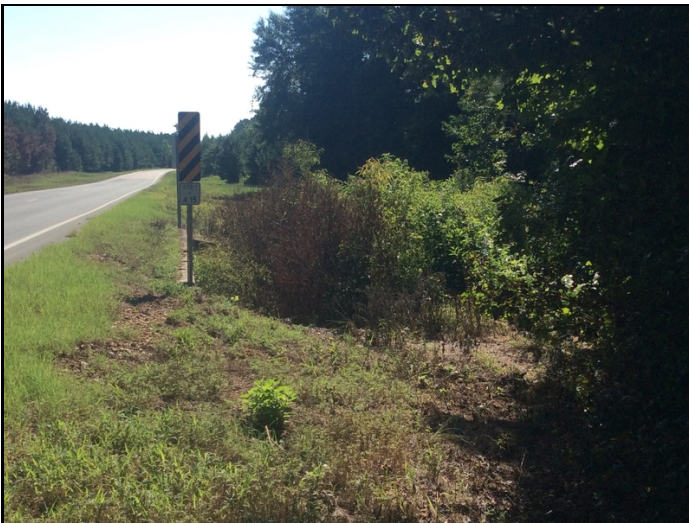
Vegetation right side

Type of Work: (Inactive) (Inactive) 1 - Clean

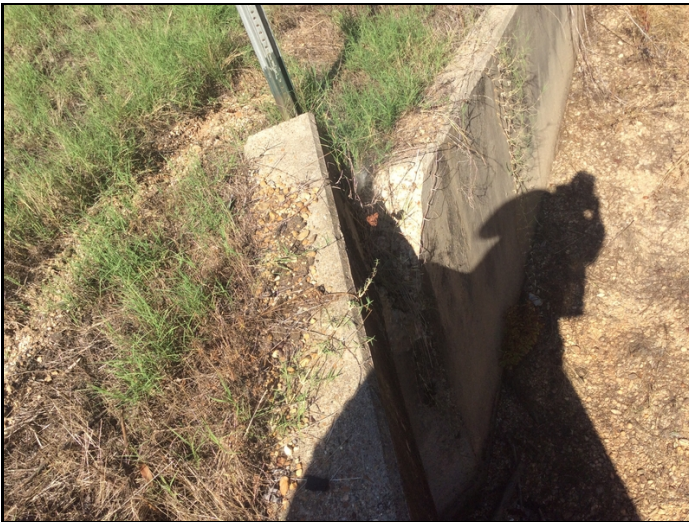
Wingwall left side broke at barrel 1

Type of Work: Repair (General)

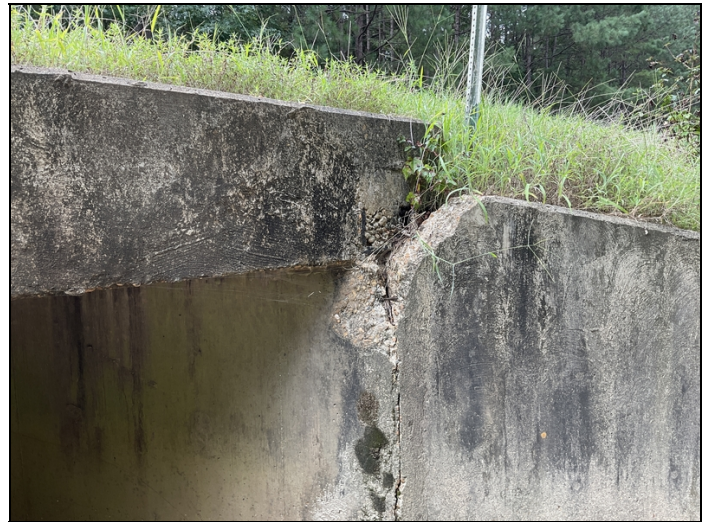
Barrel 1, left side, the wing wall has broken.

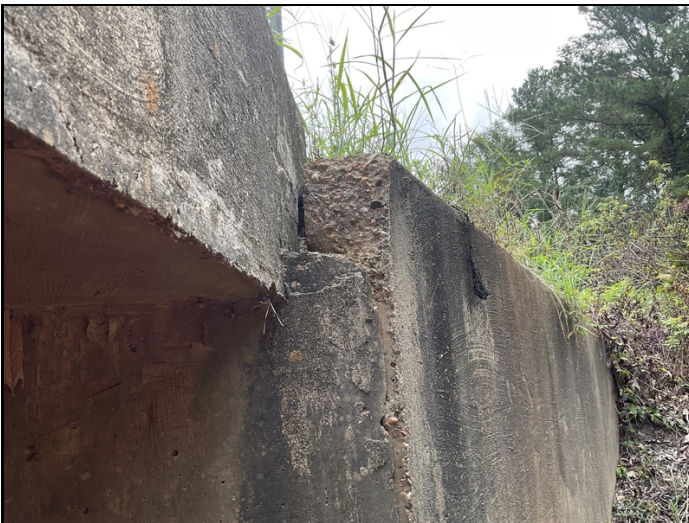
Barrel 4, right wing wall has separated.
