Asset #X0646(Routine)

SH 273 S-1 LM 9.08 over CREEK

Location: 6.3 MI W JCT US 79/79B

Team Lead: John Parks, Inspection Date: 08/25/2022

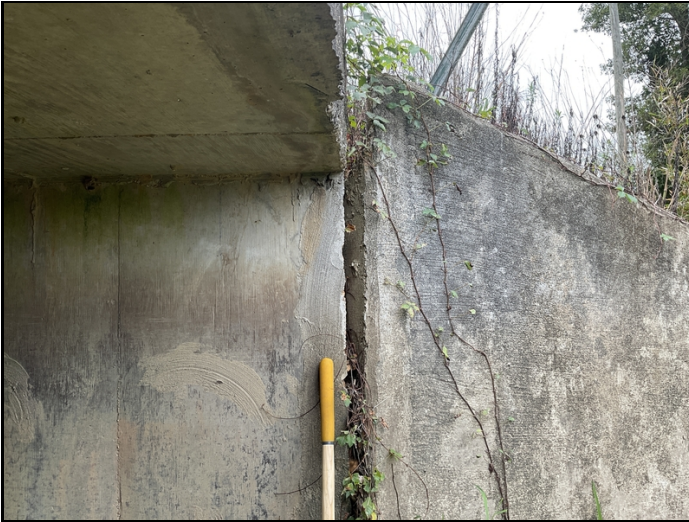
Comment: 08/06/2018 JPR -- Box Culvert barrel 3, Rt. Wingwall has separated from box Culvert outside wall.

Right end of barrel 3, the wing wall has separated.

Priority: C - Important

Type of Work: Repair (General)

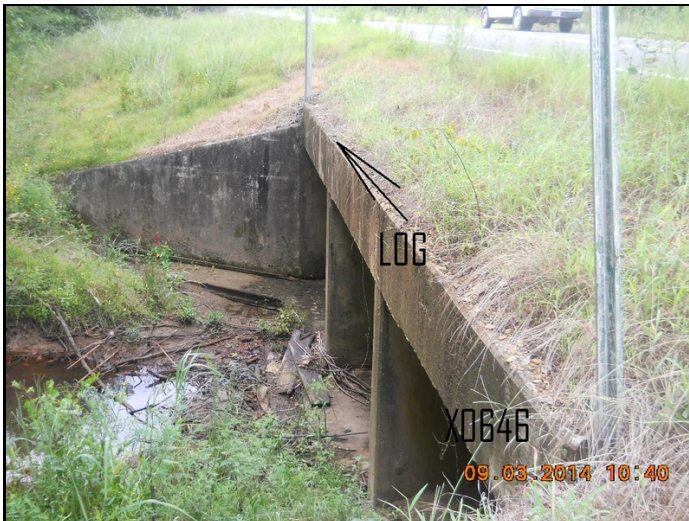
Inlet and ends of box culvert @ barrel #1 is silted in 1/4 of the barrel.

Type of Work: (Inactive) (Inactive) 1 - Clean

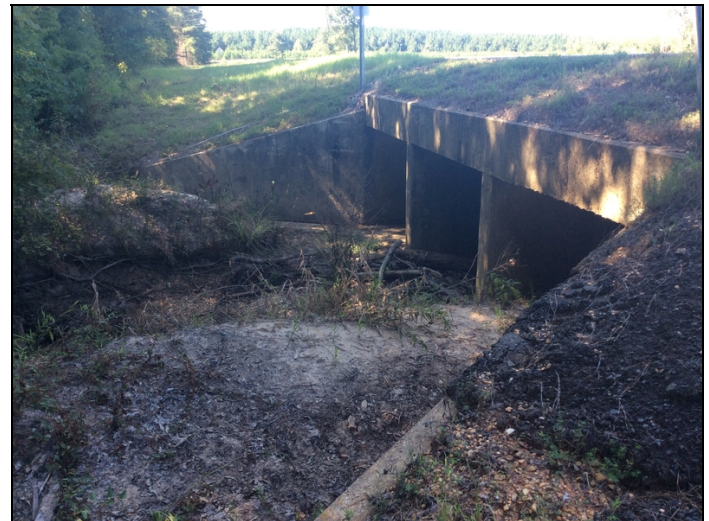
Lt. side of box has significant silt built up just outside the openings.

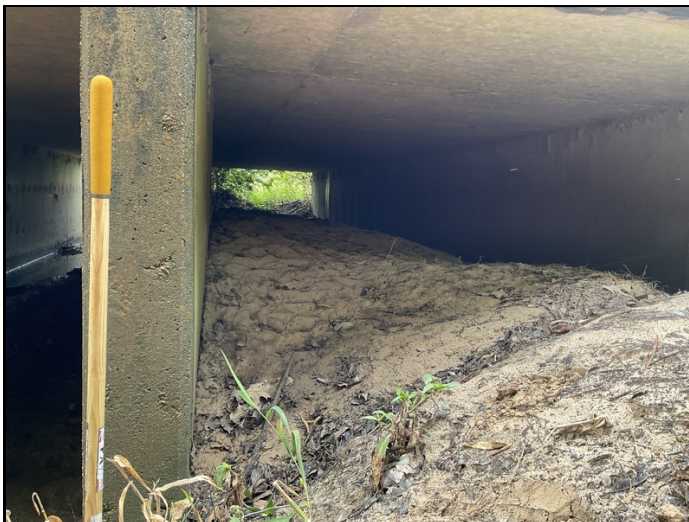
Barrel 1 is half full of sediment.
