Asset #M0161(Routine, NSTM)

SH 7 S-4 LM 2.10 over PALMER BAYOU

Location: 2.13 MI N JCT US 79B

Team Lead: Rickie Bratton, Inspection Date: 06/28/2023

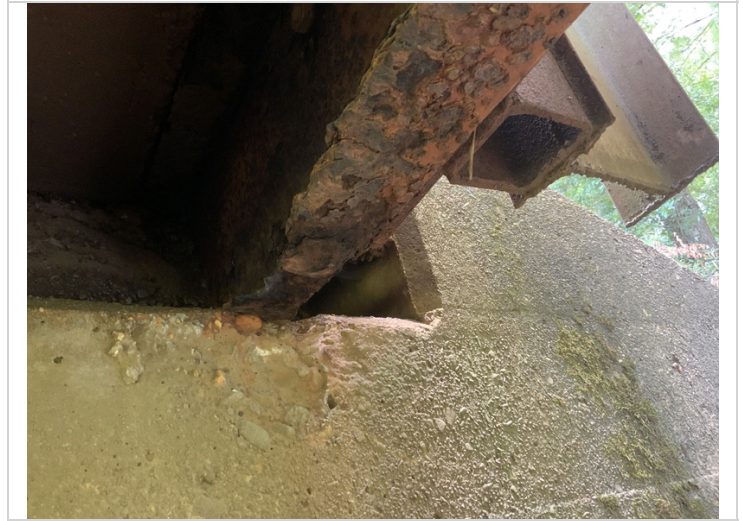
Bent 5 girder 12 section loss at bearing.

Bent 5 girder 12 section loss at bearing with hole in the web.

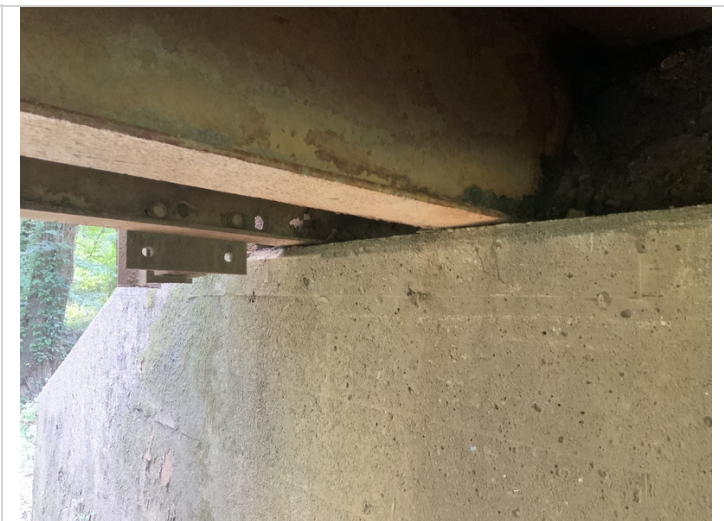
Bent 1 girders 11&12 holes in web at bearing.

Bent 1 girders 11/12 have holes in web at bearing.

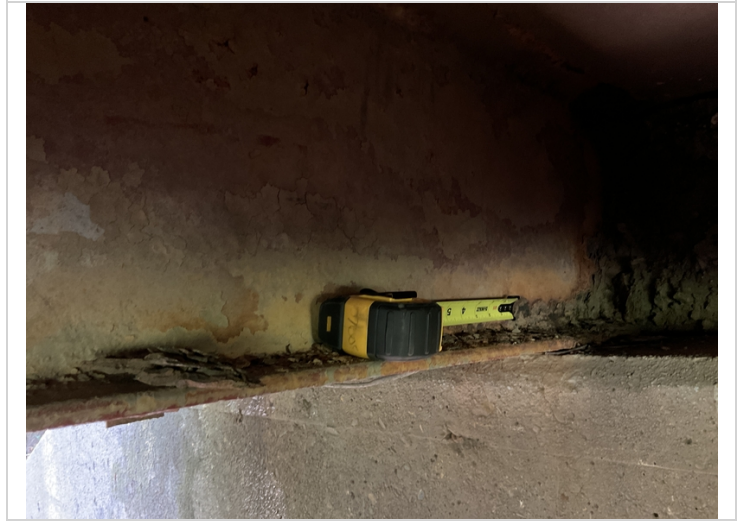
Span 1, Bt. 1, Bm 11, lower web and bottom flange have corrosion with up to 1/4" deep

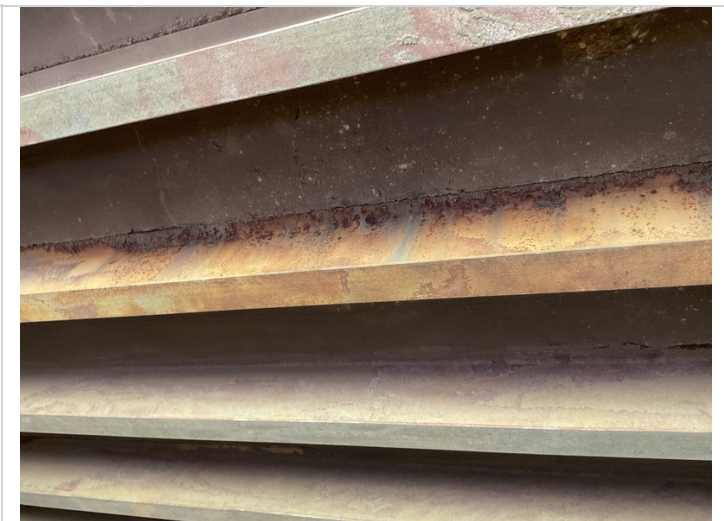
Beam 6, top flange has corrosion the entire length.

Beams 6 and 12 have active corrosion to the top flange the entire length of the beams.

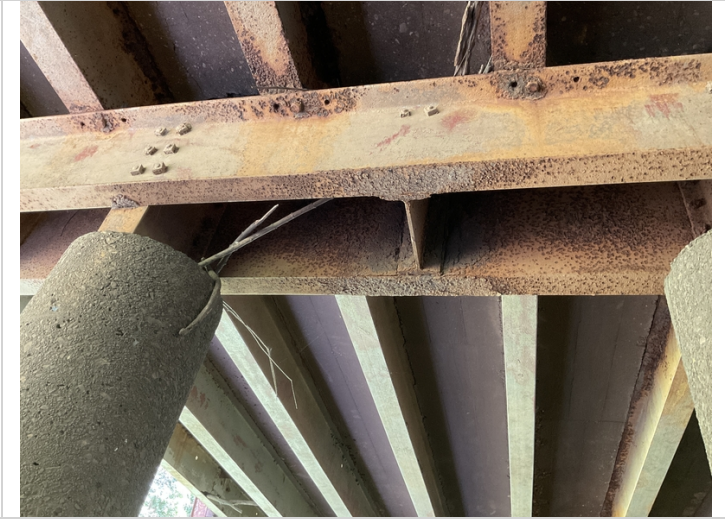
Bt. 3 steel cap, corrosion with minor pitting between columns
2 & 3.

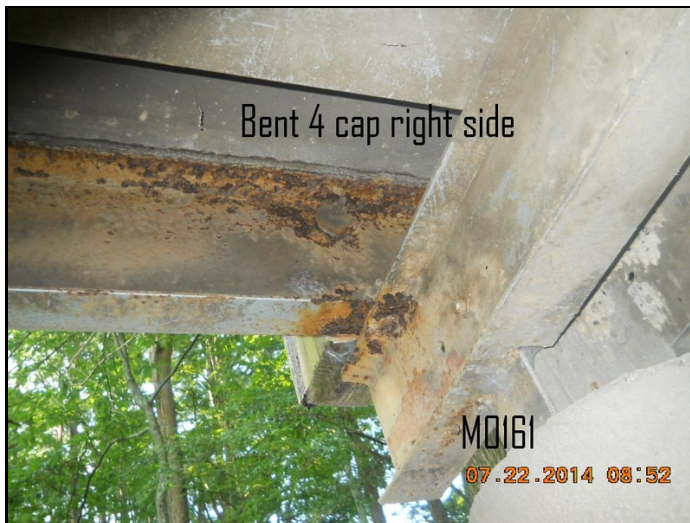
Bt 4, beam12 has some paint failure with pack rust and some section loss to top and bottom flanges and also to web over bent 4 Rt.

Bent 4 girder 12 has some pack rust with some section loss to top & bottom flanges and the web over Bt. 4.

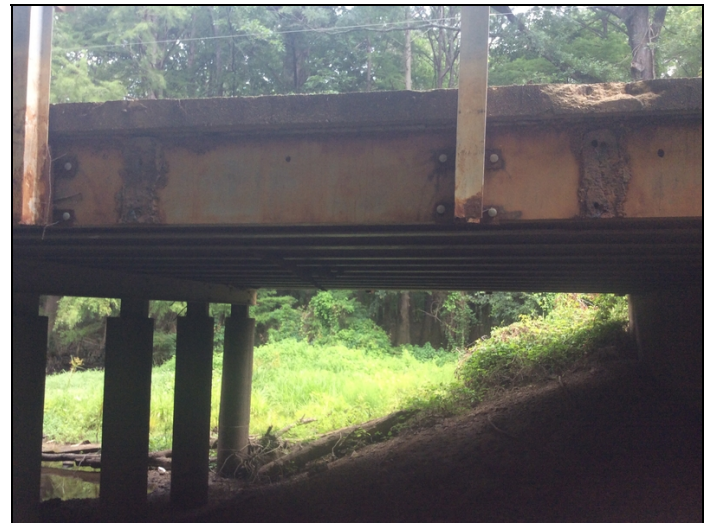
Span 4 girder 12 has some plates that were added onto girder 12 and had old guard rail posts attached to them, these plates have heavy pack rust and the rust is starting to affect the bottom flange of outside girders @ all locations of the plates.

Span 4 Girder 12, there are plates that were welded to outside of girder 12 all spans & appears the old guard rail posts were mounted to these plates. These plates have heavy pack rust and the rust is starting to affect the bottom flange of outside girders @ all locations of the plates.

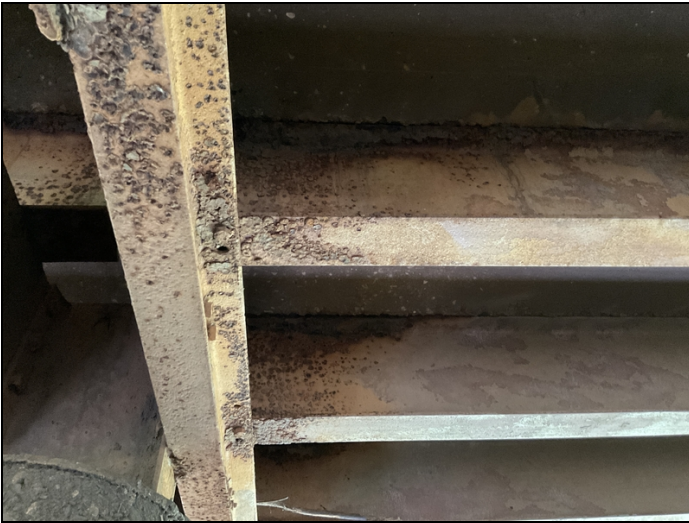
Span 3 at Bt 3, Beams 5 & 6, beam ends have active corrosion with pitting.

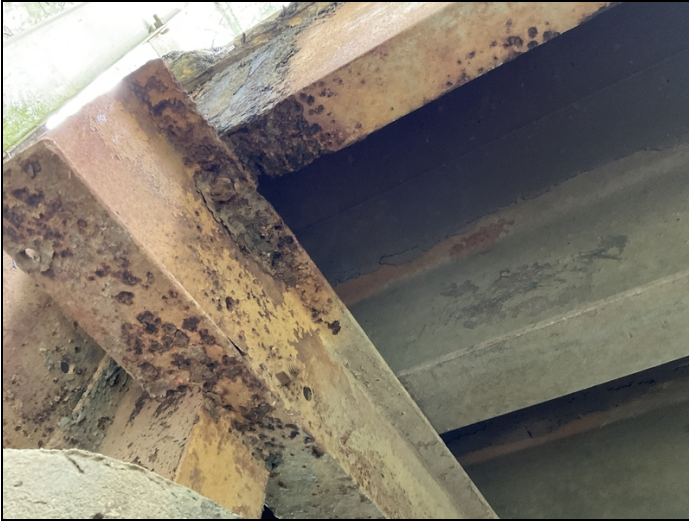
Span 4, Beam 12, Bt 3, hole in bottom flange.

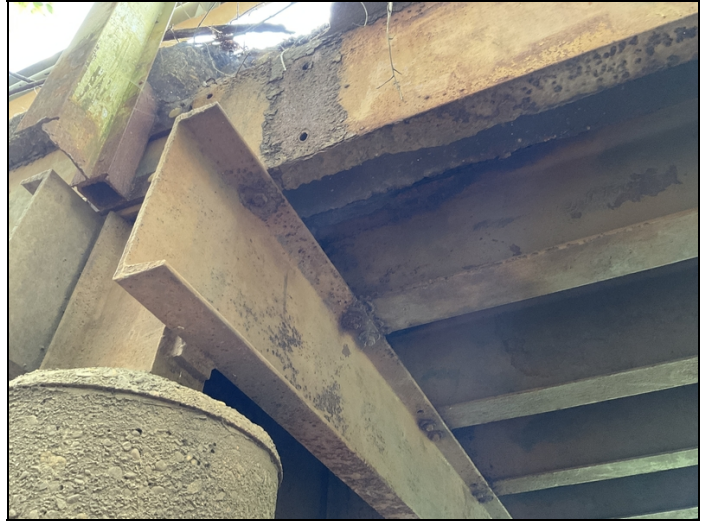
Span 3, Beam 12, Bt. 3.

Bent 3 girder 12 section loss to bottom flange.

Bt 3, beam 12 sec. loss to bottom flange and web.

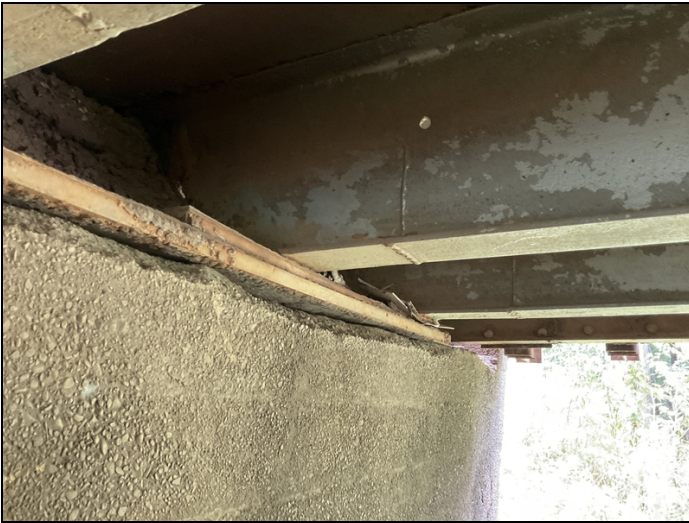
Span 1, Beam 3, Bt. 1.

Bt. 1, beam 3 has pack rust with minor section loss to bottom flange and web @ bearing area.

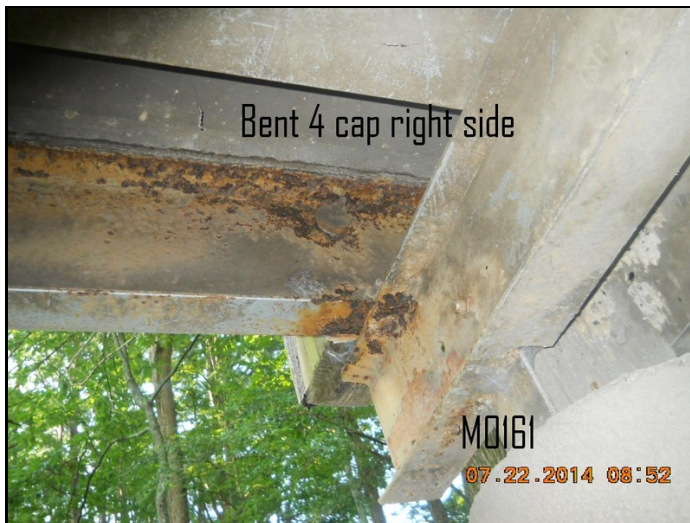
Bent 4 Cap right end has sec. loss to bottom flange and web.

Bent 4 cap rt. side, top flange has some rust with pitting and minor section loss.

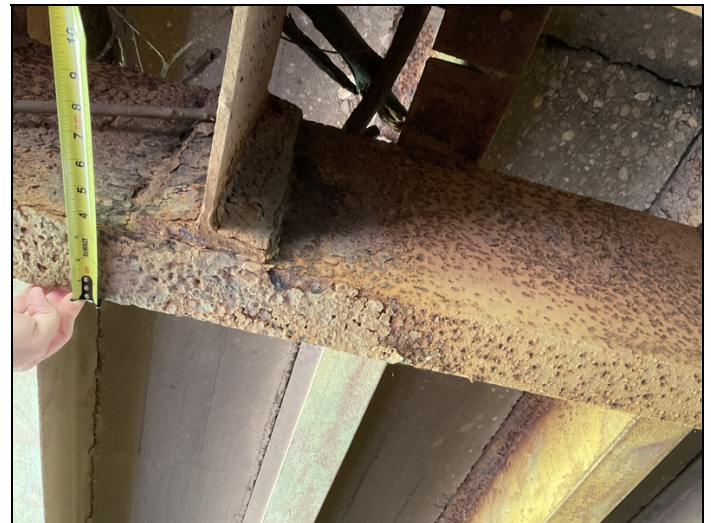
Bt. 3 cap, between columns 2 & 3.

Bent 3 Cap, the webs of the C-Channel that make the cap have 1/8" section loss at connection areas, the original section of the web is 3/8" thick. One bolt head has corroded away at Column 4 bolted connection, also one bolt head has corroded away at the cap splice plate.
