Asset #06449(Routine)

US 82 S-7 LM 11.30 over LaPILE DITCH

Location: 3.8 MI S W OF ASHLEY CO

Team Lead: Rickie Bratton, Inspection Date: 03/08/2022

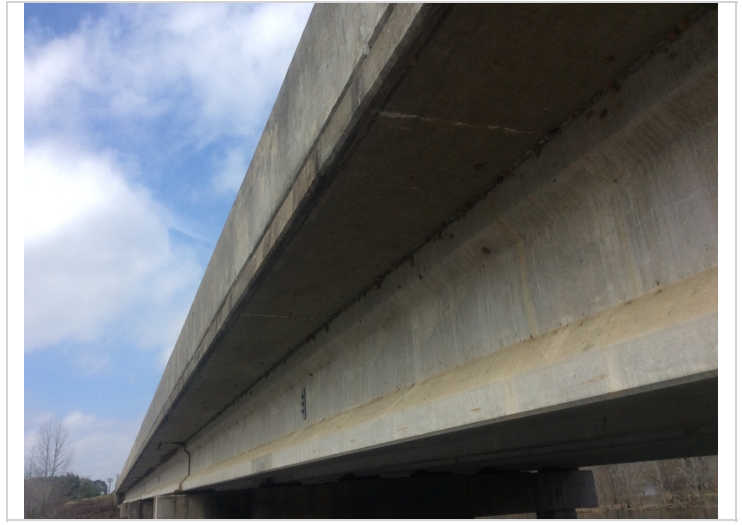
Cracks with efflorescences, on overhangs.

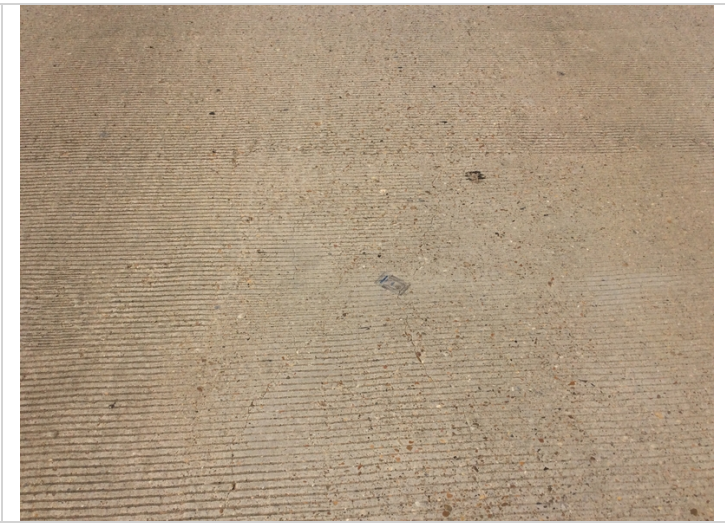
Span 2 cracks in deck.

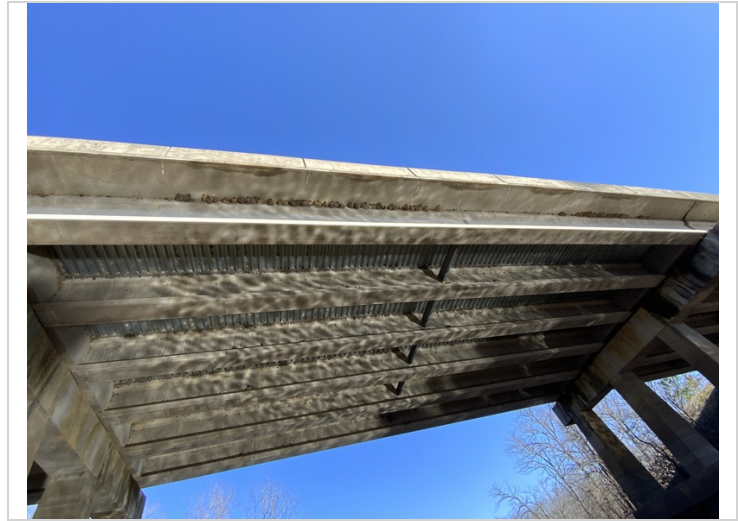
Span 3 right side soffit overhang has cracks with efflorescence, common all spans both sides.

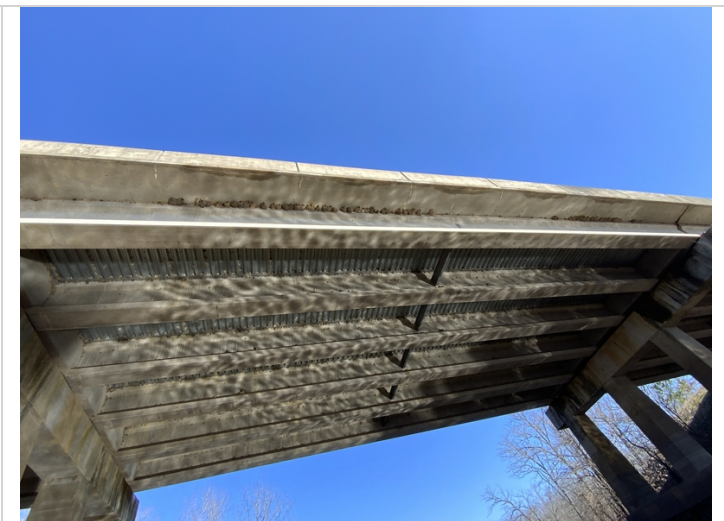
Span 3 right side soffit overhang has cracks with efflorescence, common all spans both sides.

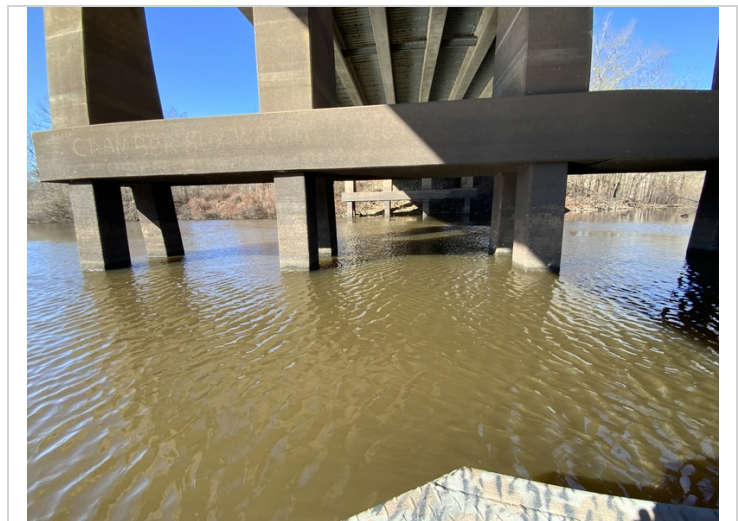
ELEMENTS	DESCRIPTION	UNITS	TOTAL				
				CS1	CS2	CS3	CS4
205	Reinforced Concrete Column	EA	12	12	0	0	0
215	Reinforced Concrete Abutment	LF	120	120	0	0	0
220	Reinforced Concrete Pile Cap/Footing	LF	114	114	0	0	0
227	Reinforced Concrete Pile	EA	24	0	24	0	0
1190	Abrasion/Wear (PSC/RC)	EA	24	0	24	0	0
(227) piles at bents 2-4 have abrasion.							
234	Reinforced Concrete Pier Cap	LF	125	125	0	0	0

Bent 3 pile have abrasion, common bents 2&4.

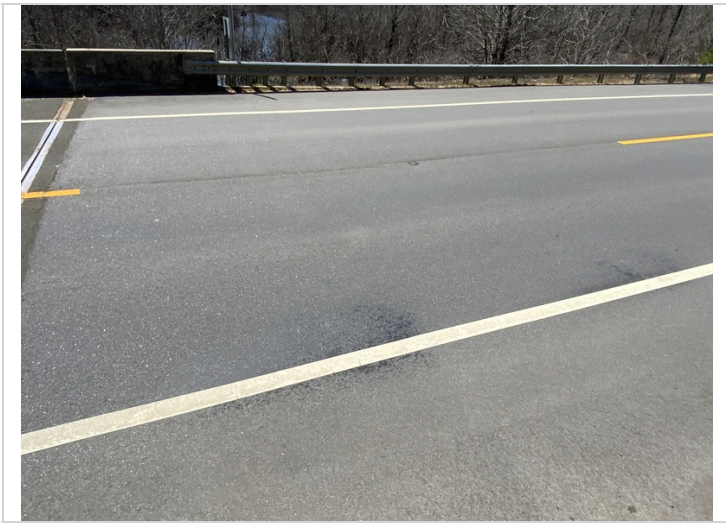
West end approach slab has been overlayed, common East end.

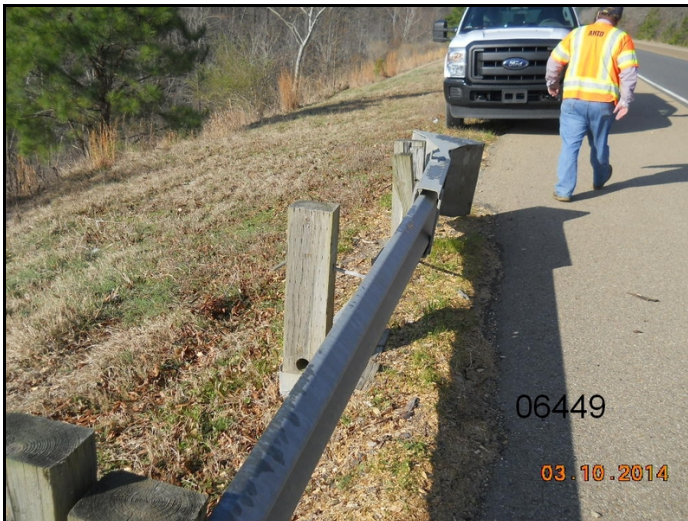
Abutment 1 end, Rt. side, Terminal anchor post.

Abutment 1 end, Rt. side, Next post from Terminal post, spacer block.
Broke.

Spacer block missing.

Abutment 1 Rt. side terminal end post and spacer block broke.
