Asset #06450(Routine)

US 82 S-7 LM 12.07 over BIG SLOUGH

Team Lead: Rickie Bratton, Inspection Date: 03/08/2022

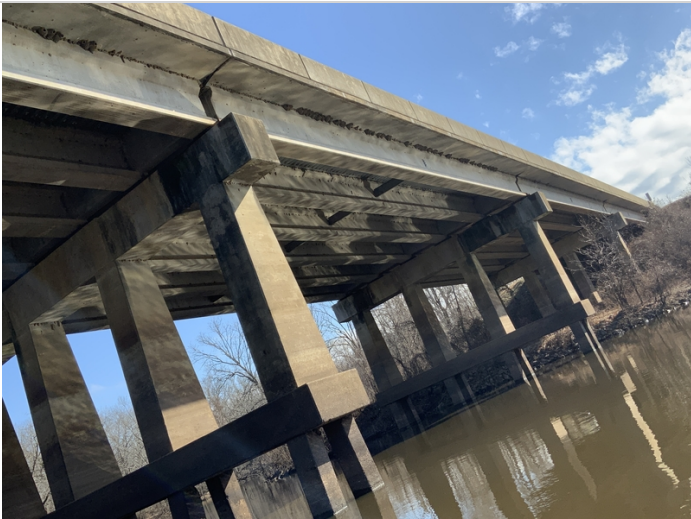
(16) Deck has new wearing surface 03/16/2022. Soffit overhangs have scattered cracks with efflorescence.							
109	Prestressed Concrete Open Girder/Beam	LF	2953	2953	0	0	0
205	Reinforced Concrete Column	EA	24	24	0	0	0
215	Reinforced Concrete Abutment	LF	82	82	0	0	0
220	Reinforced Concrete Pile Cap/Footing	LF	228	228	0	0	0
227	Reinforced Concrete Pile	EA	40	0	40	0	0
1190	Abrasion/Wear (PSC/RC)	EA	40	0	40	0	0

Span 5 right side soffit overhang overview.

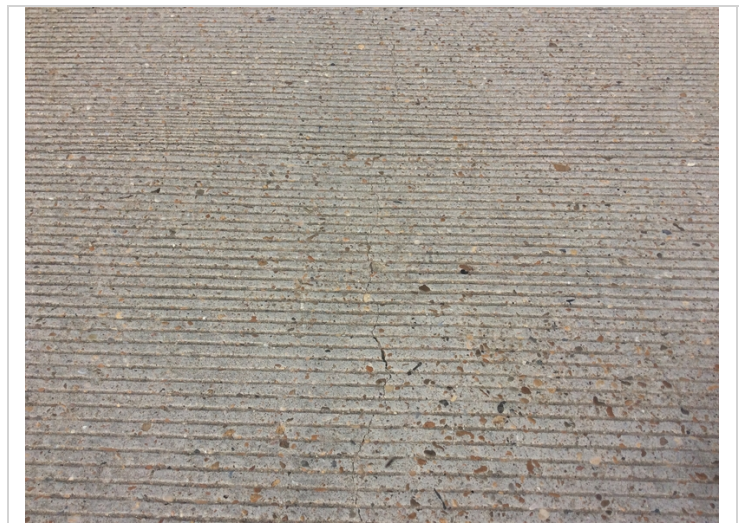
Span 1, cracks in deck. Max 0.016

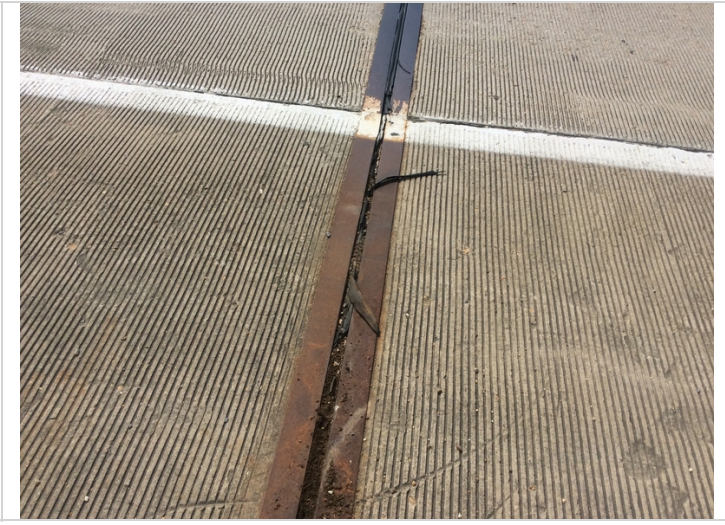
Joint 2, torn and filled with debris.

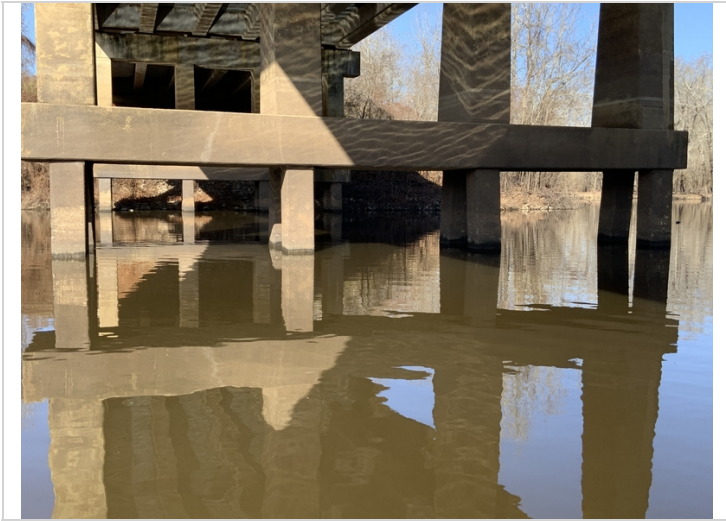
(227) bents 2-6 piles have abrasion.							
234	Reinforced Concrete Pier Cap	LF	249	249	0	0	0
302	Compression Joint Seal	LF	344	338	3	3	0
2320	Seal Adhesion	LF	3	0	3	0	0
2330	Seal Damage	LF	3	0	0	3	0

Bents 2&3 piles have abrasion, common bents 4,5,&6.

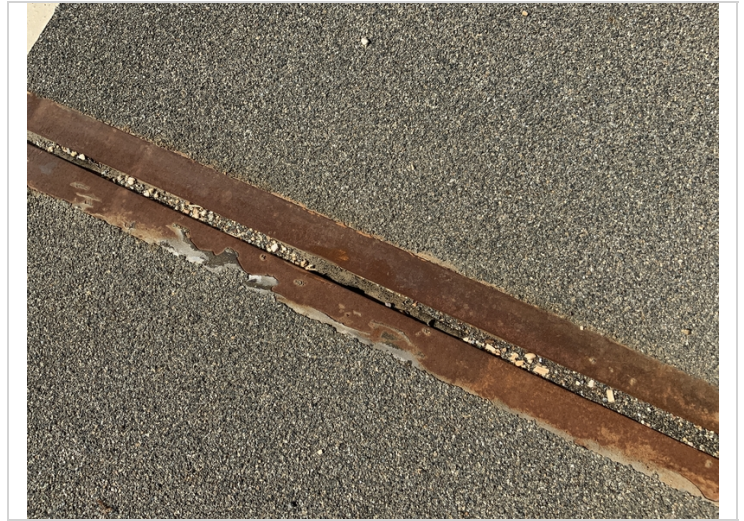
(302) Bent 3 joint seal has areas of lost adhesion. Bent 4 joint seal torn.							
311	Movable Bearing	EA	42	42	0	0	0
313	Fixed Bearing	EA	42	42	0	0	0
321	Reinforced Concrete Approach Slab	SF	3024	2824	200	0	0
1130	Cracking (RC and Other)	SF	200	0	200	0	0

Bent 4 joint seal on left shoulder is torn.

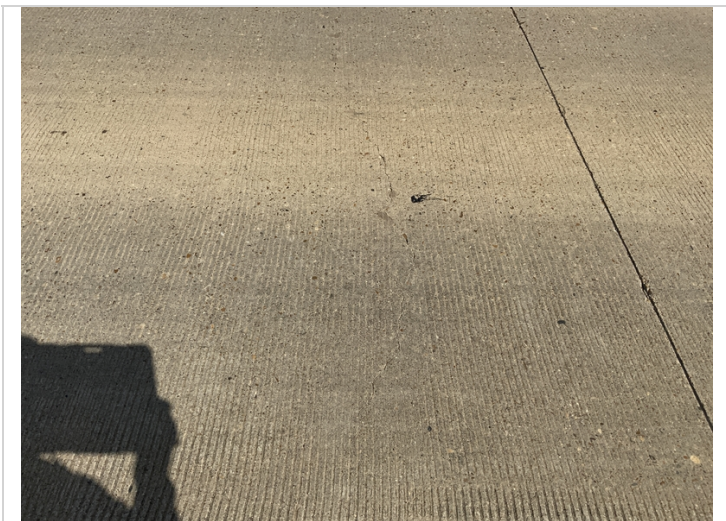
(321) Approach slabs have transverse cracks.							
331	Reinforced Concrete Bridge Railing	LF	984	984	0	0	0

East end approach slab has transverse cracks, common west end.

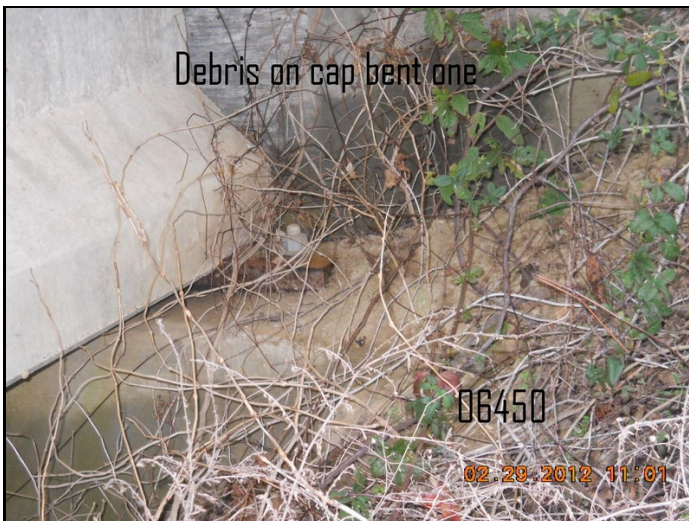
Abutment 1, cap and masonry plate, Lt side

Dirt and debris on cap and against masonry plate, thus causing premature aging and rust.

Abutment 1 cap and masonry plate are prematurely rusting due to dirt and debris built up on them.

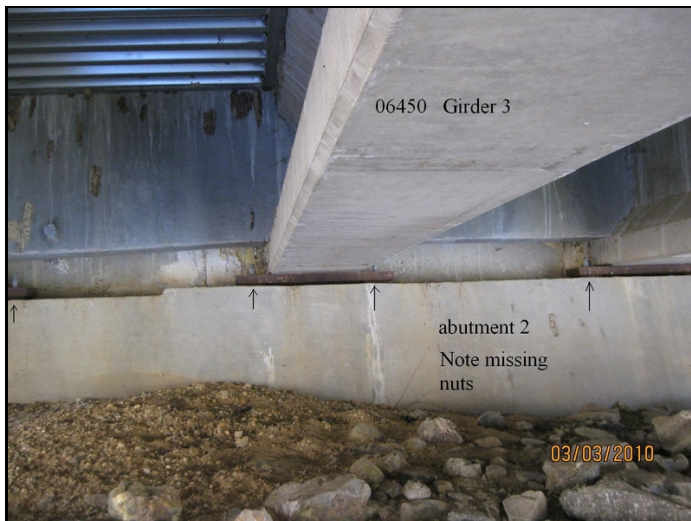
Abutment 2, girders # 2-3-4.
Anchor nuts missing.

Abutment 2 girders 2, 3, and 4, anchor nuts missing.

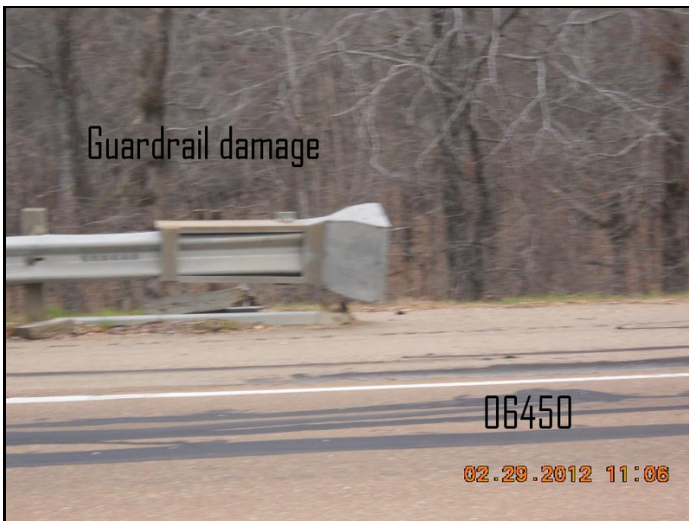
Terminal end post, Left end from abutment 2.

Collision damage to terminal end post @ terminal end section.

Terminal end post, collision damage.
