Asset #06451 (Routine, Underwater type 2)

US 82 S-7 LM 13.91 over OUACHITA REL

Team Lead: Rickie Bratton, Inspection Date: 03/08/2022

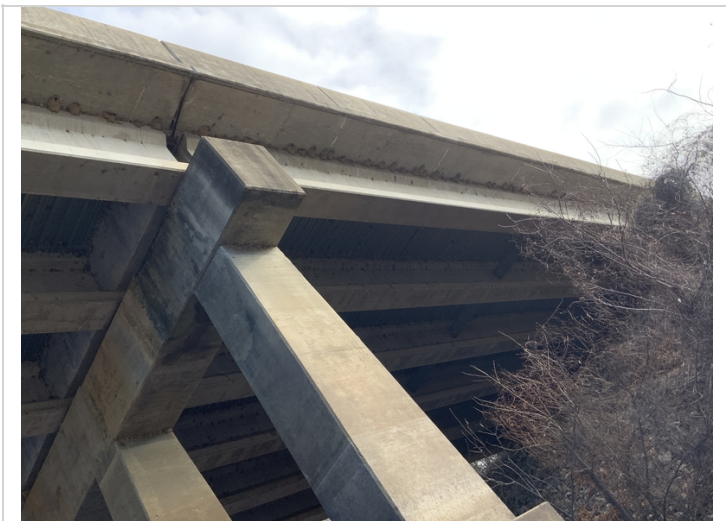
Span 5 right side soffit overhang has cracks with efflorescence.

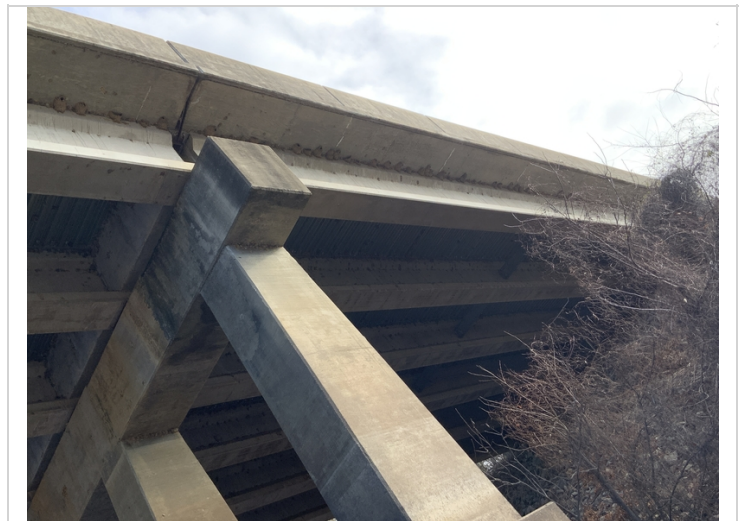
Span 5 right side soffit overhang has cracks with efflorescence.

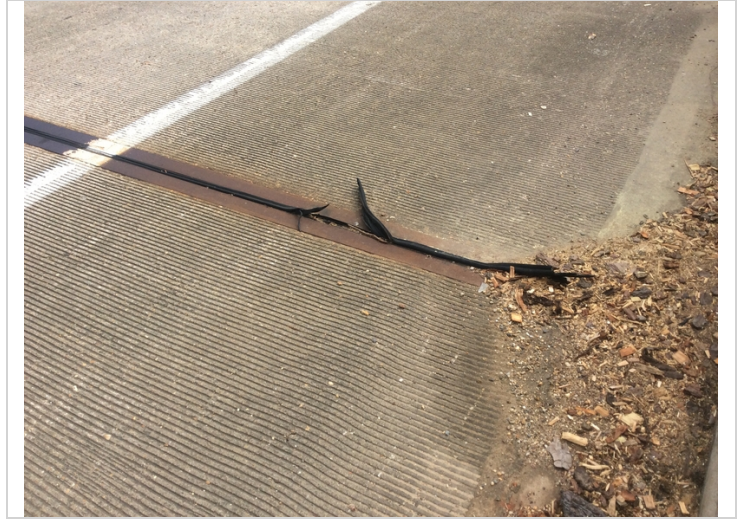
Bent 2 joint, torn.

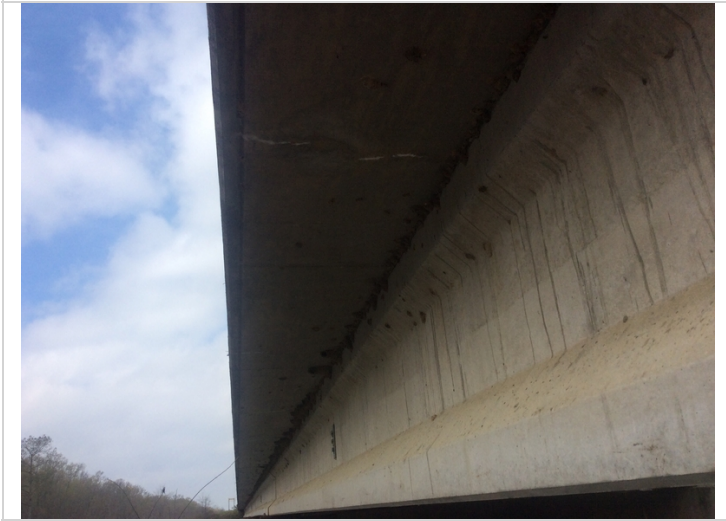
(16) Deck has new wearing surface 3/16/2022 Soffit overhangs have cracks with efflorescence.							
109	Prestressed Concrete Open Girder/Beam	LF	2113	2113	0	0	0
205	Reinforced Concrete Column	EA	16	16	0	0	0
215	Reinforced Concrete Abutment	LF	82	82	0	0	0
220	Reinforced Concrete Pile Cap/Footing	LF	152	152	0	0	0
227	Reinforced Concrete Pile	EA	32	8	24	0	0
1190	Abrasion/Wear (PSC/RC)	EA	24	0	24	0	0

Cracks with light efflorescences in deck overhang.

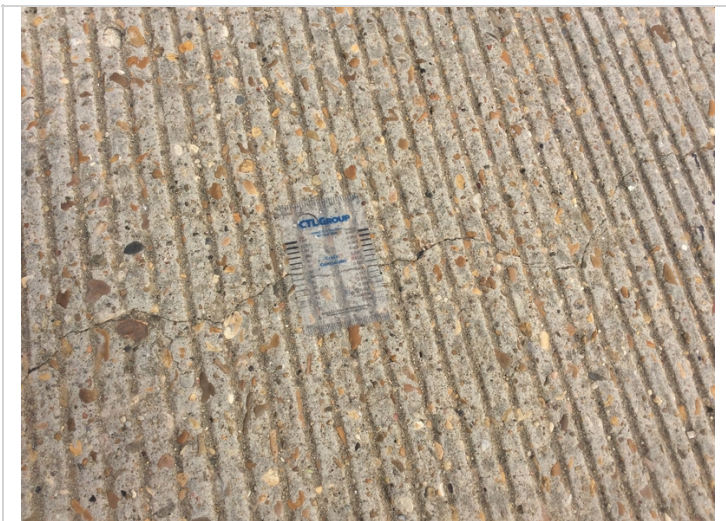
Span 2 small cracks.

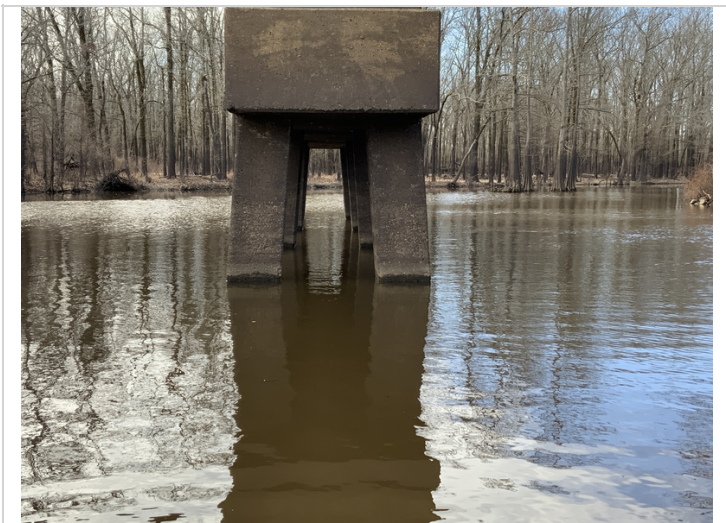
(227) Bents 3-5 piles have abrasion.							
234	Reinforced Concrete Pier Cap	LF	166	166	0	0	0
302	Compression Joint Seal	LF	258	258	0	0	0
(302) Compression joint seals have been replaced.							
311	Movable Bearing	EA	30	30	0	0	0
313	Fixed Bearing	EA	30	30	0	0	0
321	Reinforced Concrete Approach Slab	SF	3024	3024	0	0	0

Bent 3 piles have abrasion, common bents 4&5.

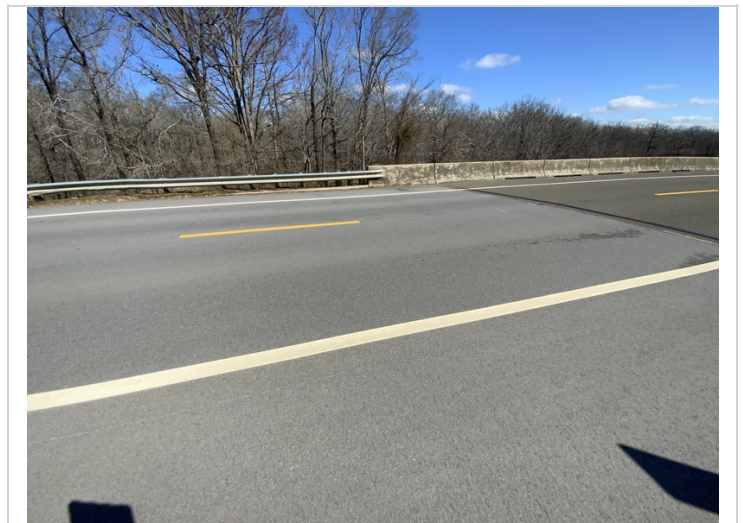
(321) Both approach slabs have been overlayed.							
331	Reinforced Concrete Bridge Railing	LF	704	704	0	0	0

West end approach slab has been overlayed common East end.

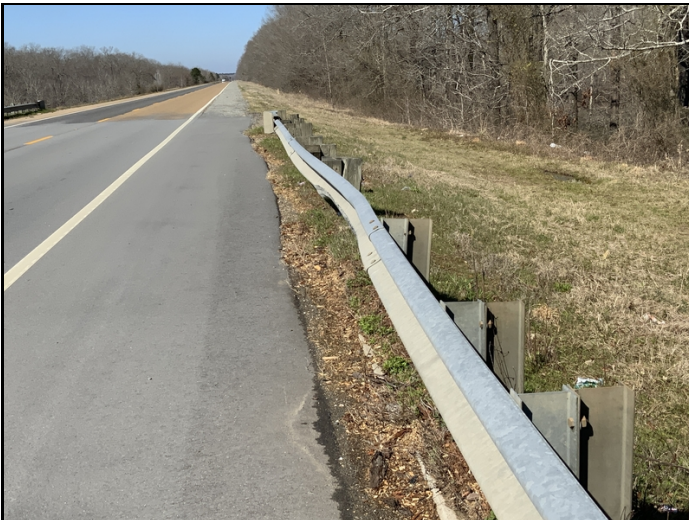
Abutment 1 end, Lt side Approach guardrail.
Collision damage.

Abutment 1 end, Lt side Approach guardrail has Collision damage.

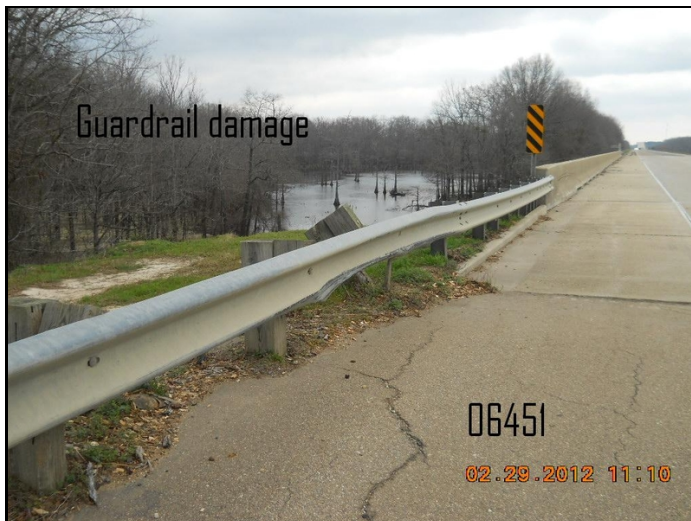
Abutment 1 Lt. Guardrail has old collision damage to the rail and post.

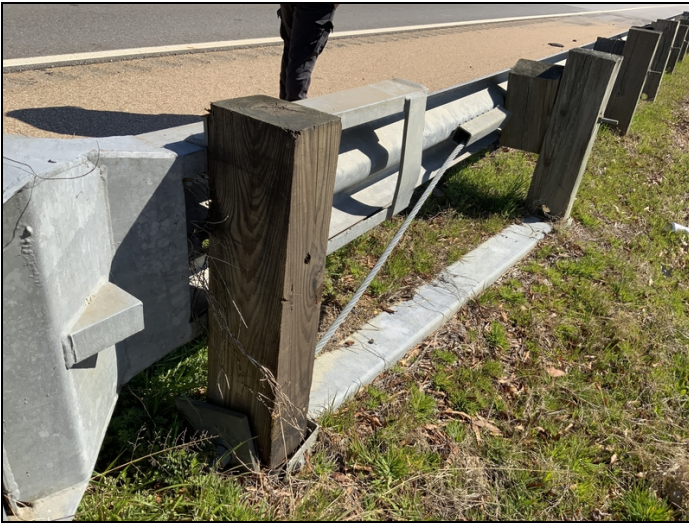
Abutment 1 end, Rt side Terminal Anchor post.
Broke.

Abutment 1 end, Rt side Terminal Anchor post missing bolt.
