Asset #06491(Routine)

UnionUS167S1LM10.4 over GUM CREEK

Location: 0.1 MI N JCT SH 7 SEC 1

Team Lead: Rickie Bratton, Inspection Date: 11/09/2021

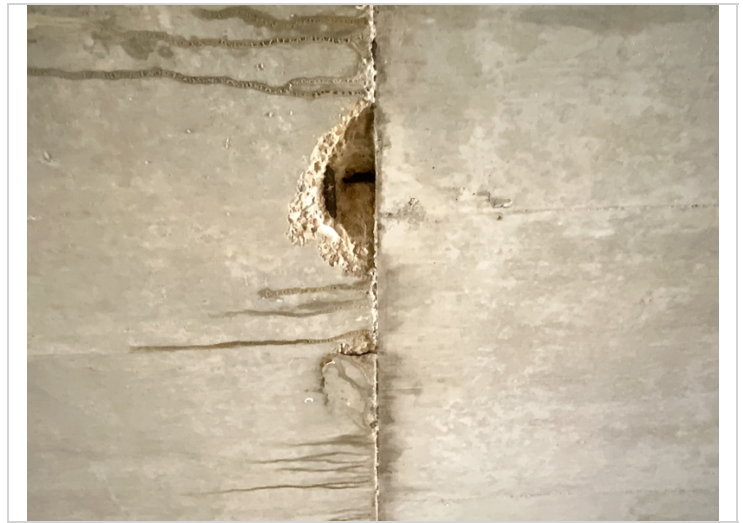
Span 7 at centerline spall with exposed rebar

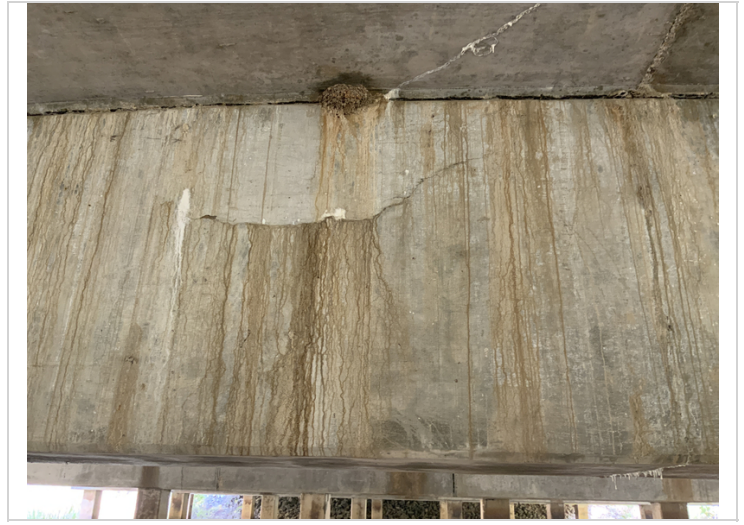
Bent 4 cap, back crack

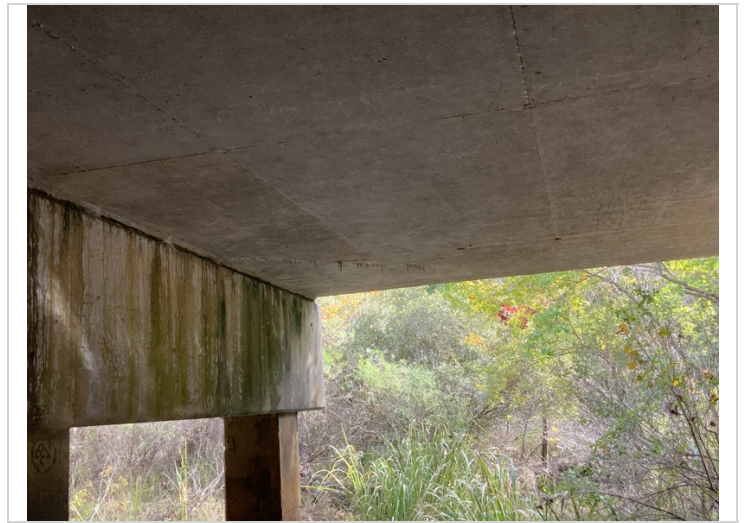
Span 1 efflorescence

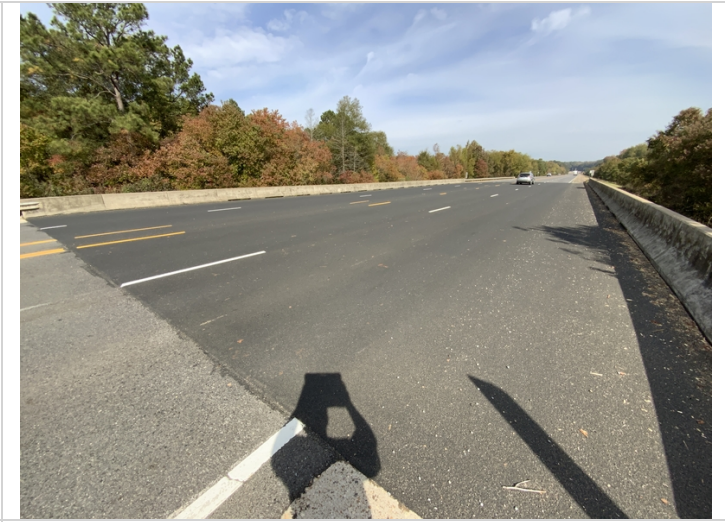
New overlay

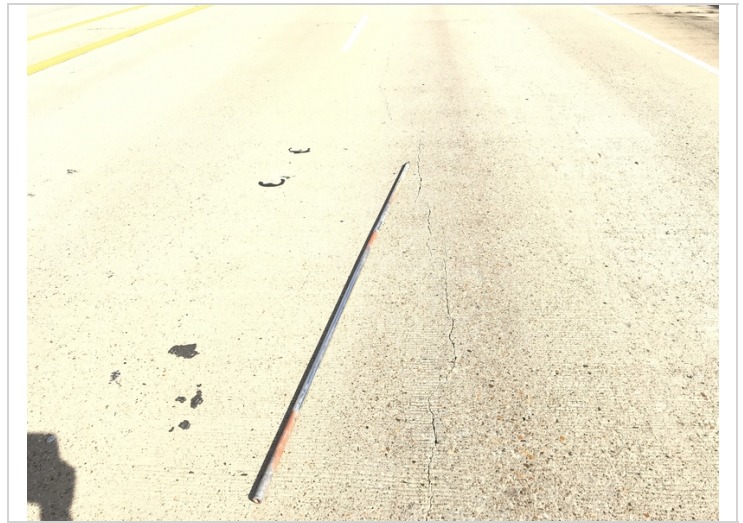
(38) There is 630' of deck cracking, 210' or full length of bridge on NB lanes next to white line. There is 210' of deck cracking next to white line & 210' of deck cracking in center of outside travel lane of SB lanes. 11/20/2019 JPR -- added 2 more 210' x 2 for total of 5 x 210 = 1050' of full length cracking + another 150' of diagonal cracking for total of 1200' of cracking. Also added defect of abrasion and wear (210' x 3' x 8 = 5040 sq. ft.) 11-9-21,RHB, Inspection revealed bridge has been overlayed with polymer overlay.							
215	Reinforced Concrete Abutment	LF	179	179	0	0	0
227	Reinforced Concrete Pile	EA	48	48	0	0	0
234	Reinforced Concrete Pier Cap	LF	441	435	6	0	0
1010	Cracking	LF	6	0	6	0	0
301	Pourable Joint Seal	LF	437	437	0	0	0

Span 1 longitudinal deck crack, this crack goes full length of the bridge.

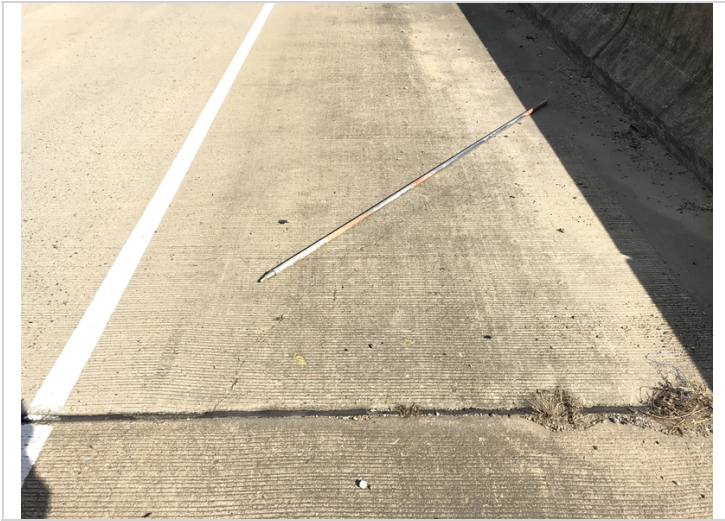
Span 7 Rt. Shoulder diagonal shear crack in deck.

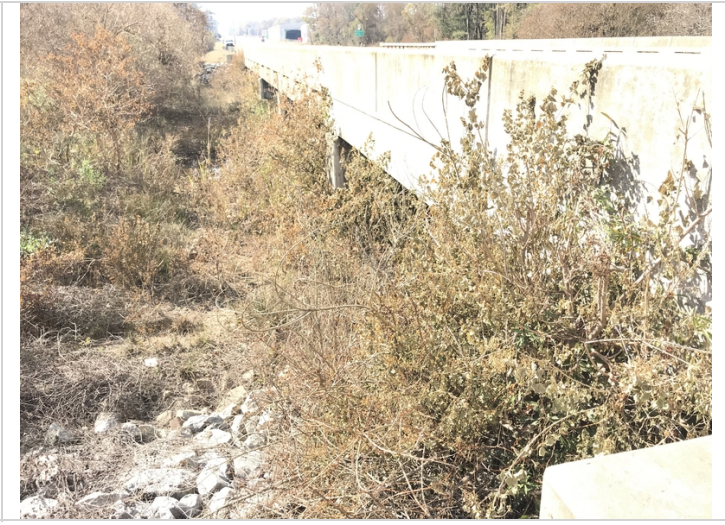
Rt. Side lookingback from abutment 2 @ vegetation growing back under & up beside the bridge.

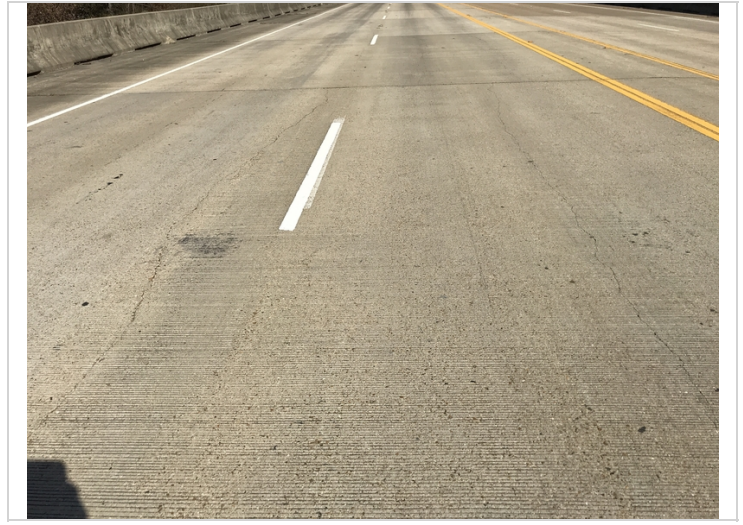
Deck cracks

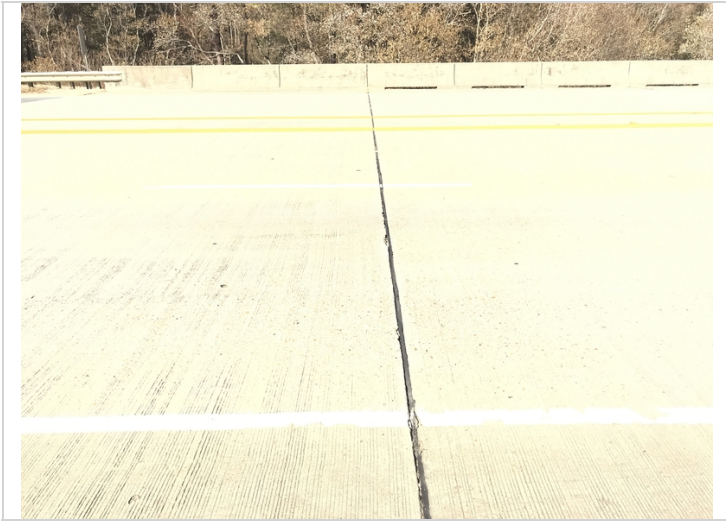
(301) All joints, full width are worn and tattered and are losing their bond with the concrete deck, with leakage and loss of seal adhesion.							
331	Reinforced Concrete Bridge Railing	LF	420	420	0	0	0

Joint between Spans 1 & 2, joint material is losing bond with the concrete.

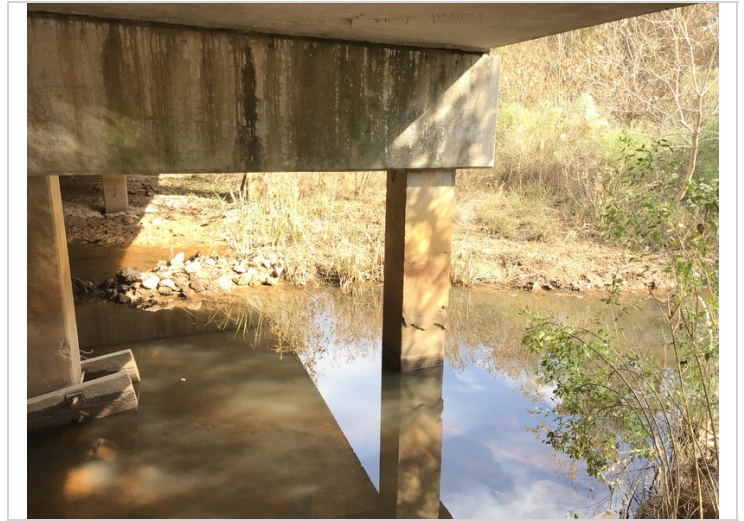
Bent 2 pile 8 appears to have a patch on the back side of the pile from bottom of the cap down about 5';, this was likely a build up on this pile.

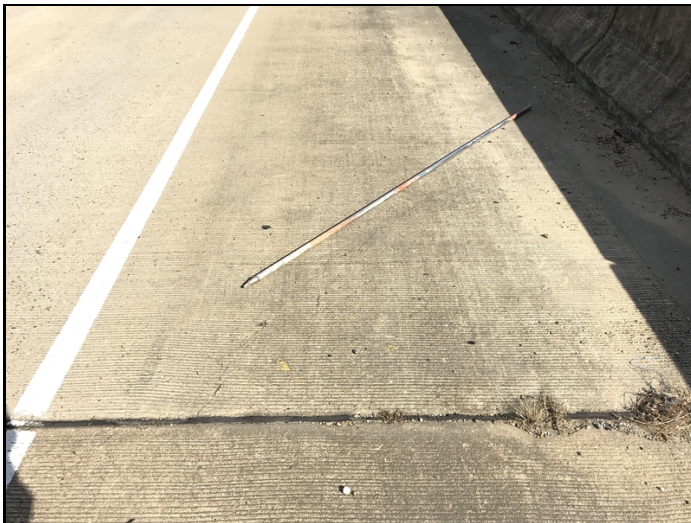
Numerous sealable cracks all spans.

Span 7 Rt. Shoulder diagonal shear crack in deck.

Overlay has sealed all cracks.

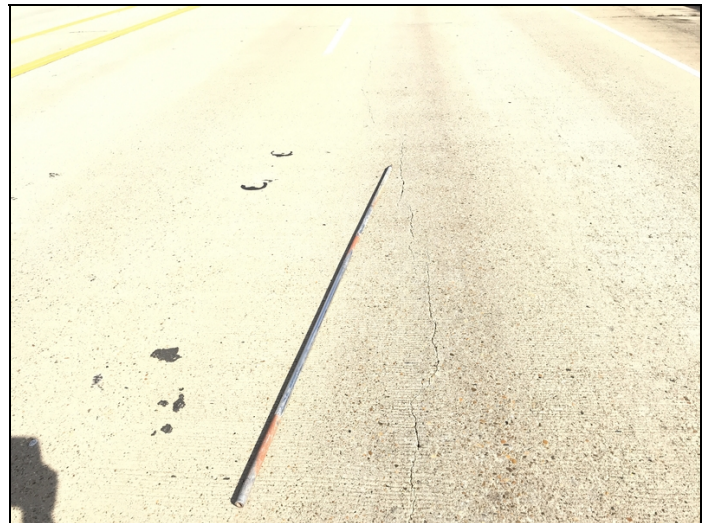
Span 1 longitudinal deck crack, this crack goes full length of the bridge.

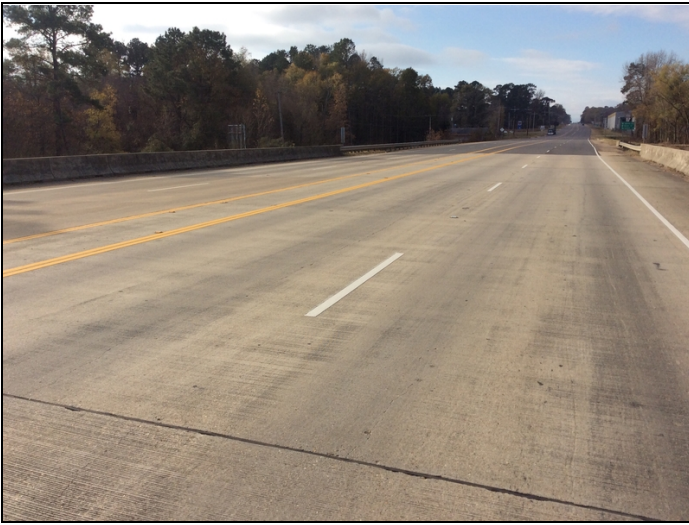
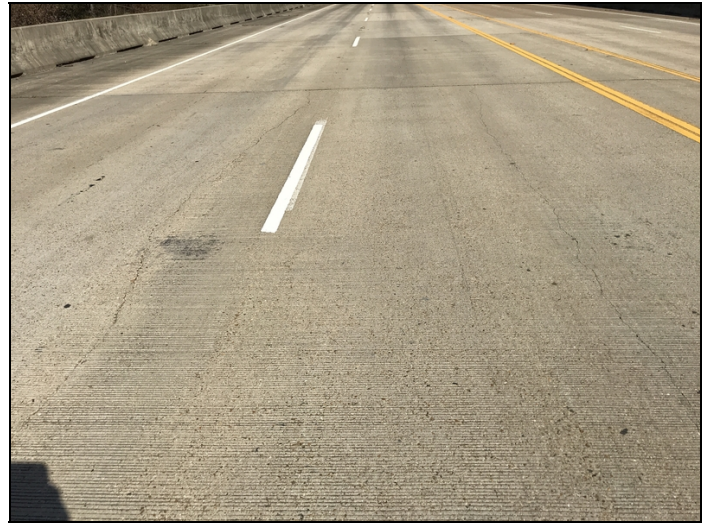
Deck cracks

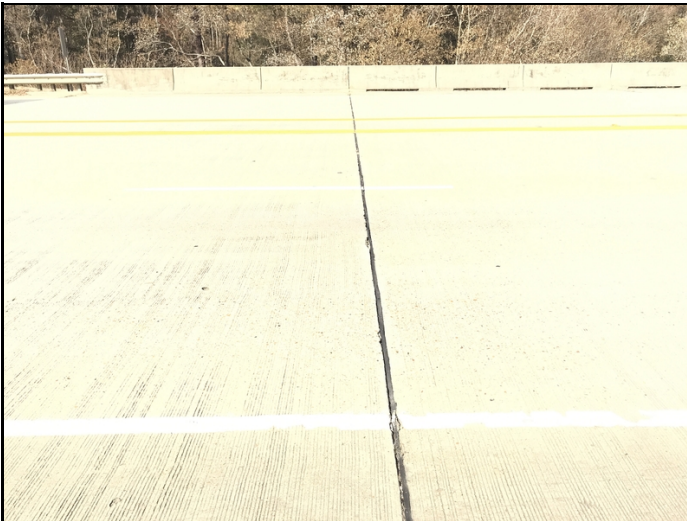
Joint material, all joints.

Joint material is tattered and losing bond with concrete.

11/03/2015 JPR All joints are leaking some and allowing water and road salts to get to ends of slabs and caps.

Joint between Spans 1 & 2, joint material is losing bond with the concrete.

Overlay has sealed all joints.

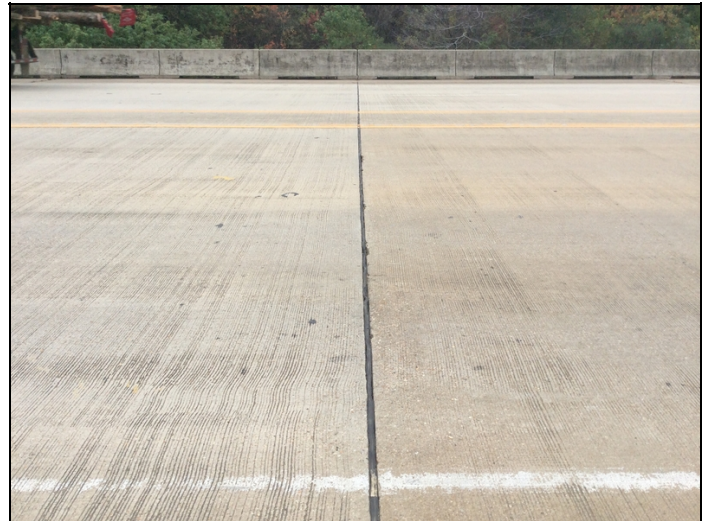
Bent 4 joint material, worn & tattered and losing the bond with the concrete, typical of all joints.

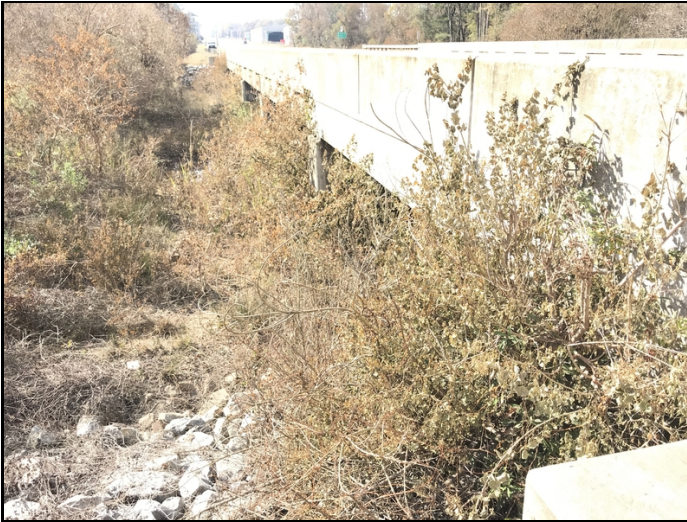
Rt. Side lookingback from abutment 2 @ vegetation growing back under & up beside the bridge.
