Asset #06492(Routine)

UnionUS167S1LM10.9 over BAYOU LOURE

Location: 0.6 MI NO JCT SH 7

Team Lead: Rickie Bratton, Inspection Date: 11/09/2021

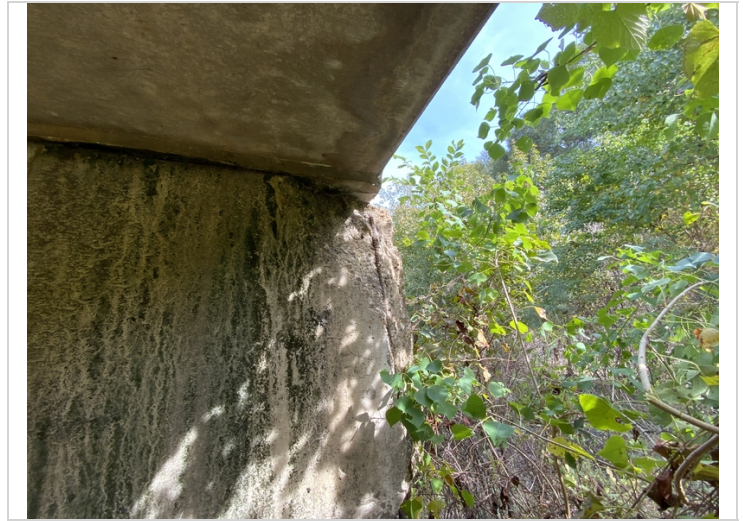
Bent 6 right end of cap spalled

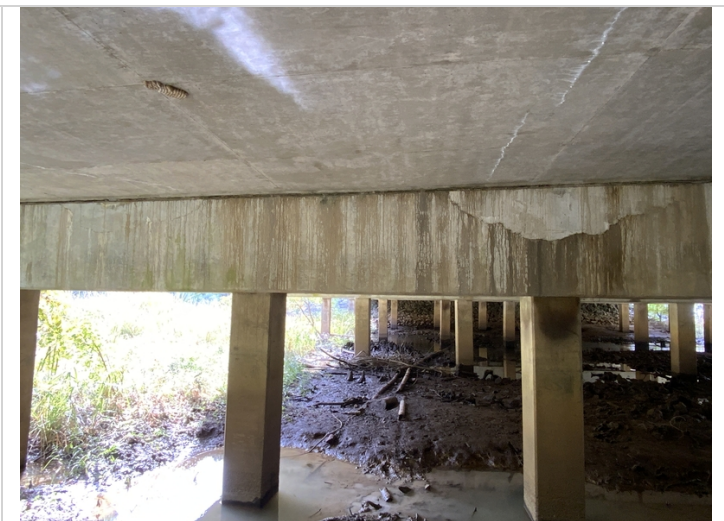
Bent 5 ahead, delams over piles 6 and 8

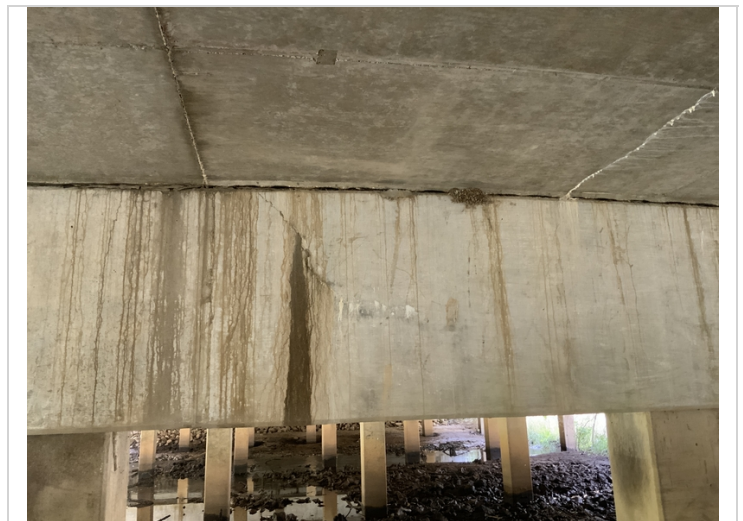
Bent 5 ahead, crack between piles 4 and 5

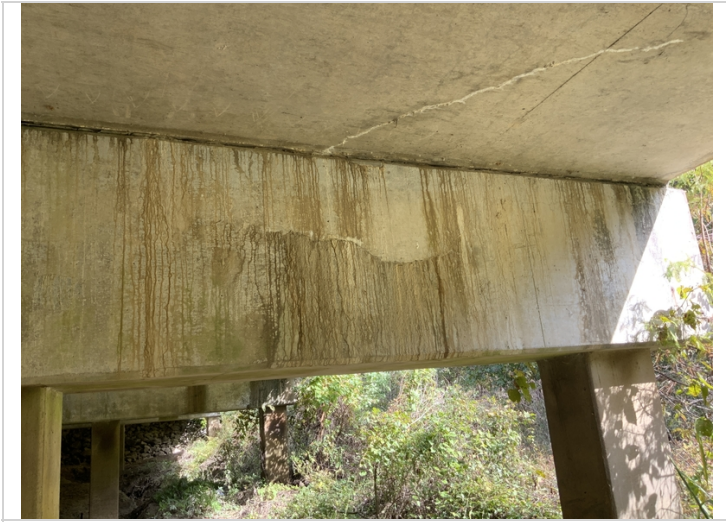
Bent 5 cap back, crack right end.

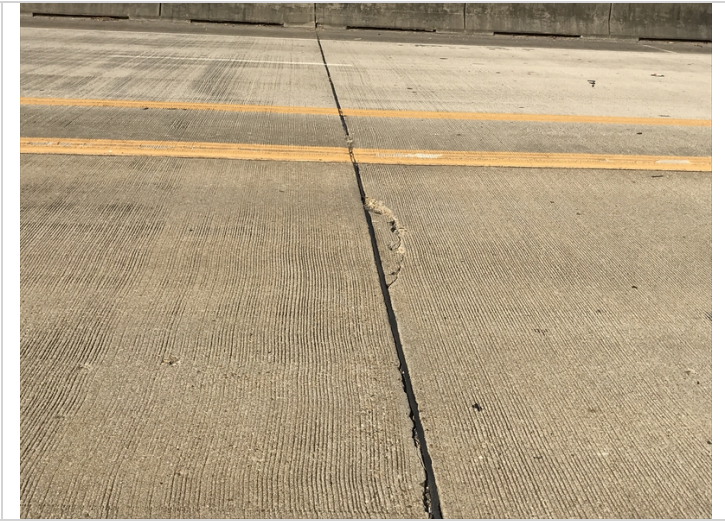
Numerous cracks, all spans. Normal wear and abrasions. Joint material has failed all joints. Span 4 @ Bent 4 there is a small 6" spall with and approx. 3' of delamination.

Span 4 @ bent 4 Rt. Inside Main Lane 4' Rt. Of C/L there is a large crack & small spall @ the joint.

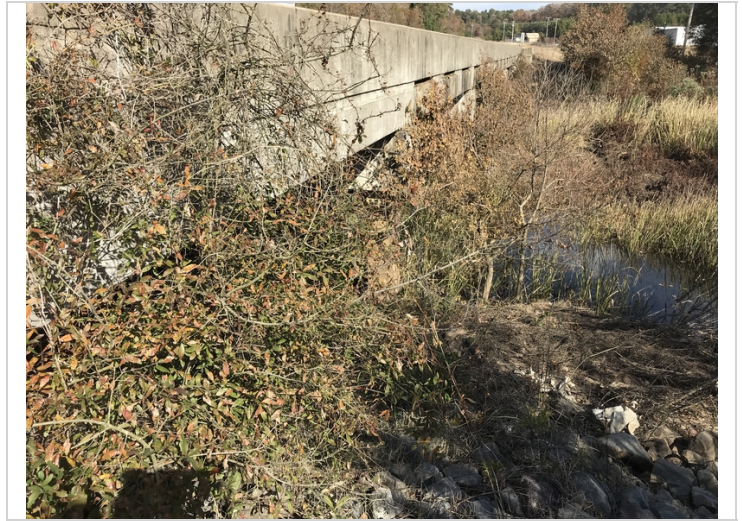
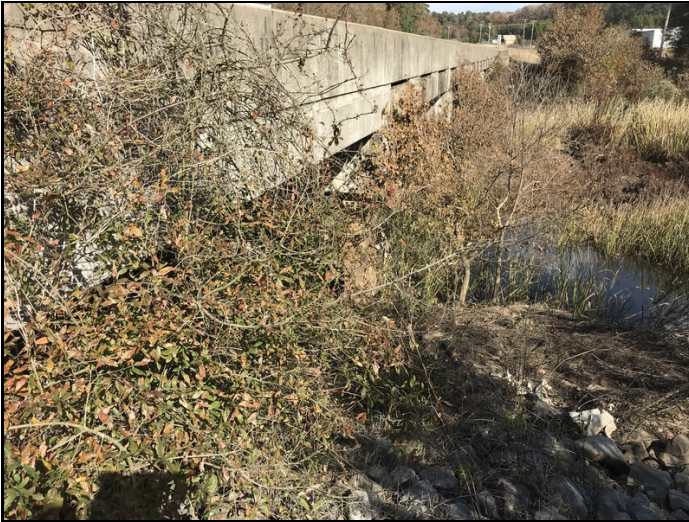
Vegetation right side

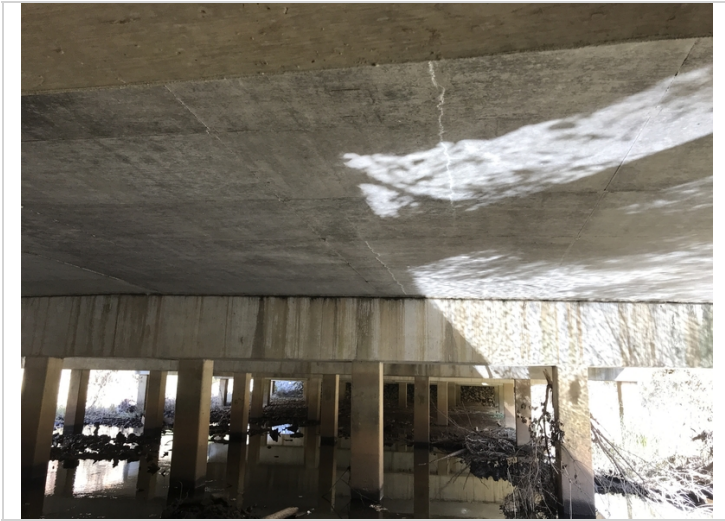
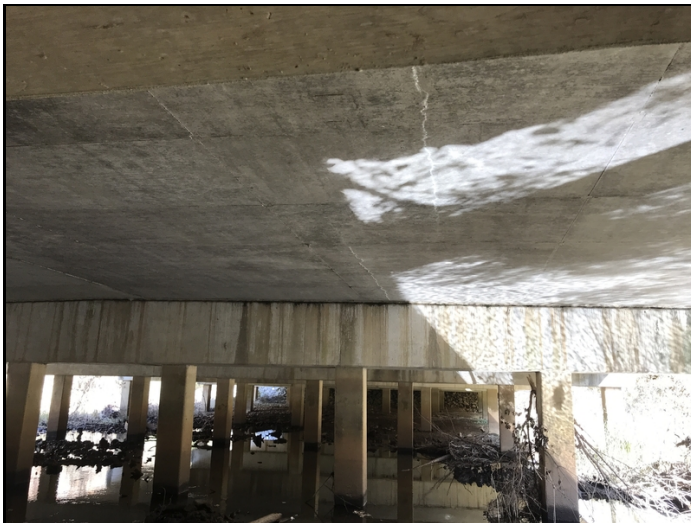
Span 2 looking ahead from bent 2 @ deck soffit cracks with efflorescence.

Sealable Deck Cracks entire bridge.

Overlay has sealed all cracks.

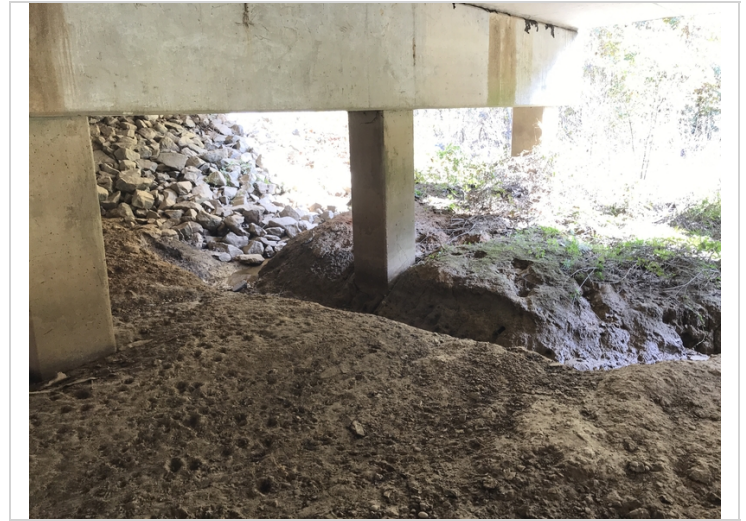
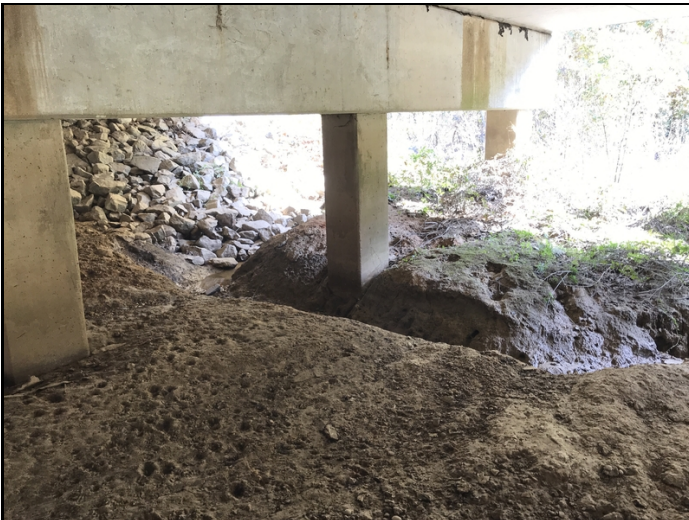
Span 7 looking ahead & Rt. @ scour hole running from outside Rt. & between piles 6 & 7. This is a drainage ditch than runs from bent 5 to ahead of bent 7.

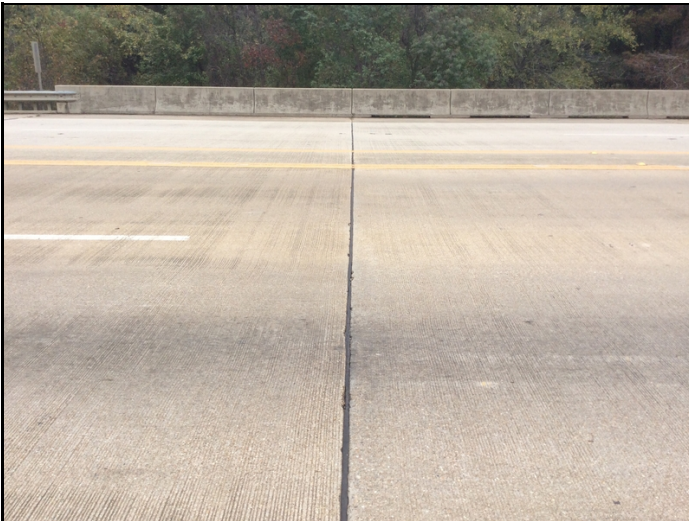
(301) All poured joints are worn and tattered and are leaking and allowing some water and road salts to get through to Slab ends and tops of the caps.							
331	Reinforced Concrete Bridge Railing	LF	420	420	0	0	0

Joint material is tattered and losing bond with the concrete.

11/03/2015 JPR All joints are leaking some and allowing water and road salts to get to ends of slabs and caps.

Joint material bent 2, is worn & tattered and is losing bond with the concrete. This is typical of all joints.

Overlay has sealed all joints
