Asset #01978(Routine)

US 79 SEC2 LM3.65 over SL SW RR

Location: 2.0 MI SW OF SH 98

Team Lead: John Parks Inspection Date: 05/30/2023

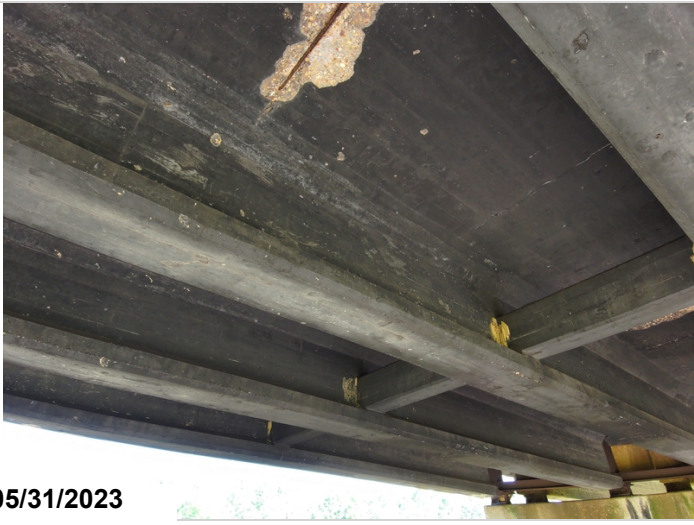
Typical Superstructure, encased steel beams.

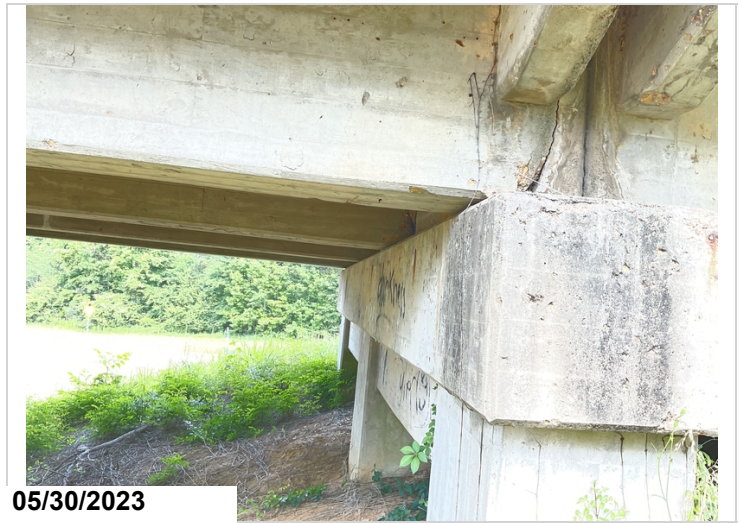
Span 10 bent 11 cracks in girders 3 and 4

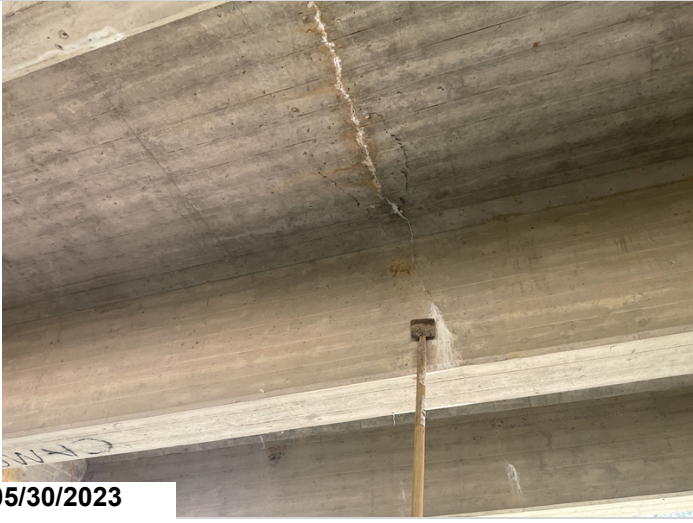
Span 10 girder 3 vertical crack 0.050" with efflorescence

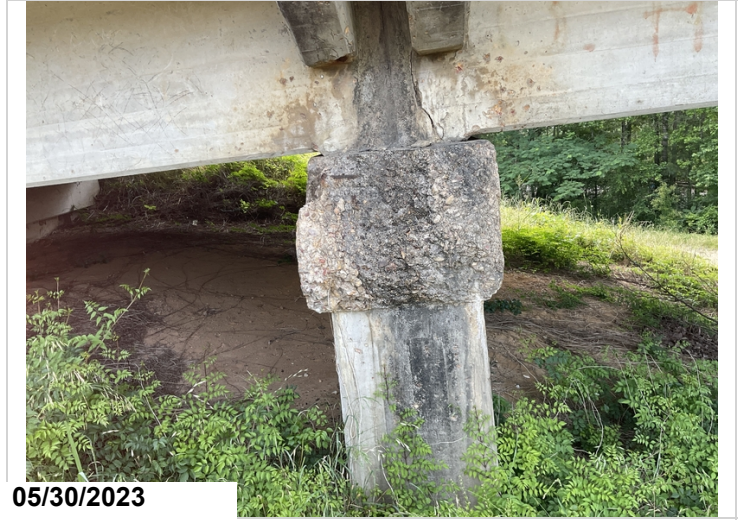
Bent 11 right end of cap spalled

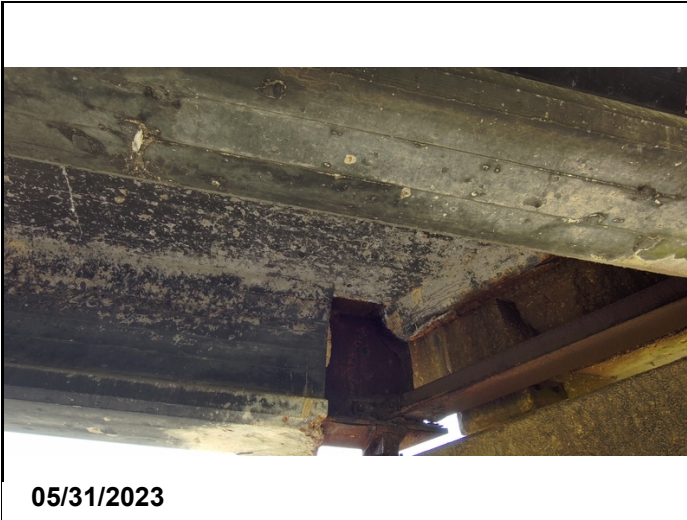
Span 6, Beams 1 & 5, flange and bottom web have upto 1/8" pitting at the beam ends.

Span 6, Beam 5 @ Bent 6, flange and bottom web have upto 1/8" pitting at the beam end.

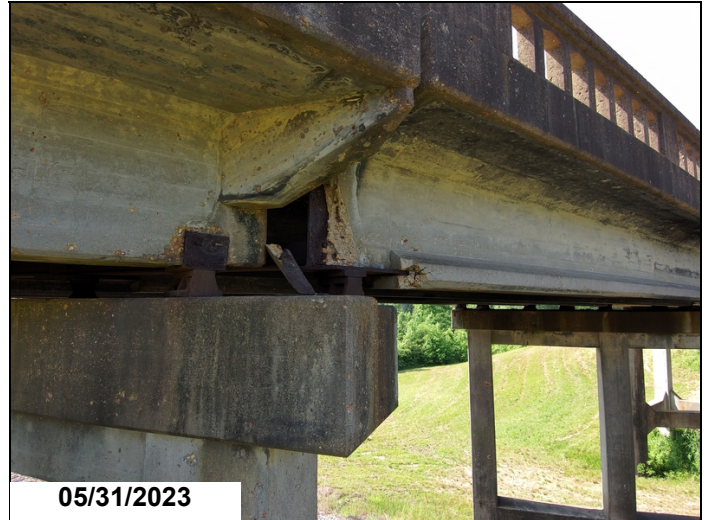
Span 6, Beam 1 @ Bent 7, flange and bottom web have upto 1/8" pitting at the beam end.

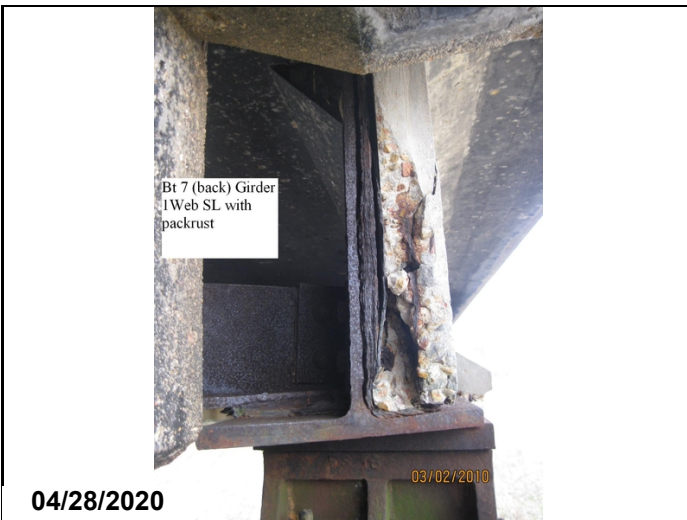
Span 6 @ bent 7, girder 1 web has heavy pack rust that is causing the encasement to shell off the girder.

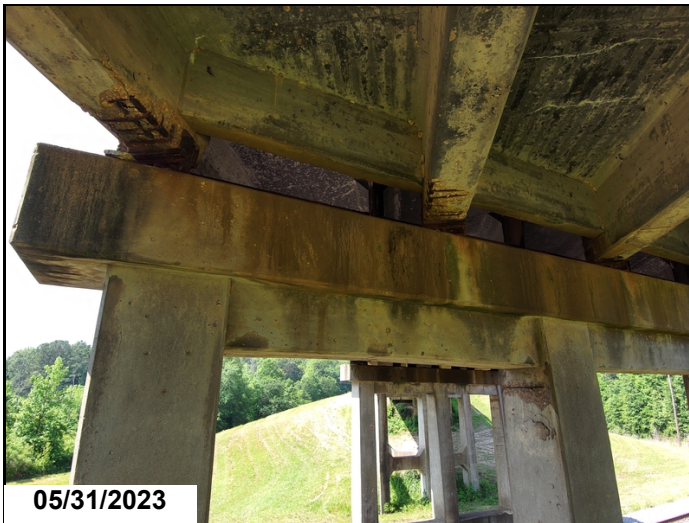
Span 7 @ Bent 7, Girder 2 - 4 have spalls with exposed rebar in the bearing area.

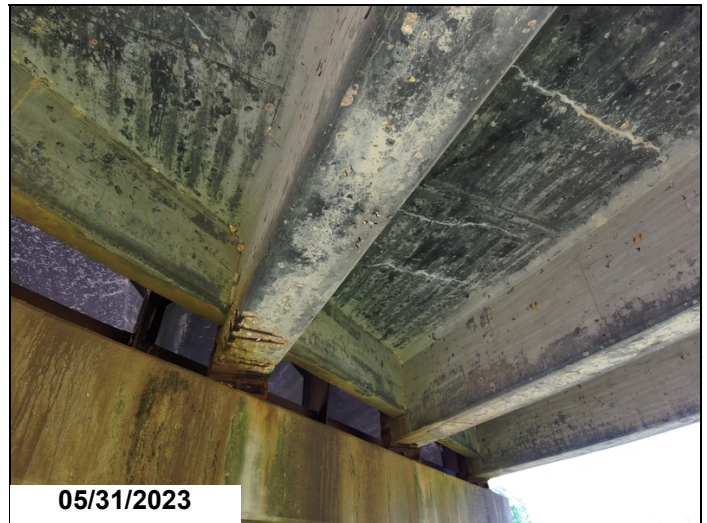
Span 7 @ Bent 7, Girder 3 exposed rebar.

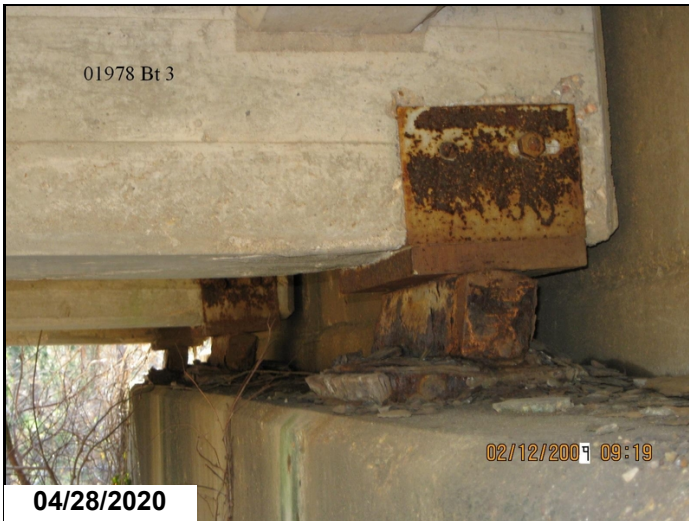
All bearings have heavy corrosion and pack rust that is inhibiting the movement of the bridge.

Bearing @ Bent 3 are rotated back, the masonry plates have heavy pack rust.

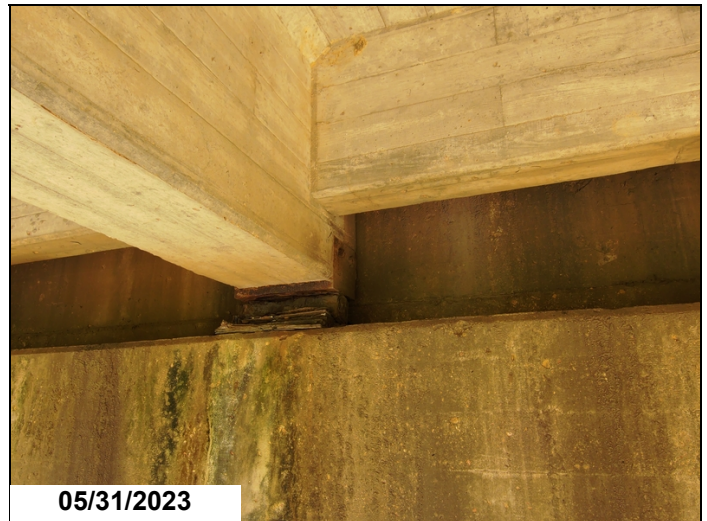
Span 9 @ Bent 10, bearing 2 has heavy corrosion.

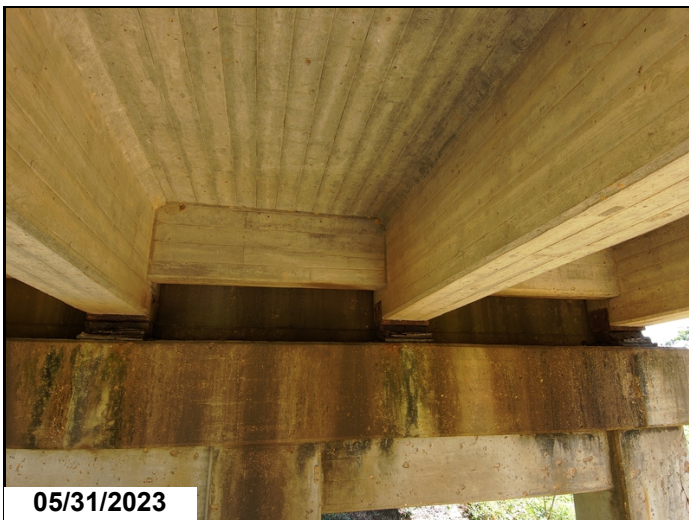
Span 9 @ Bent 10, bearings 2-4 heavy corrosion.

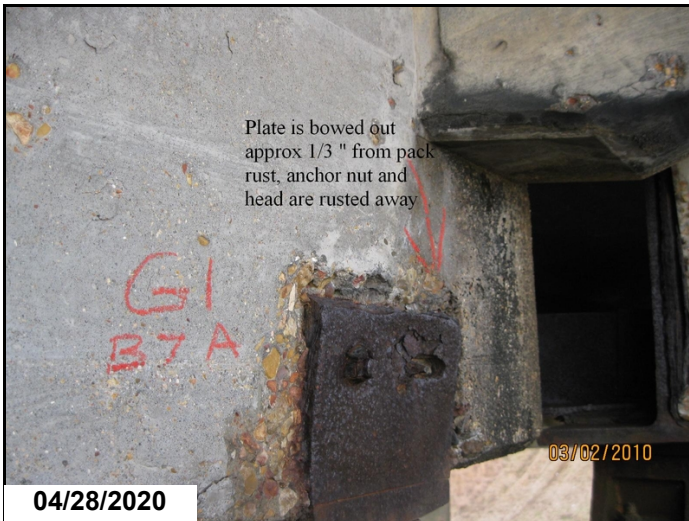
Bents 3 & 7 (ahead), girder #1 nuts connecting sole plate bracket to girder rusted with 100% sec. loss.
Bent 7, Girder # 1, outside bracket pushed away from the girder by pack rust.

Bent 7, girder 1 the plate is bowed out approx. 1/3" from pack rust, and anchor bolt nut and head are rusted away.

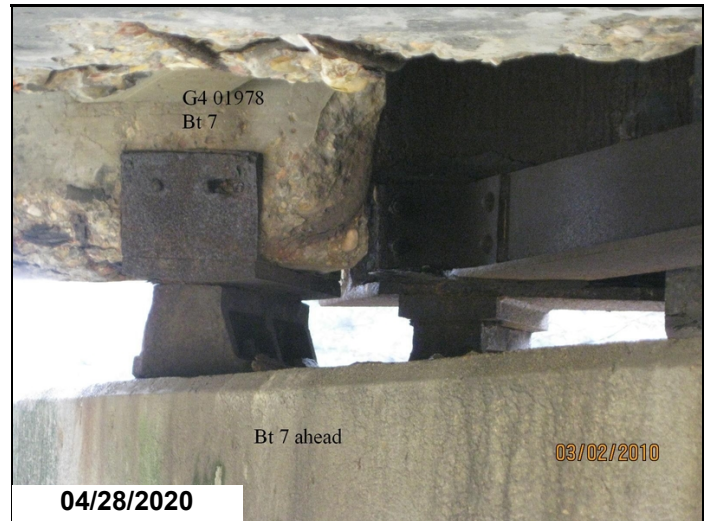
Bent 7, Girder #4 nut connecting sole plate bracket to girder is rusted with 100% sec. loss.

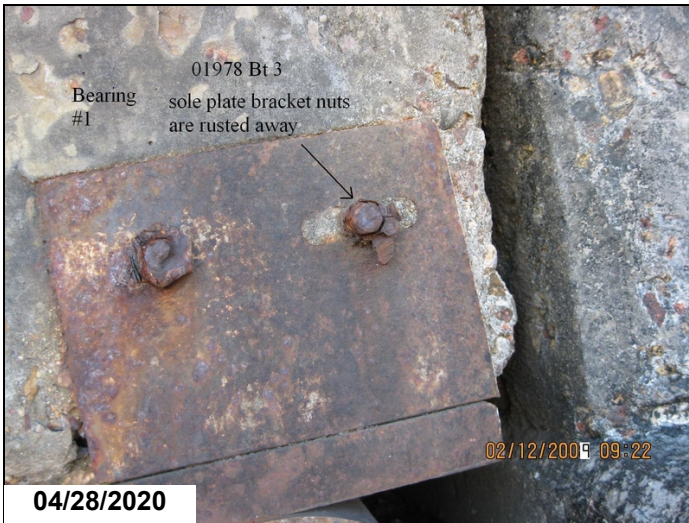
Bent 3 (ahead), girder #1 nuts connecting sole plate bracket to girder is rusted with 100% sec. loss.

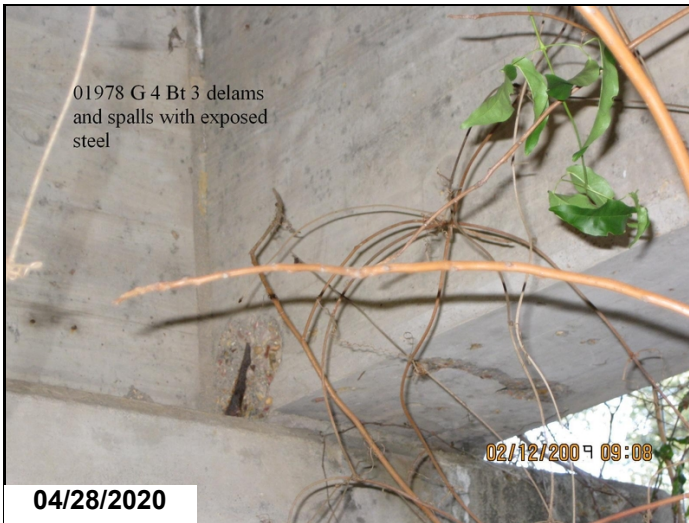
Span 3, @ Bent 3, Girder 4 has a spall with exposed rebar.

Bent 3 girder 4 with delamns and spalls with exposed rebar.

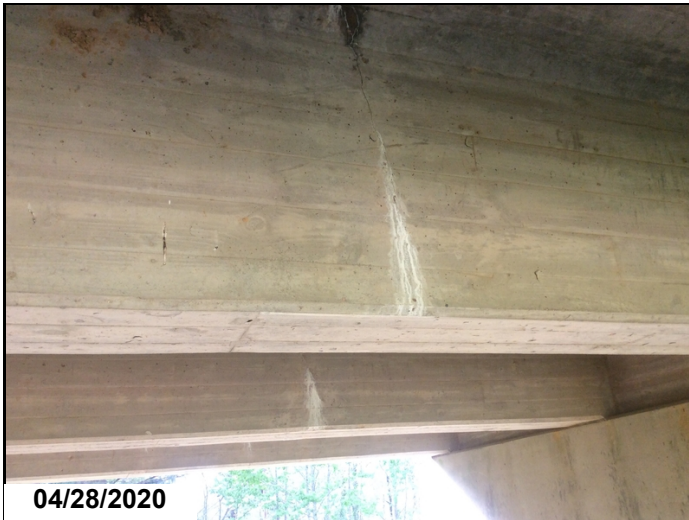
Soffit crack that propagates across entire deck and down all of the girders

Span 10 girder 2, crack with efflorescences.

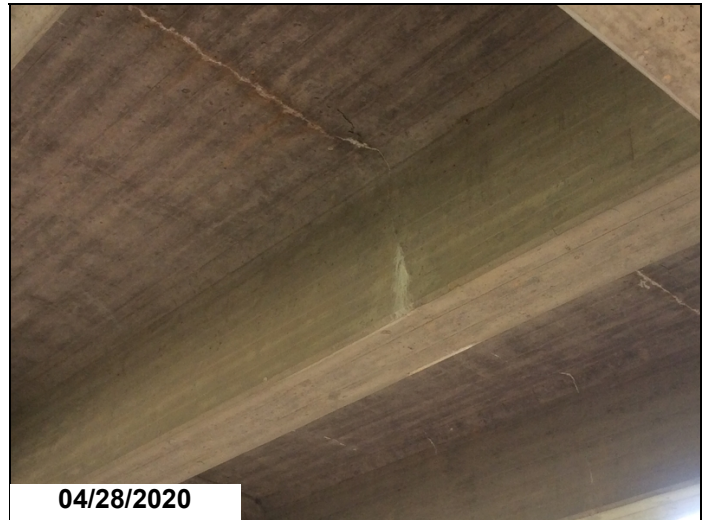
Span 10 cracks in girders

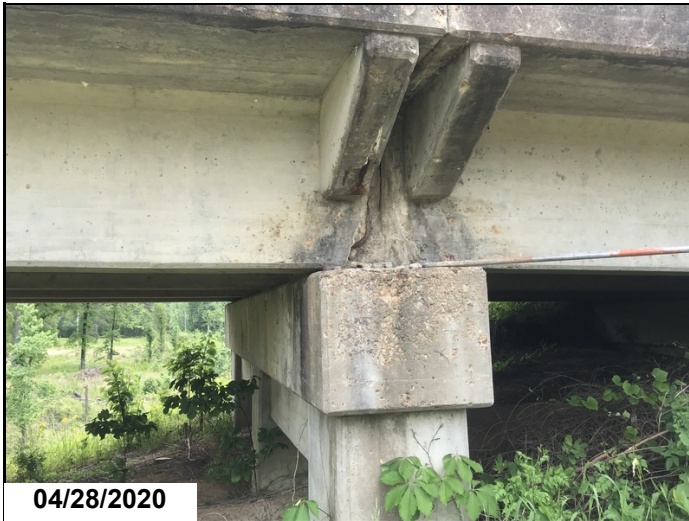
Bent 2, girders 1 & 4 @ jct with cap.
Have cracks and spalls.

Span 2 girder 1 spalled

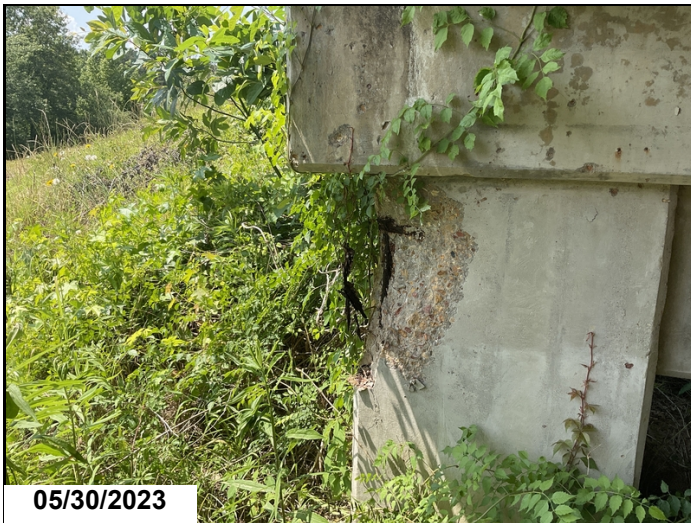
Bent 2, column 3, spall with exposed rebar.

Bent 2 column 3 spalled with exposed rebar

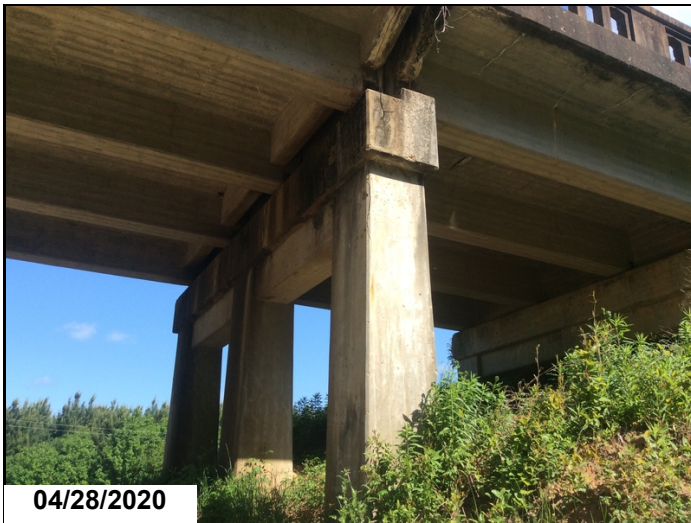
Column 3 bent 10 large vert crack, no exposed steel

01978 column 3 BT. 10 vertical crack.

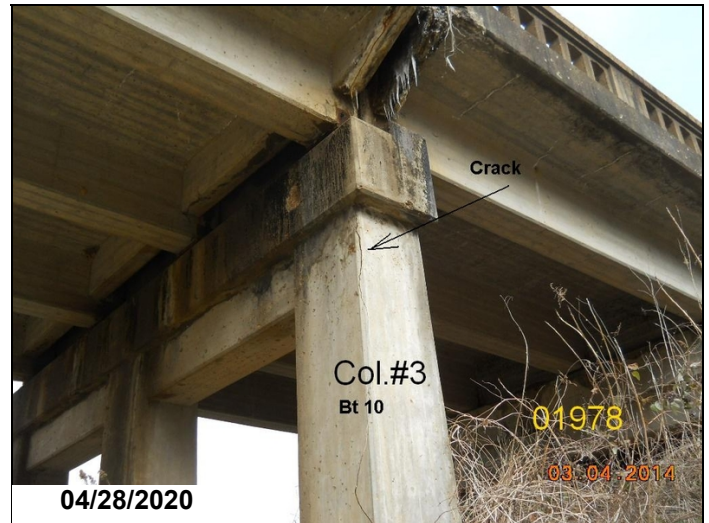
Bent 10, column 3 has a large crack on back side below bottom of the cap.

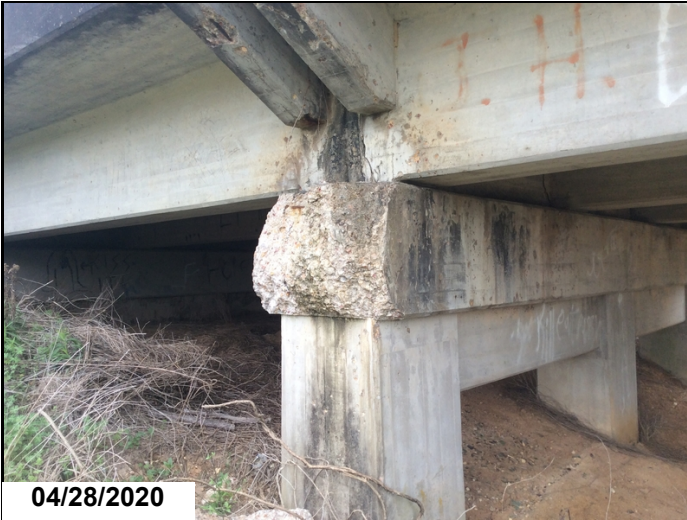
04/28/2020

Bent 11 Left end of pier cap is spalled with extensive salt contamination.

Bt. 11 Lt. end of pier cap is spalled with extensive salt contamination.

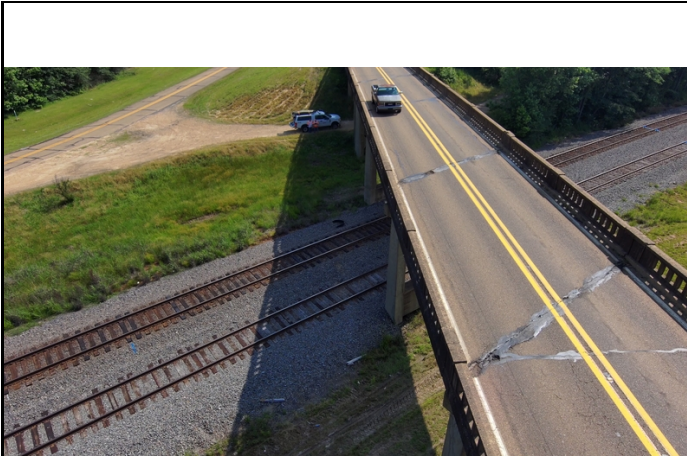
05/31/2023

The asphalt wearing surface has scattered potholes through out the deck along the joint lines.

Pothole in the wearing surface along joint lines.

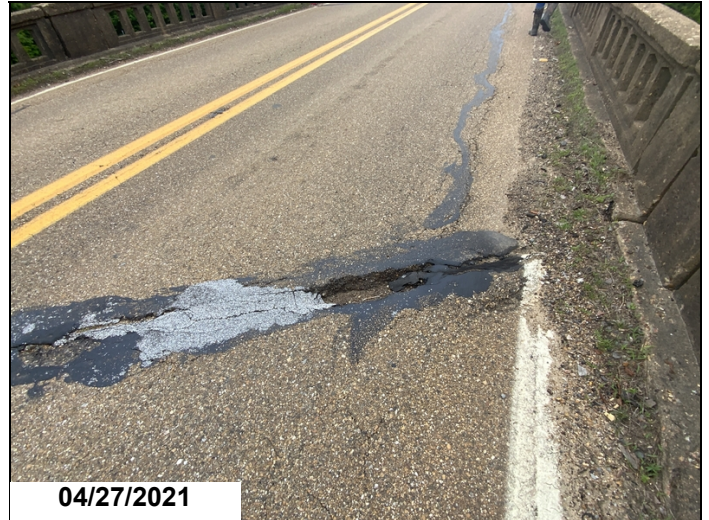
04/27/2021

Joint 6 spalled

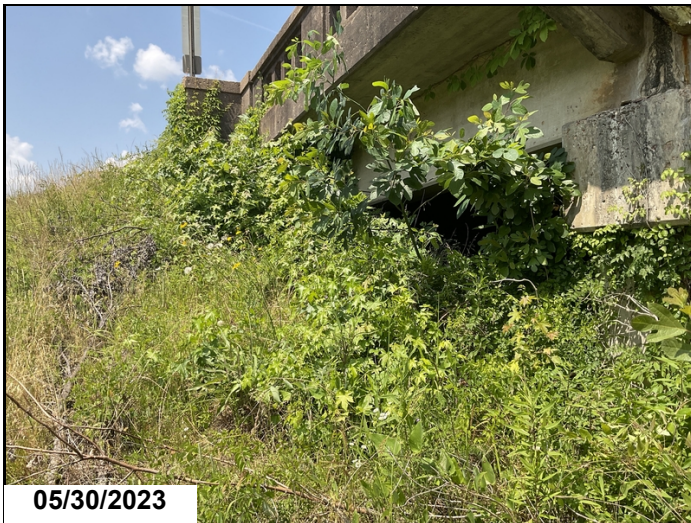
Vegetation both sides

Vegetation
