Bridge 05438 Inspection Report

Asset #05438(Routine)

SH 8 over COOKS CREEK

Team Lead: Rickie Bratton Inspection Date: 02/12/2024

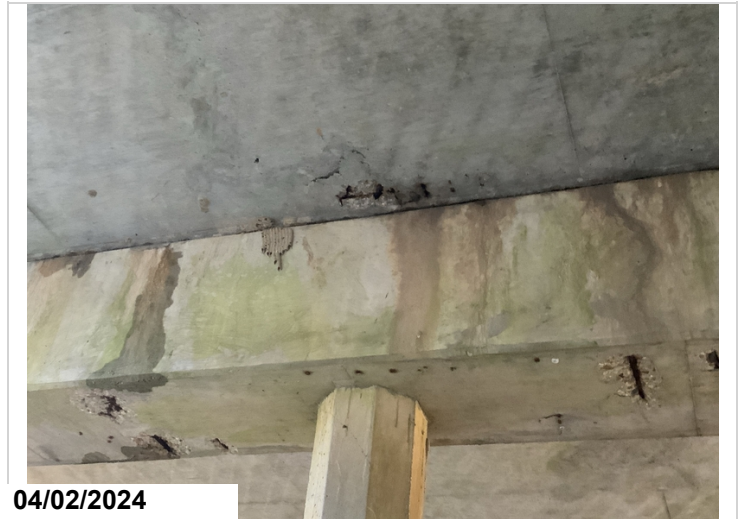
Good Condition - Span 2 soffit has small exposed rebar with minimal section loss.

Span 2 soffit exposed rebar ahead of bent 2.

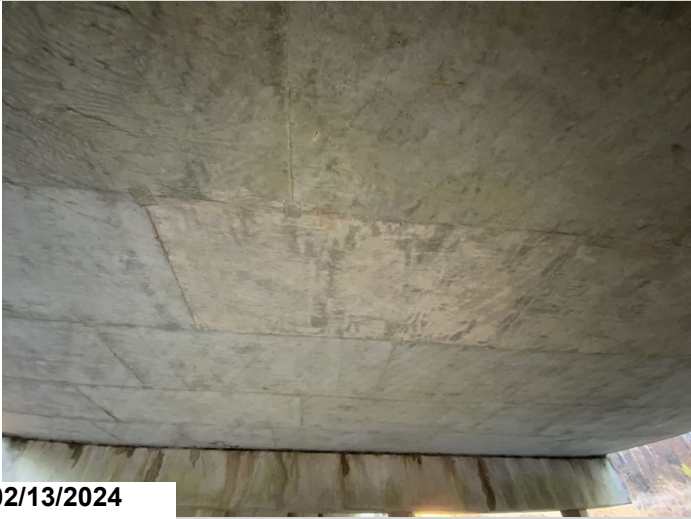
Span 2 soffit overview

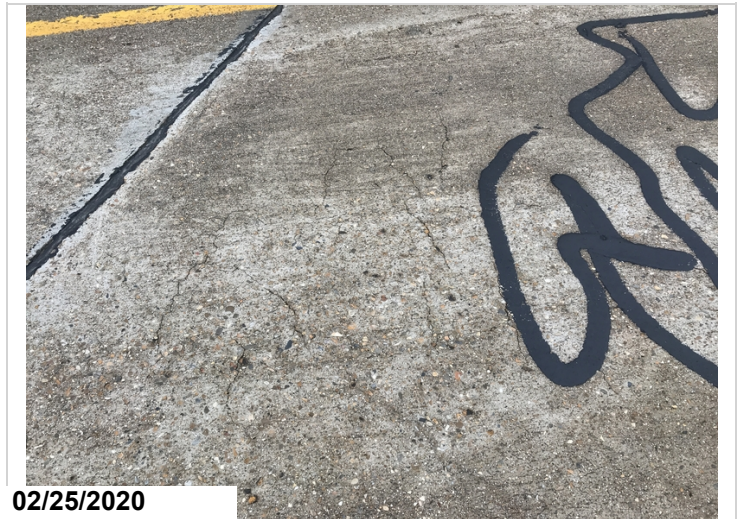
Span 3, map cracks

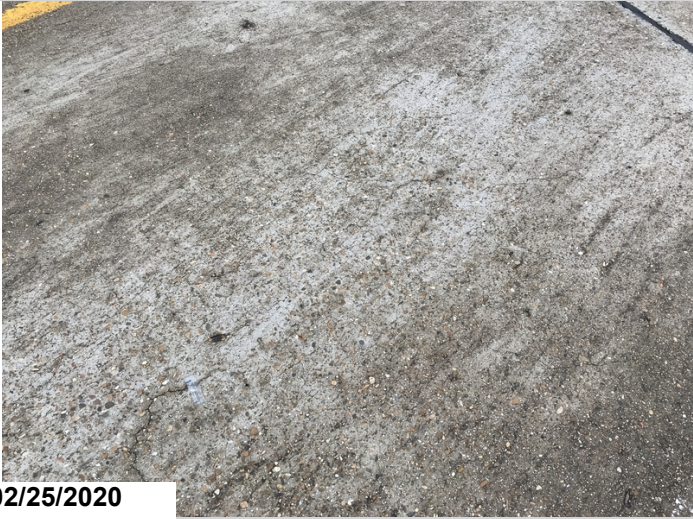
Span 2, map cracks

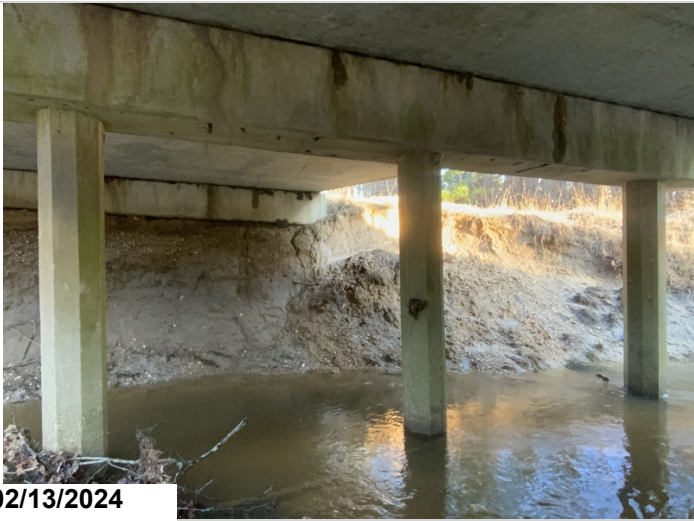
Bank erosion encroaching left side abutment 1.

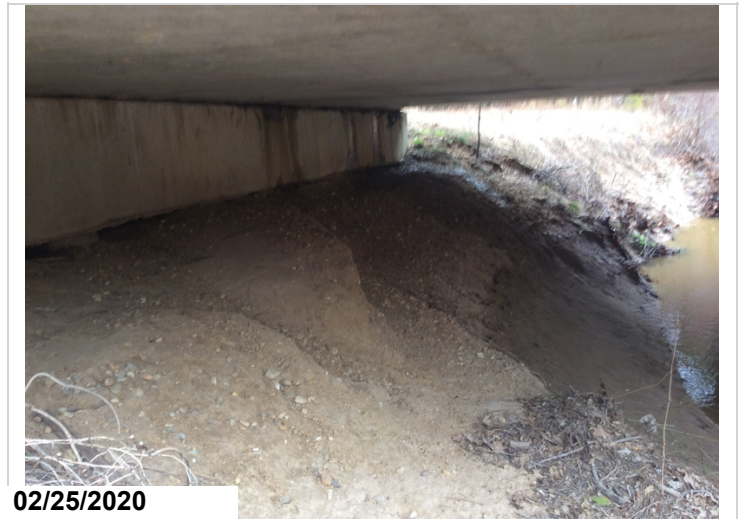
Abutment 1, scour back under abutment cap, and scour encroaching the abutment cap from C/L left.

Abutment Scour, both abutments have scour below and back under abutment caps, with abutment 2 being the worst with scour about 1 ft below bottom of cap and goes back to back of cap. There is about 3 ft hole between pile 1 & 2 @ abut. 2 that goes back under the cap. Both Abut. slopes have scour that is encroaching upon the abutments, & there is no slope protection on either abutment slope. There is little or no roadway settlement @ either abutment, but there appears to be approach slabs @ both ends of the bridge.

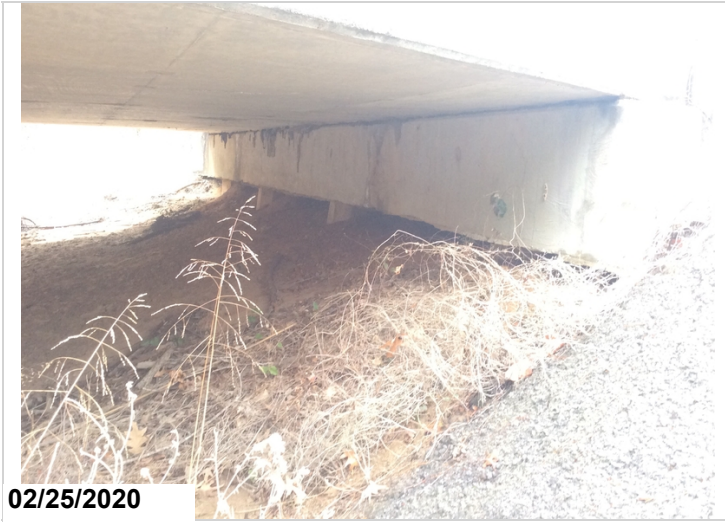
Scour abutment 2

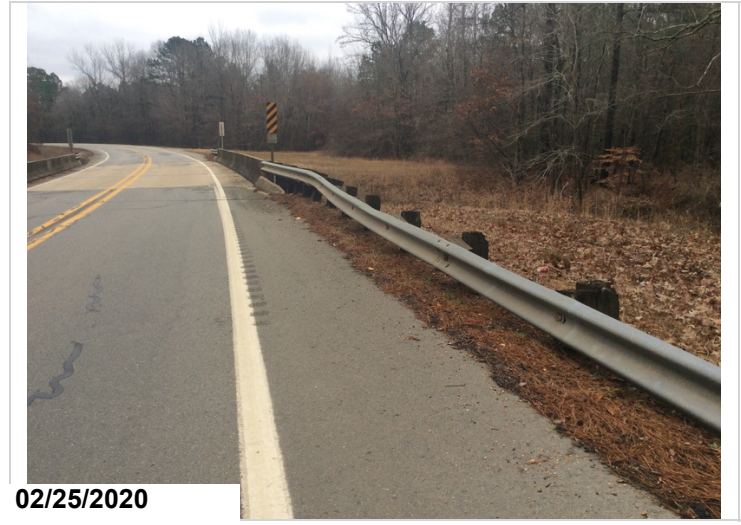
Rail damage right side

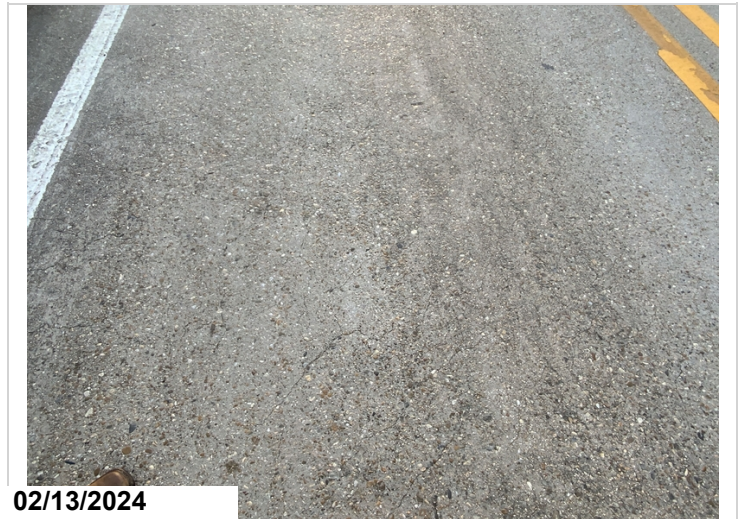
Good Condition - Deck has areas of map cracking and exposed rebar on soffit.

Scattered areas of map cracking.

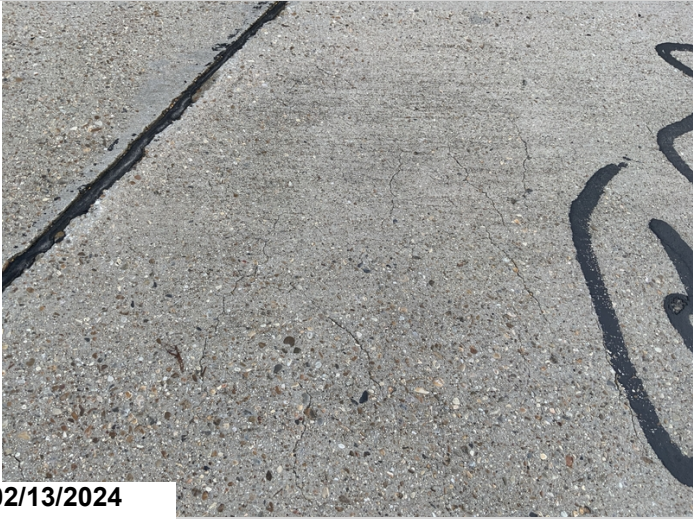
Unsealed cracks span 3 common all spans.

A-54 - Sealable Deck Cracks (Yes)

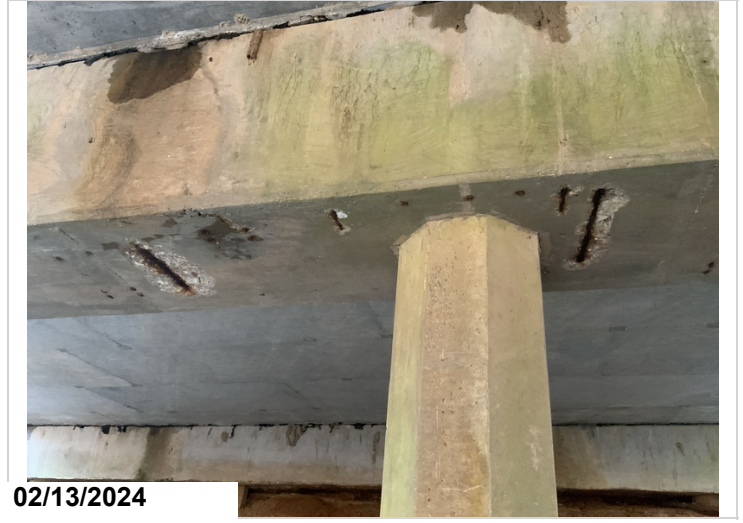
Satisfactory Condition - Caps have exposed rebar with minimal section loss, abutments have scour full length, piles have light abrasion.

Bent 3 cap bottom exposed rebar, common bent 2.

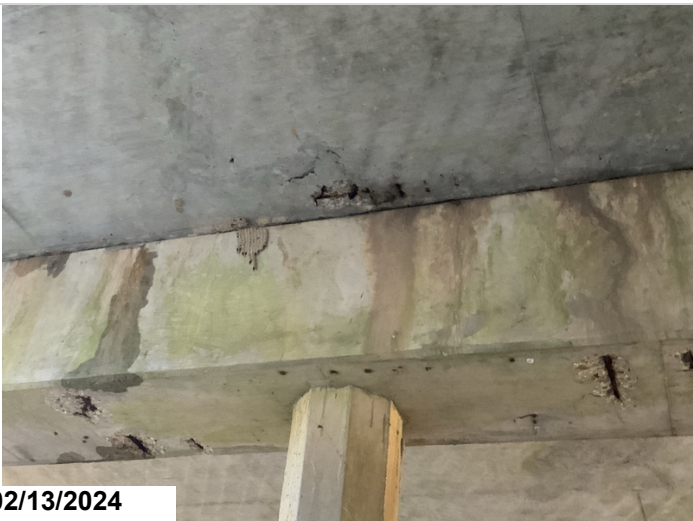
Span 2 soffit exposed rebar ahead of bent 2.

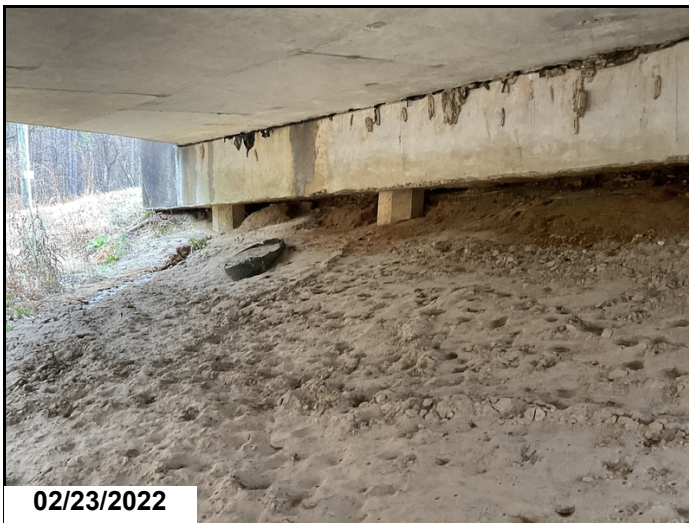
Scour abutment 2 all pile exposed

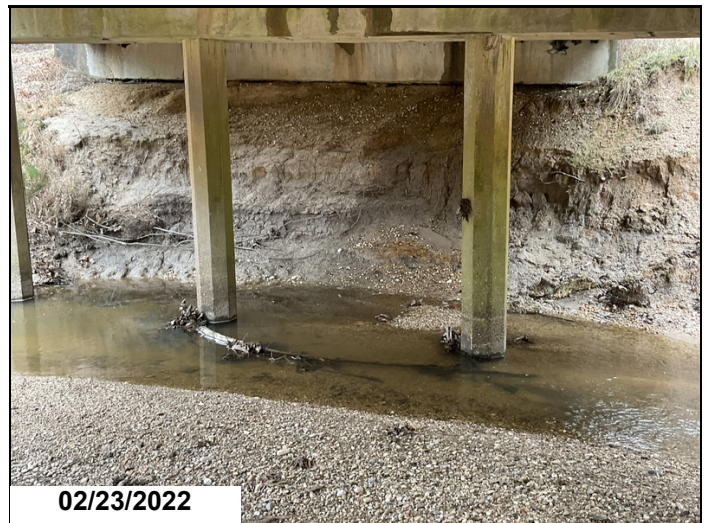
Scour abutment 1

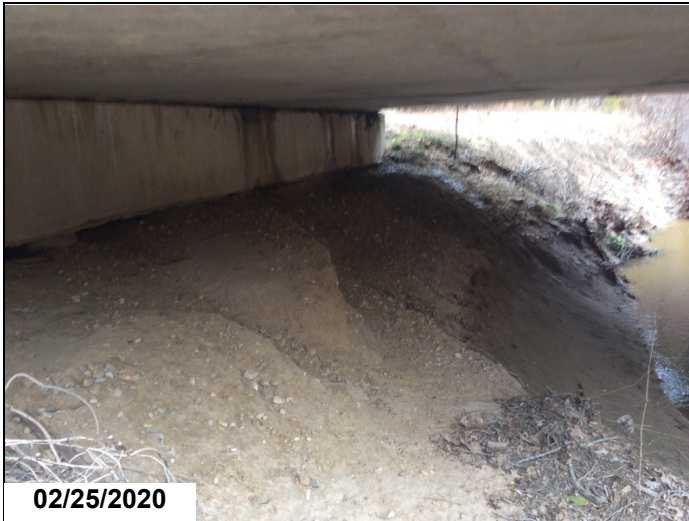
Abutment 1, scour back under abutment cap, and scour encroaching the abutment cap from C/L left.

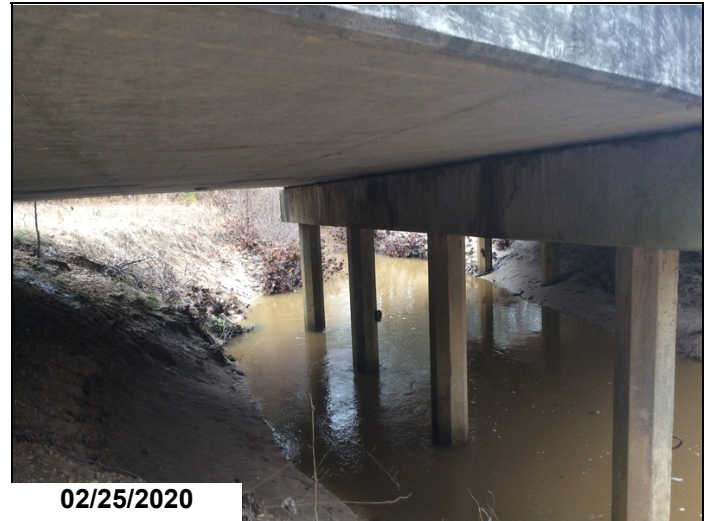
Abutment 1 slope erosion.

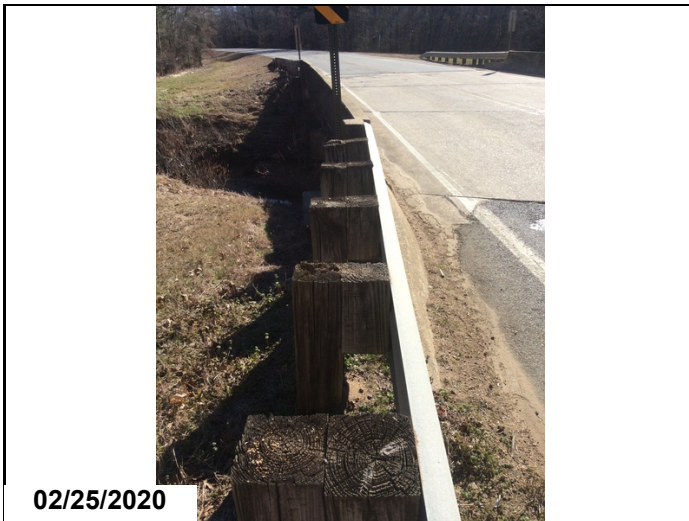
Wooden guard rail posts are beginning to rot and delaminate.

05438 wooden guard rail posts are beginning to rot.
