Asset #01381(Routine, NSTM)

US67 Sec4 Lm 0.01 over LITTLE MISSOURI RIVER

Team Lead: John Parks Inspection Date: 01/24/2023

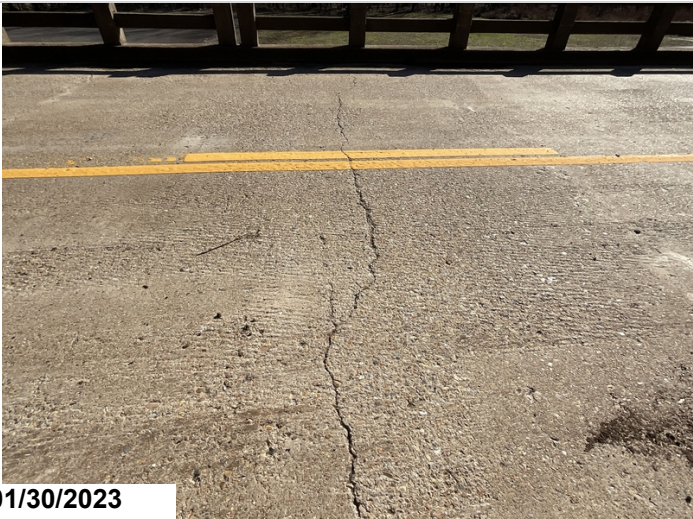
Span 1 transverse crack

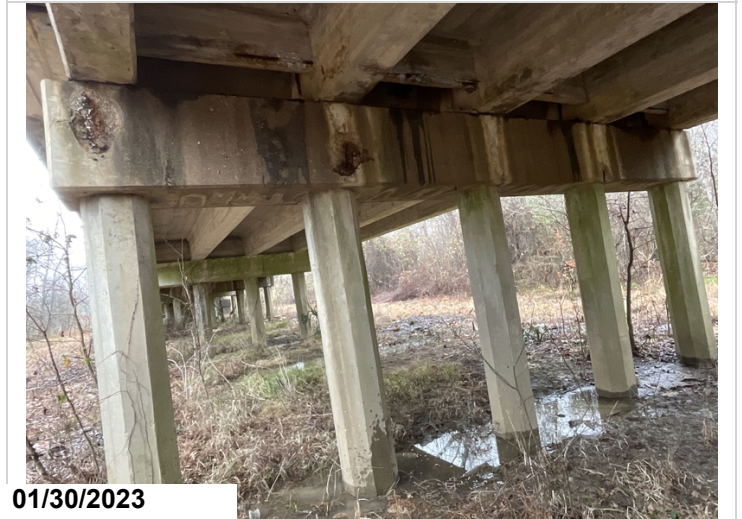
Bent 18 cap, ahead side, spalls with exposed rebar.

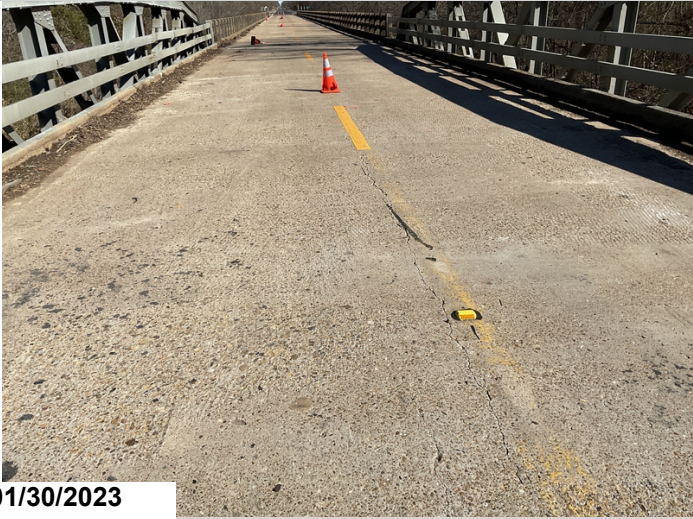
Deck cracks span 13

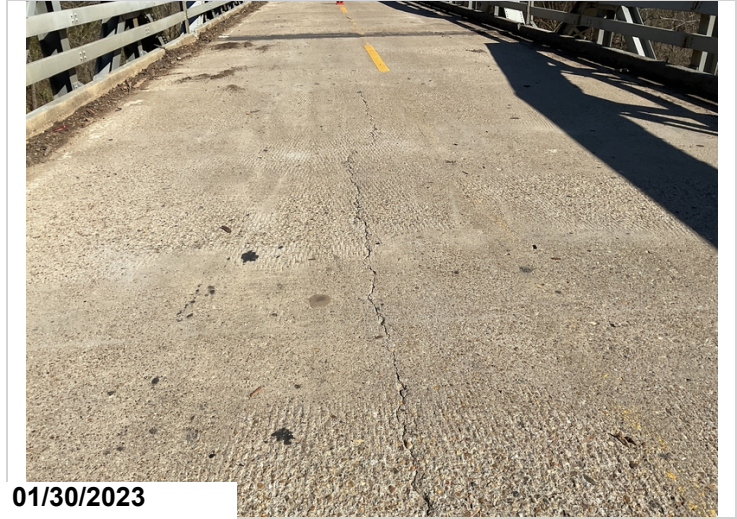
Cracks in deck span 12

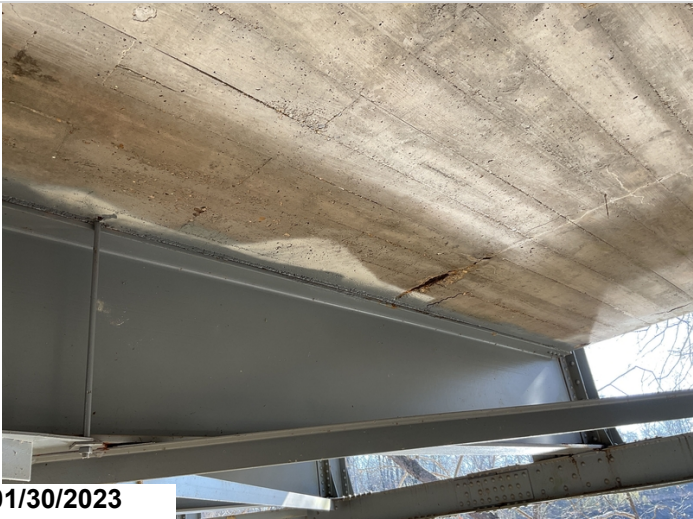
Truss 1, exposed rebar in deck.

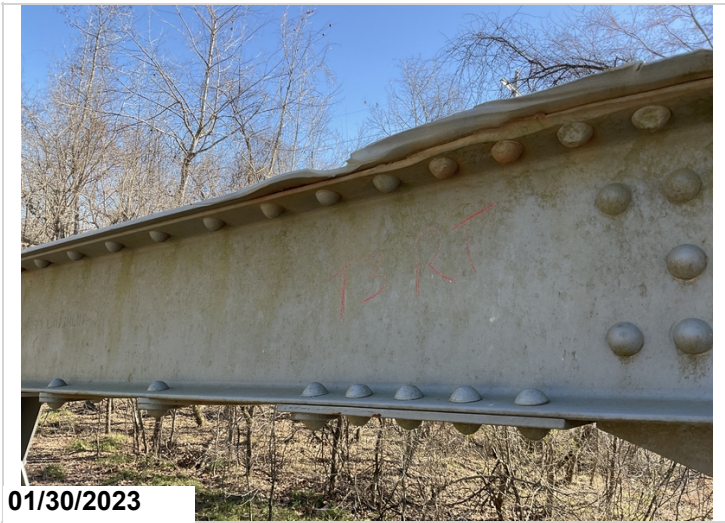
Top flange damage between U7 & U8.

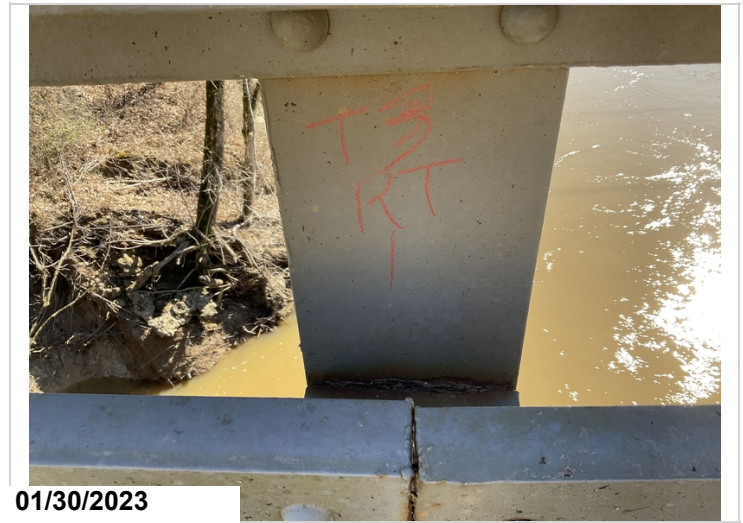
Upright flange, pitting 1/4" deep.

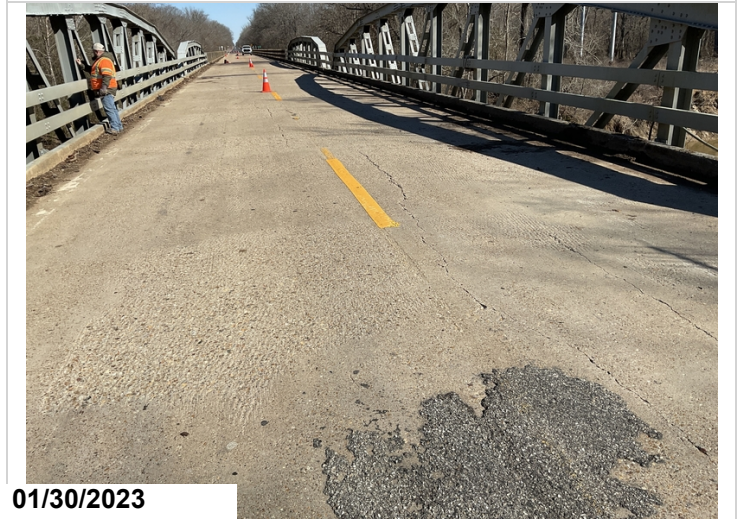
Deck cracks span 12

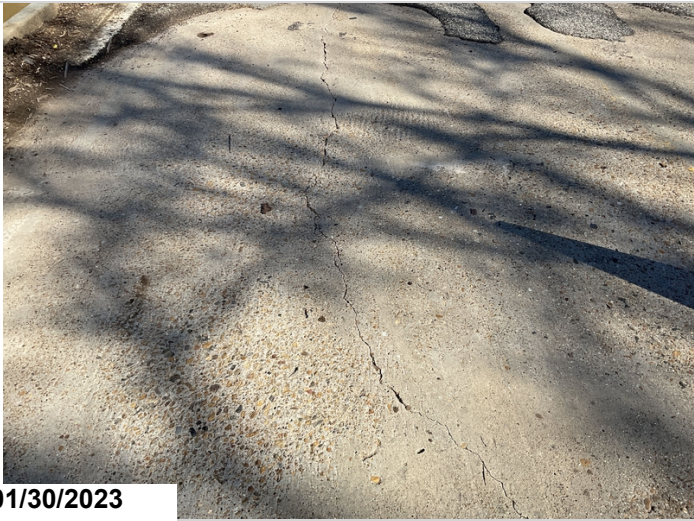
Crack in deck span 11

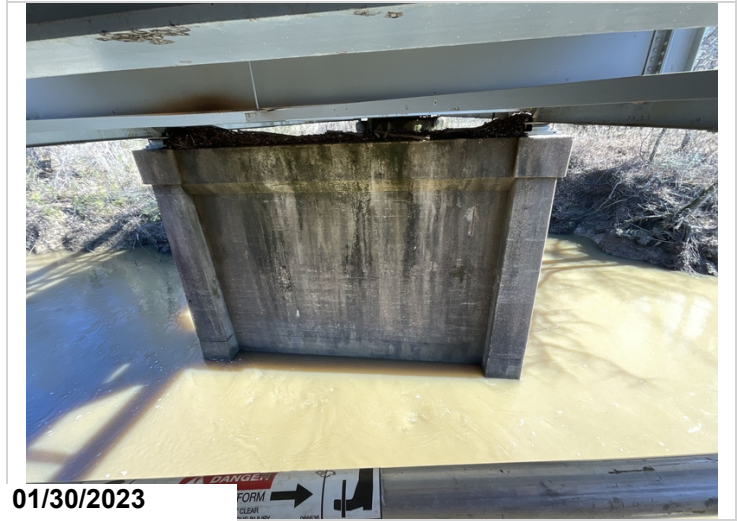
Bent 13, columns and pier wall have abrasion.

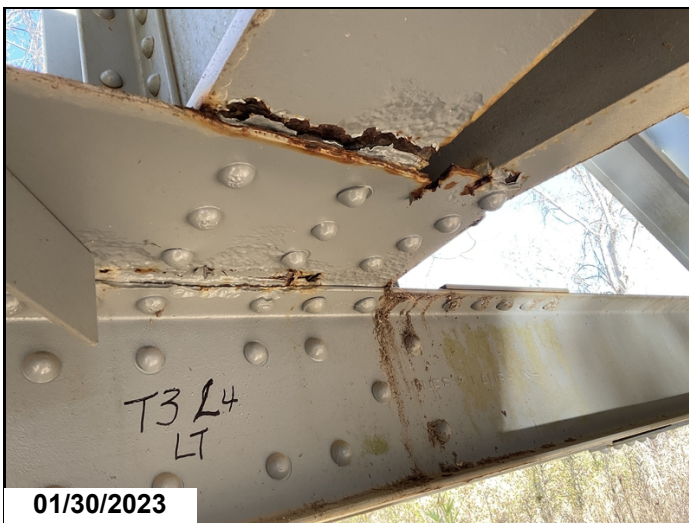
T3 L4 Lt., Corrosion hole in gusset plate, pitting in the bottom web of the FB upto, 3/8" deep.

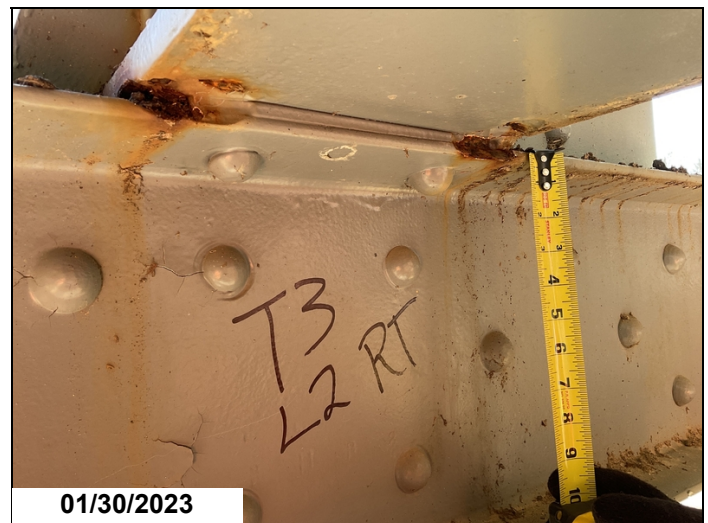
T3 L2 Rt. Pitting upto 1/4" deep, bottom flange of FB, Top flange of chord.

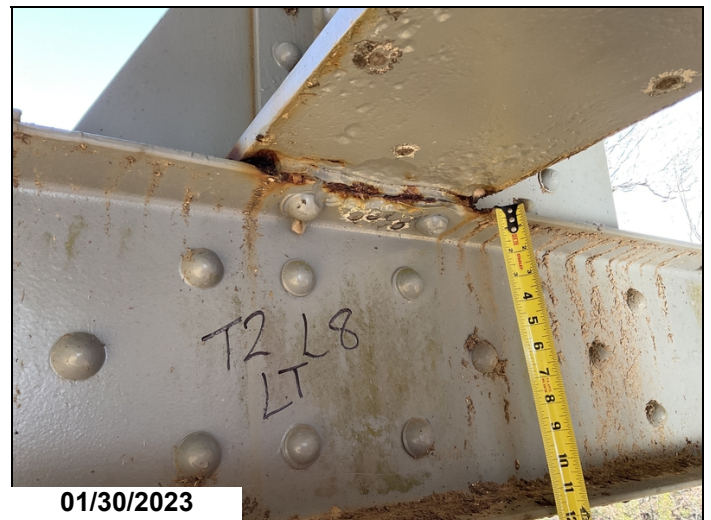
T2 L8 Lt. Top flange of chord outside edge is corroded away. Bottom flange of floor beam has upto 3/8" pitting.

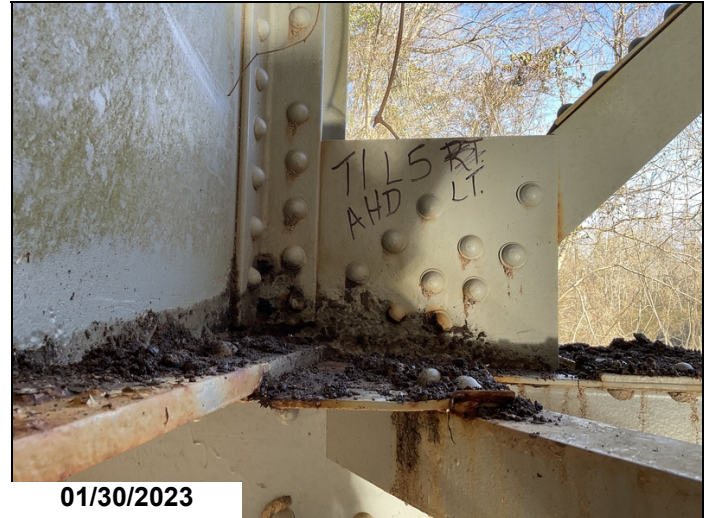
01/30/2023
T1 L5 Lt. Gusset plate has 1/4" deep pitting, 2 rivet heads are half way corrode away. Gusset plate on backside similar.

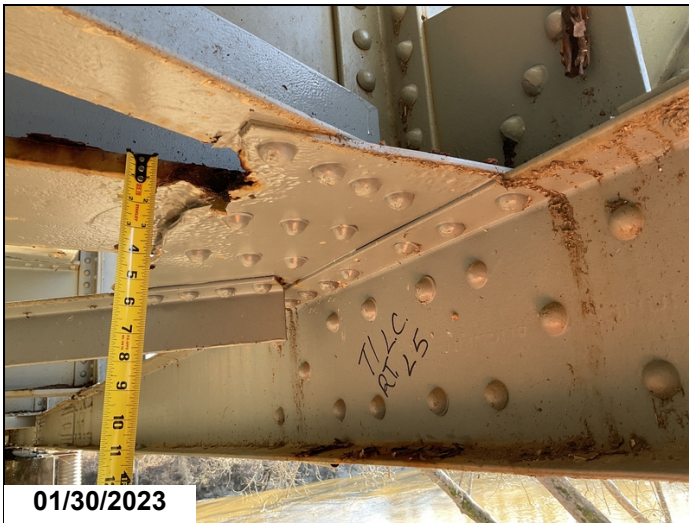
T1 L5 Rt. 3/8" section loss lower flange of floor beam.

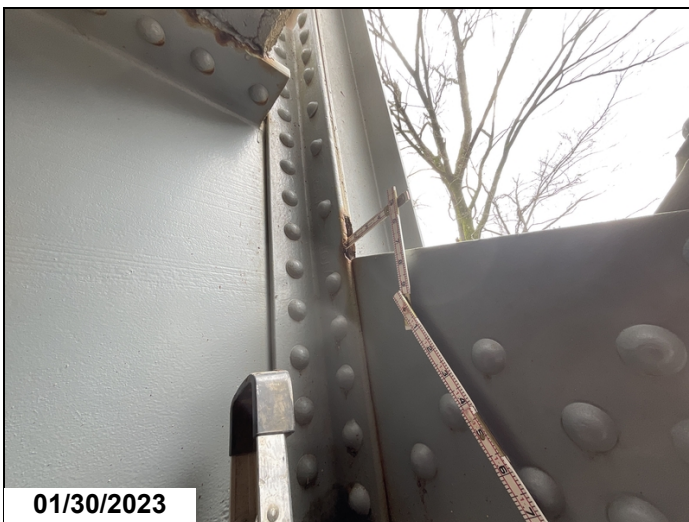
T1 L3 Rt. Pack rust at connection plates.

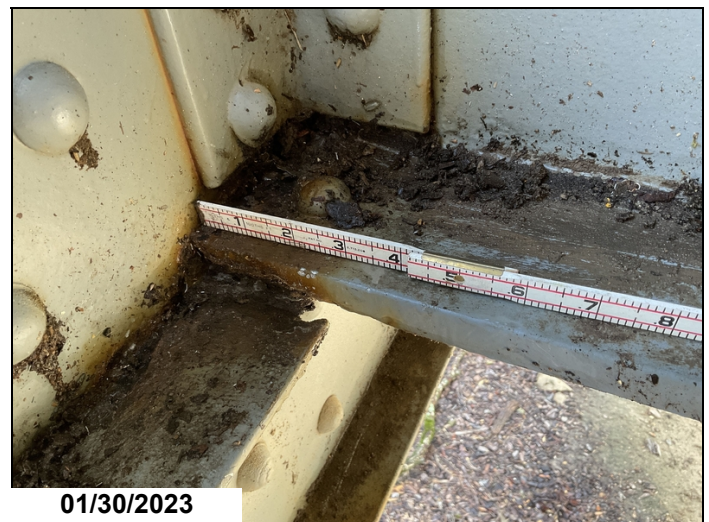
T1 L2 Lt., back side. 0.5" hole in top flange of lower cord.

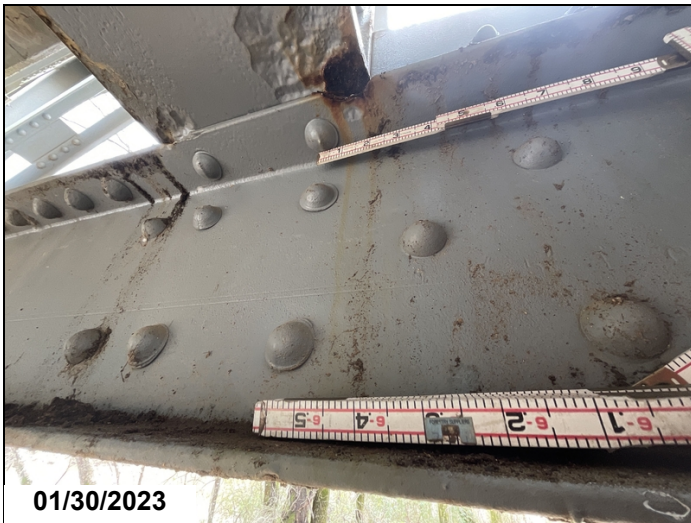
T1 L3 Rt., back side. Corrosion has top flange down to knife edge of lower cord.

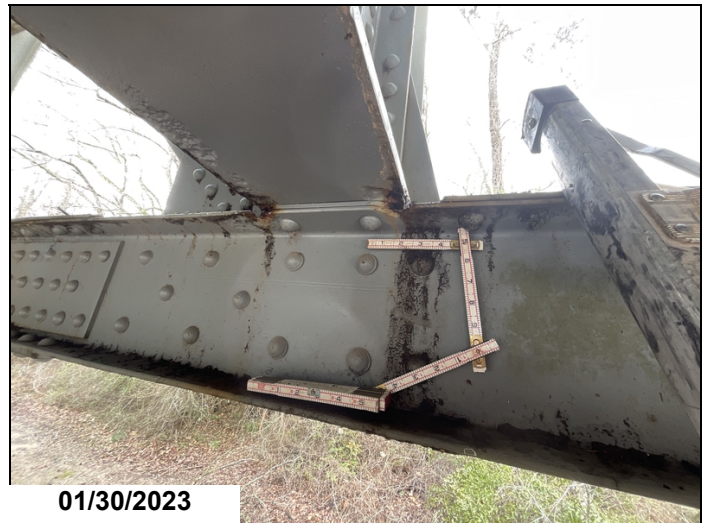
T1 L3 Lt., ahead side. Corrosion has top flange down to knife edge of lower cord.

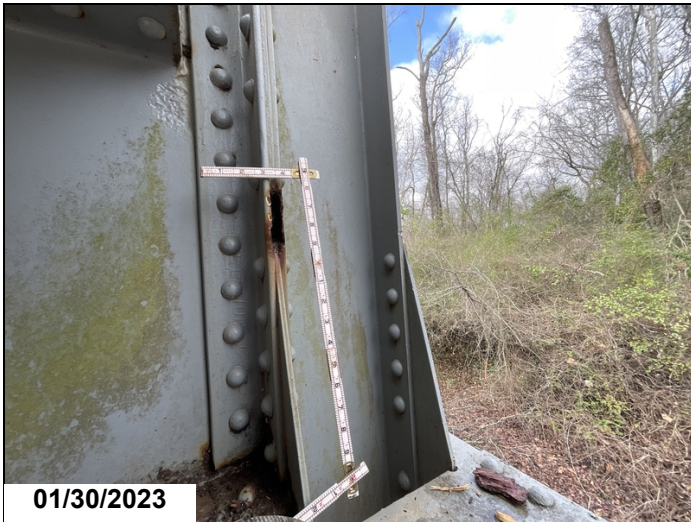
T1 L3 Lt., ahead side. Pack rust at connection plates.

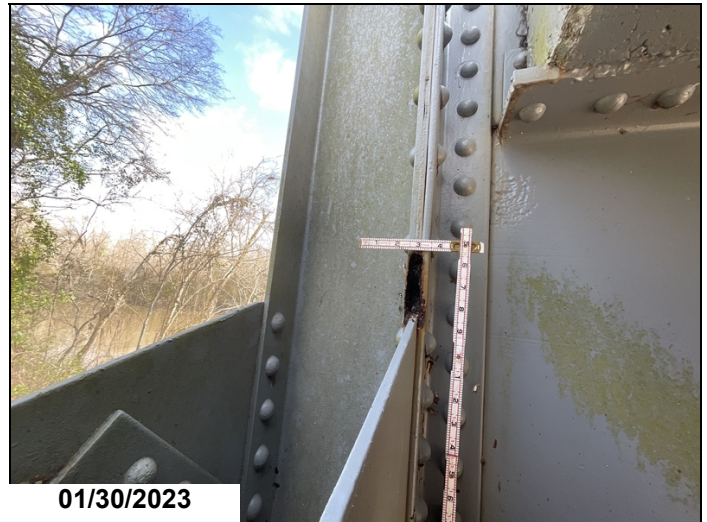
T1 L3 Lt., back side. Pack rust at connection plates.

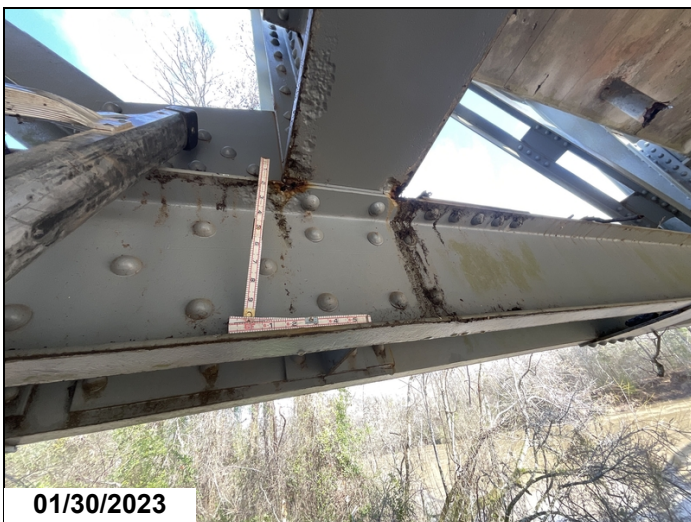
T1 L3 Lt., back side. 0.5" hole in top flange of lower cord.

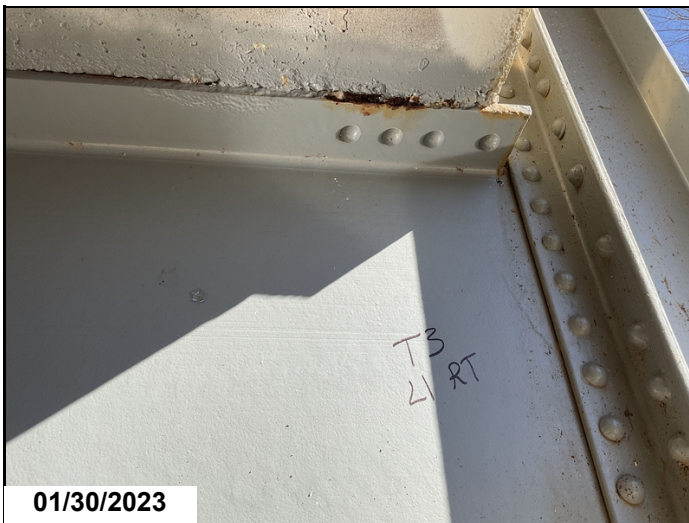
Crack repaired, hole drilled & arrester installed.

HBM drilled 1/2" holes in the ends of the cracks and placed compression sleeves in the holes to arrest the cracks.
1/26/2023 JDP

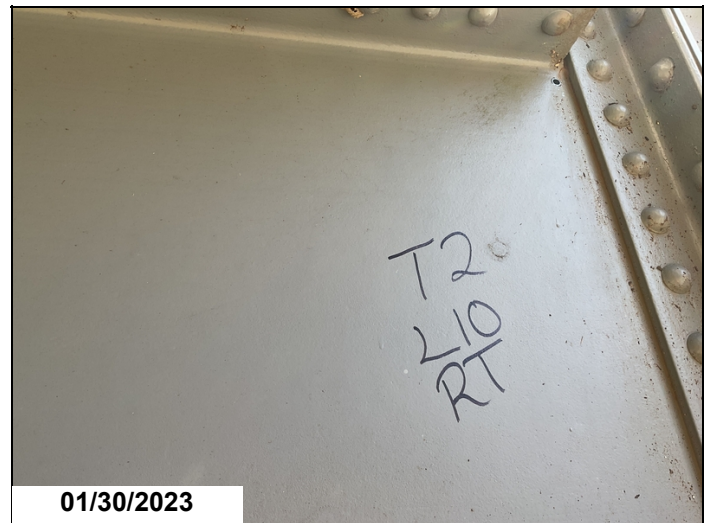
T2 L10 Rt. Crack repaired, hole drilled & arrester installed.

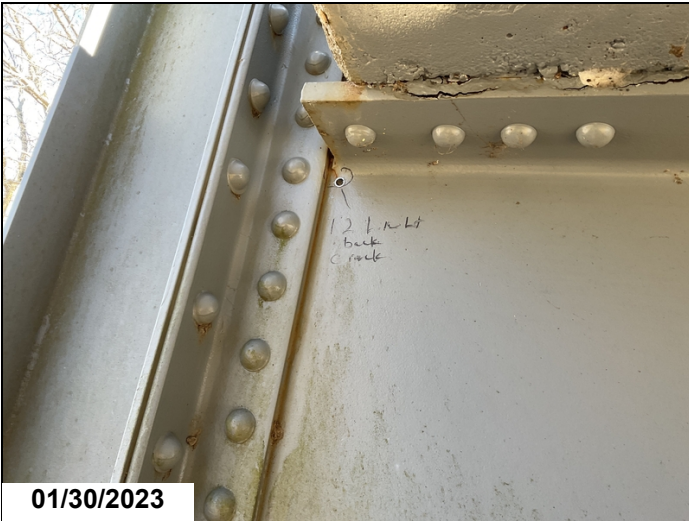
T2 L10 Lt. Crack repaired, hole drilled & arrester installed.

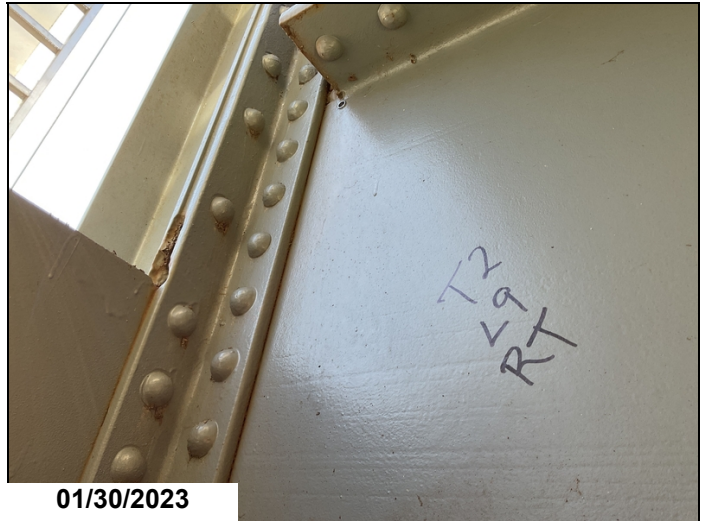
T2 L9 Rt. Crack repaired, hole drilled & arrester installed.

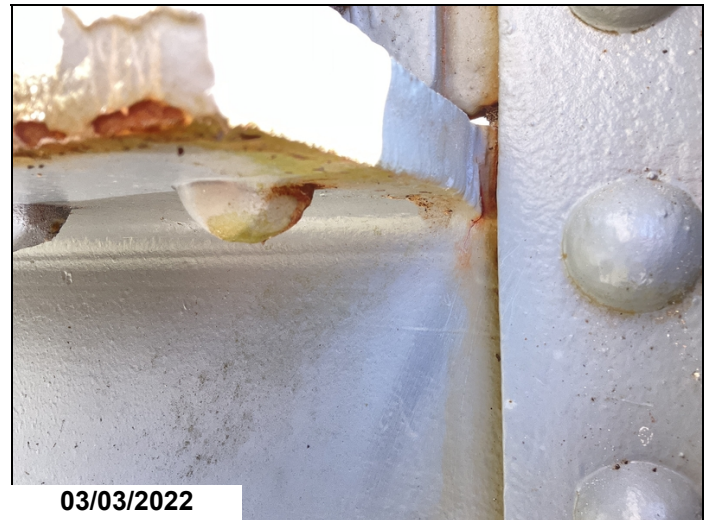
Truss 3 at L1 crack in FB

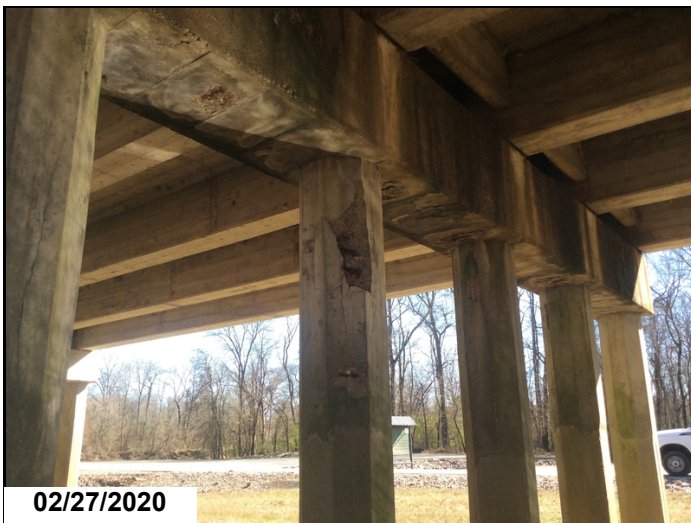
Bent 5, pile 2 has 1 1/2' of spall & delam with exposed steel

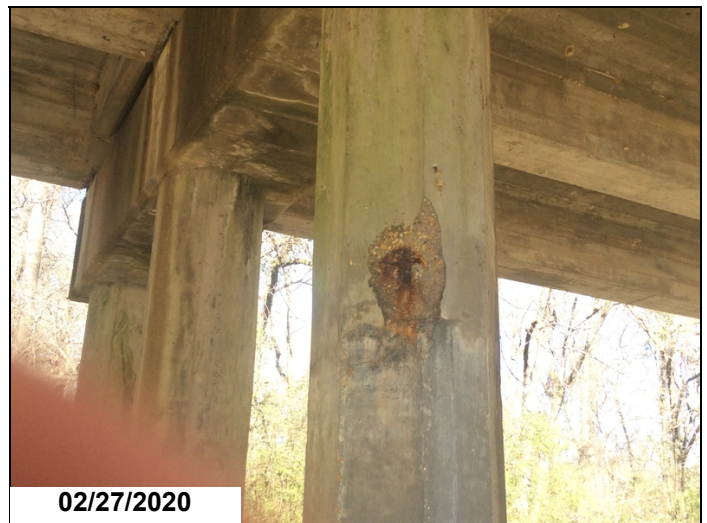
Bent 7, pile 3 has a small spall with some exposed steel, approx. 8" of spall.

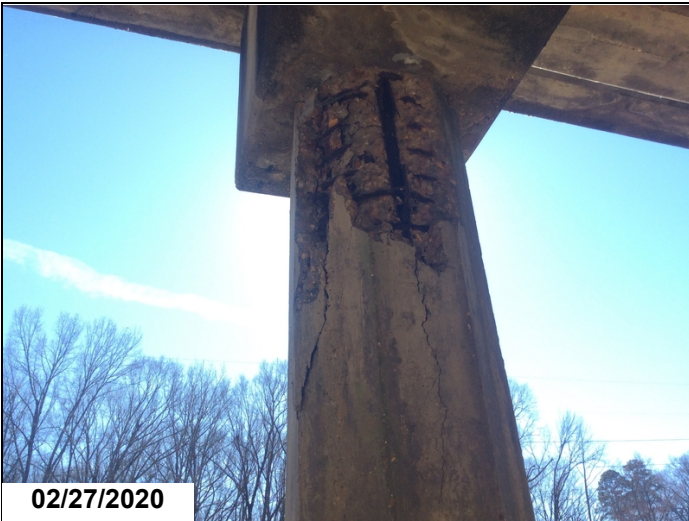
Bent 3, pile 5 has a large spall at top of pile, with exposed steel, with about 2' of cracks coming down the face of the pile below the bottom of the spall.

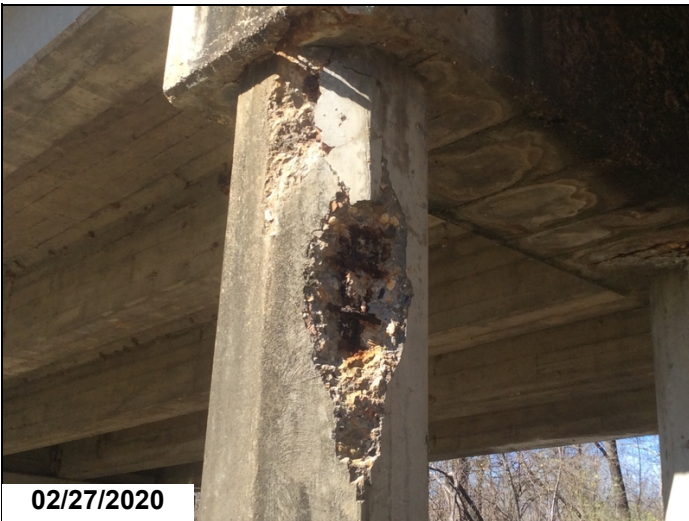
Bent 5, pile 5 has 2 1/2' of spall & delam with exposed steel.

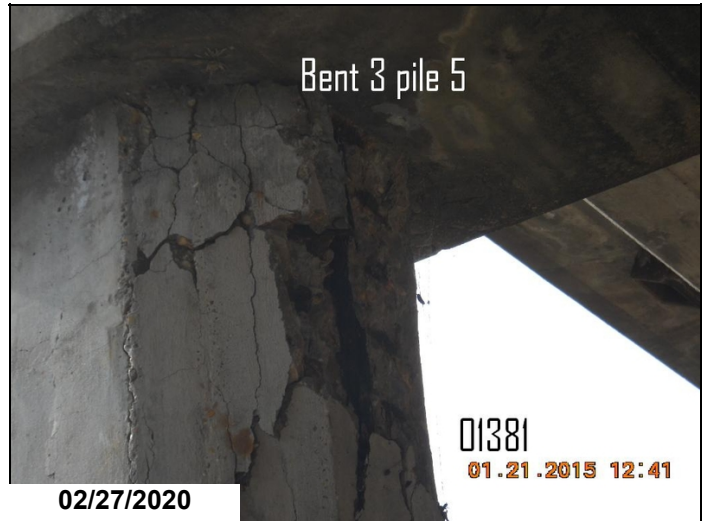
Bent 3 pile 5 has spall and delamination with exposed steel.

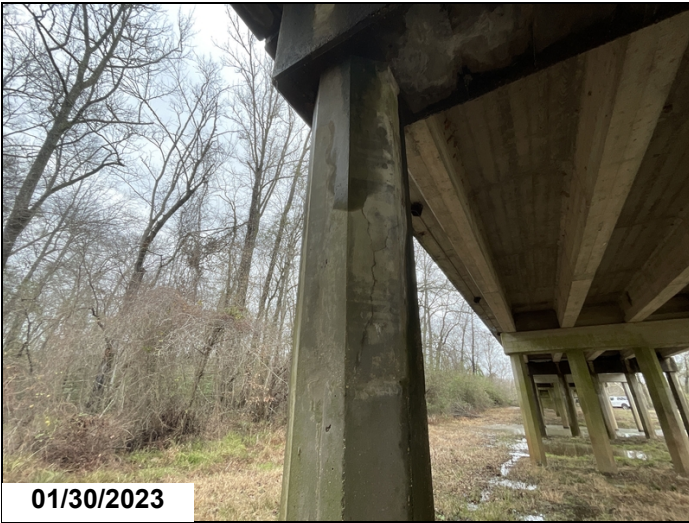
Bent 5 pile 1, vertical crack upto .030"

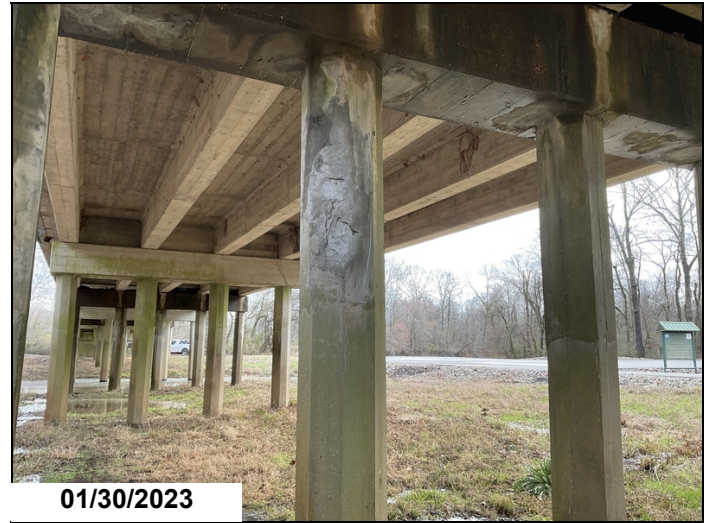
Bent 5, pile 2 has been repaired.

Bent 3, piles 3-5 have been repaired.
Bent 5, piles 2 & 5 have been repaired.
01/25/2023 JDP

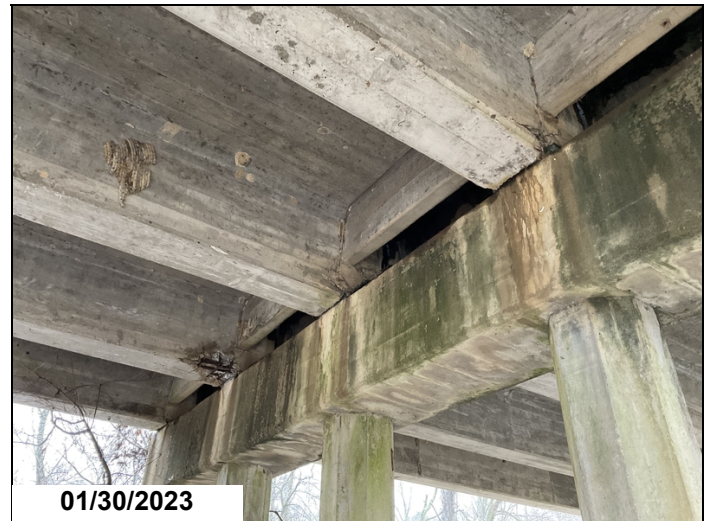
Span 24, @ Bent 24, Girders 2- 4 have spalls with exposed rebar.

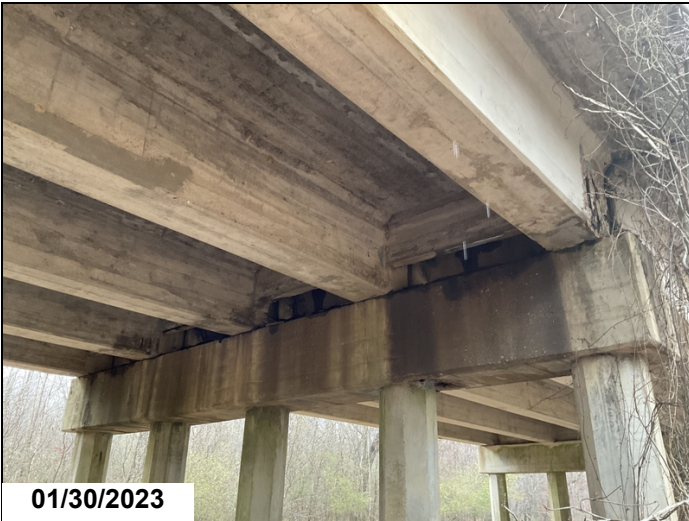
Span 19, Girders 1, 2, & 5 have spalls with exposed rebar.

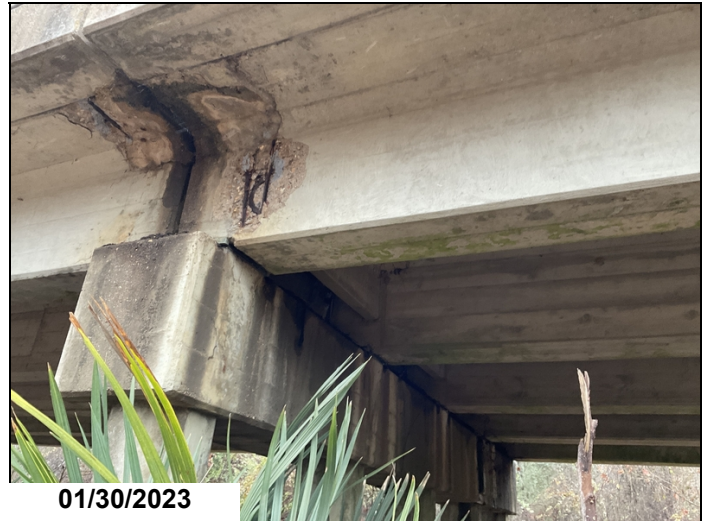
Span 15 @ Bent 5, Girder 5, spall with exposed rebar.

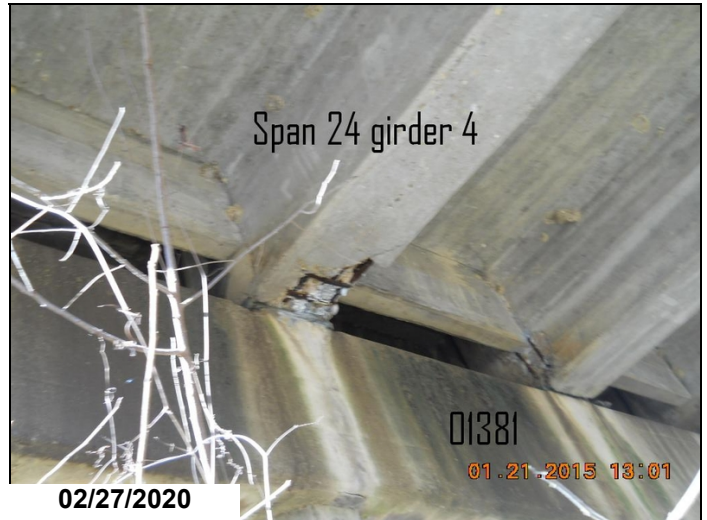
Span 24, girder 4, spall with exposed steel to bottom of girder @ bearing area.

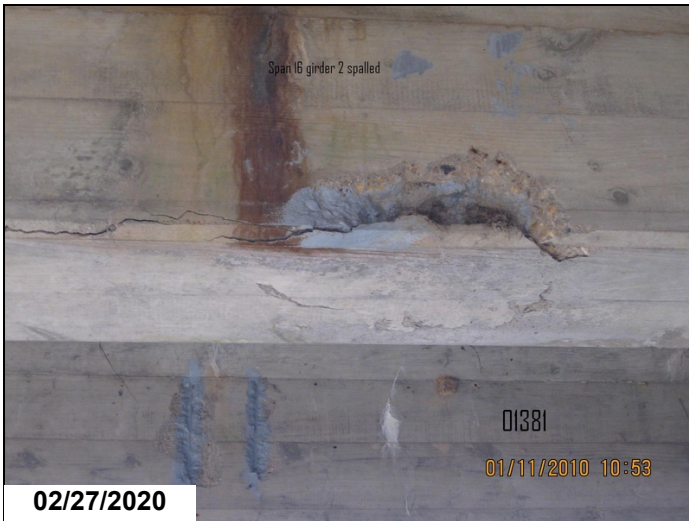
01381 span 16 girder 2, 4' back of Bt. 17, spall on bottom of girder also has some longitudinal cracks along bottom of girder.

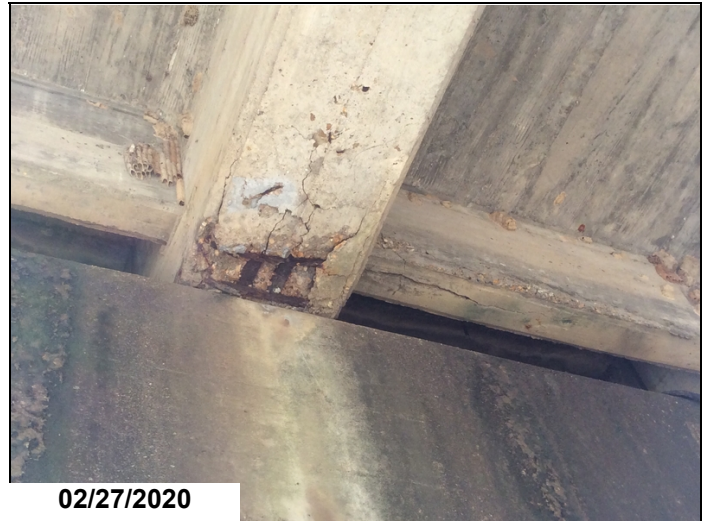
Span 5 girder 4 @ bent 5 bearing area has 1' of spall with exposed steel.

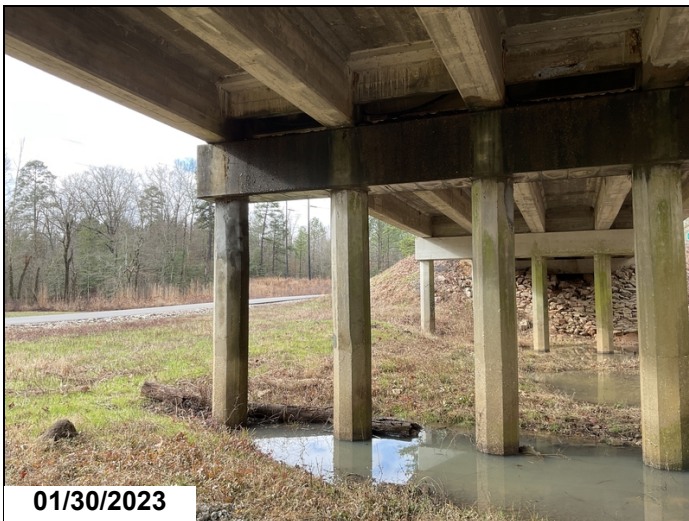
Bent 3, piles 3-5 have been repaired.

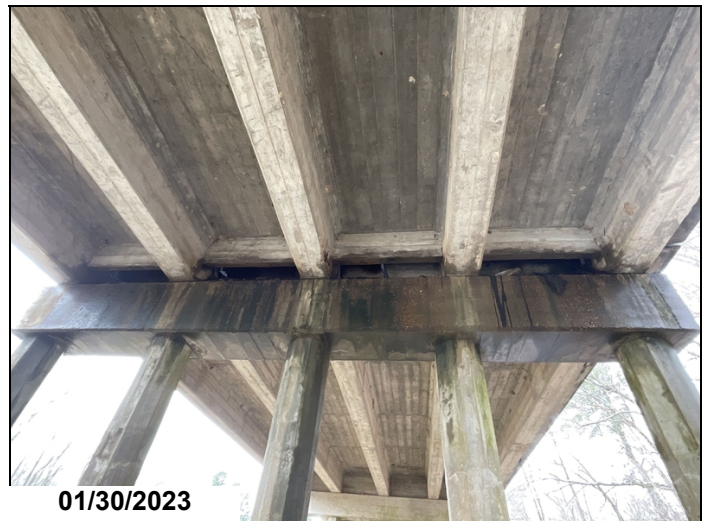
Span 7, @ Bent 7, Girders 1, 2, 3, & 5 have spalls with exposed rebar.

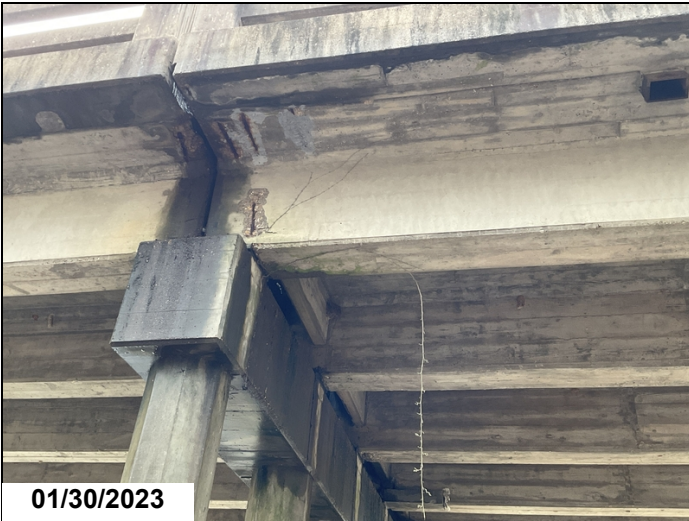
Span 6 @ Bent 7, spall with exposed rebar.

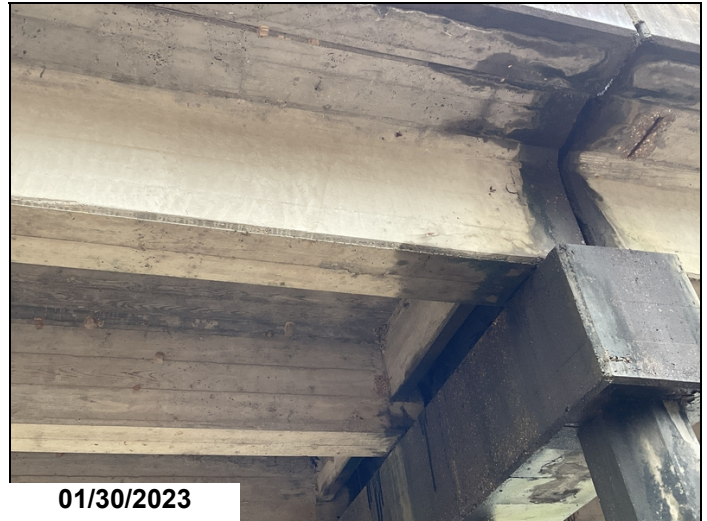
Span 5 @ Bent 5, Girder 1 has a small delam & crack 2' long horizontal crack that is 0.025".

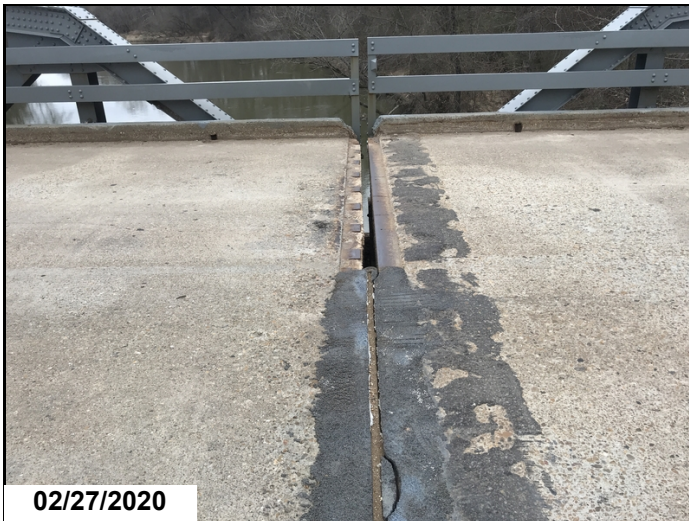
Joint between T3 & approach span 14, the gap is 4" & there is about a 2" drop from approach span to T3. Road iron on T3 Lt. from C/L Lt. The road iron is missing on truss 3 EB lane and there is a bump of asphalt remaining on the approach span thus making it look as if the truss span is lower than the approach span. Joint between T2 & T3 Lt. side looking from Rt. to Lt., gap is 3 1/2" wide between road iron, sliding plate is missing thus making the joint rough to traffic.

Joint between T2 & T3 Lt. side looking from Rt. to Lt., gap is 3 1/2" wide between road irons.

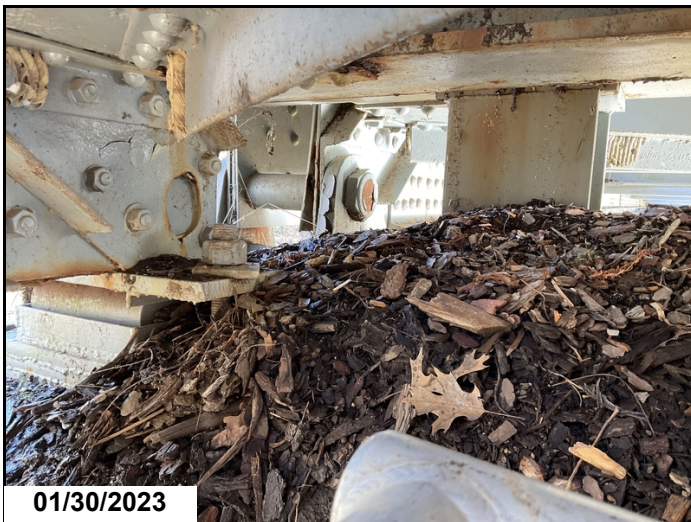
T2, L0, Left, pack rust at gusset plates.

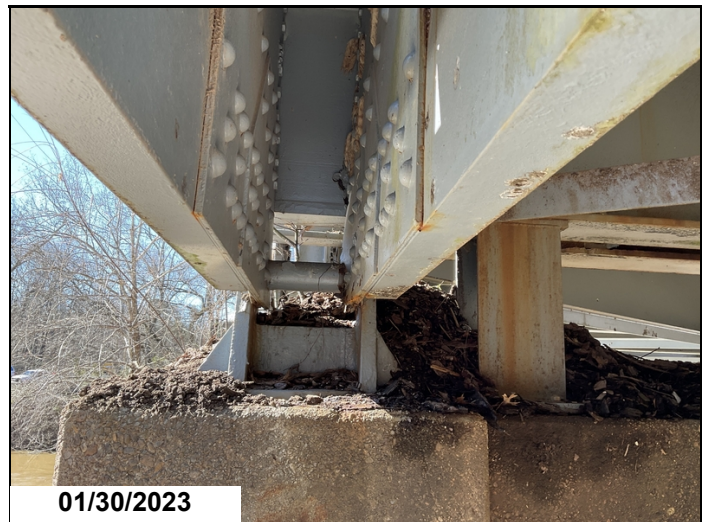
T3, LO, Rt, gusset connection has pack rust.

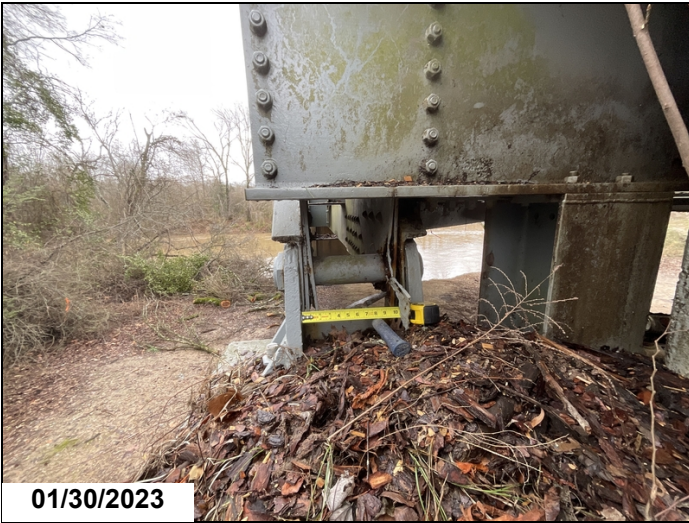
Truss 1 @ L0, left bearing, pack rust between gusset plates, lower cord, & diagonal.

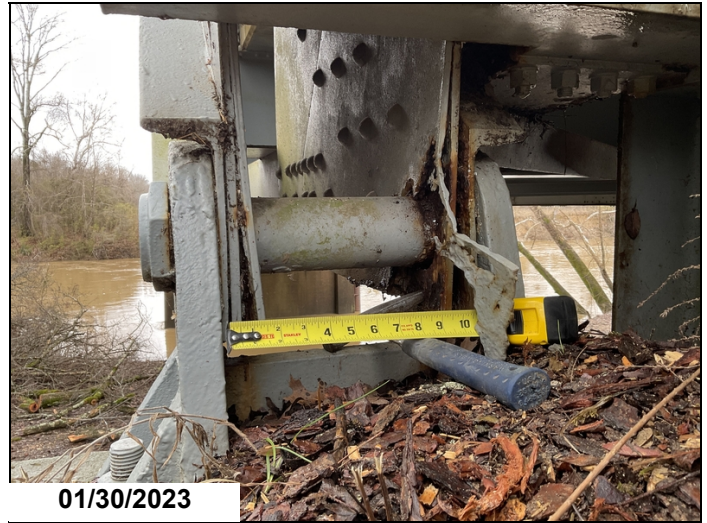
Truss 1 @ L0, left bearing, pack rust between gusset plates, lower cord, & diagonal.
Left L0, one plate has corroded away from around the pin and there is a 3/4" corrosion hole in the second plate.

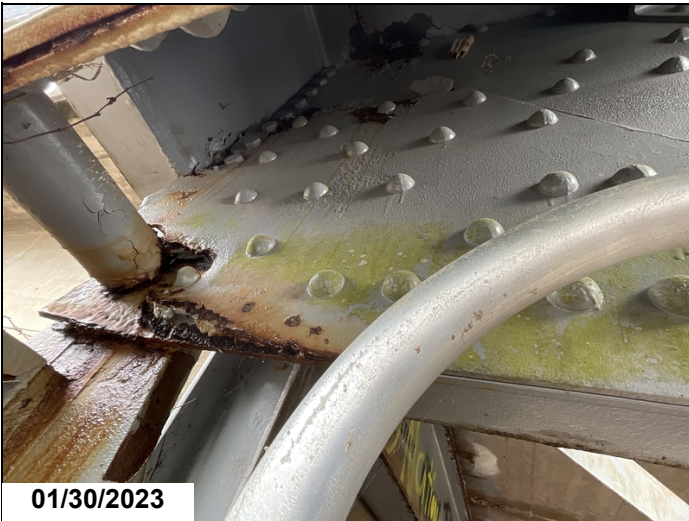
Truss 1 @ L0, right bearing, pack rust between gusset plates, lower cord, & diagonal.

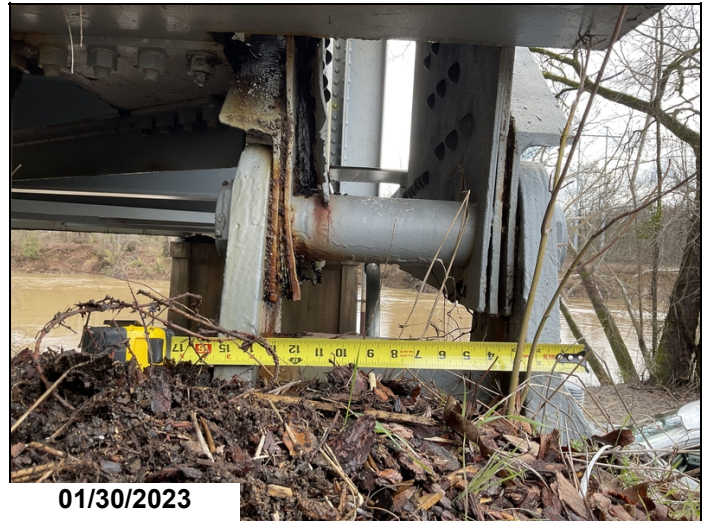
Truss 1 @ L0, right bearing, pack rust between gusset plates, lower cord, & diagonal.

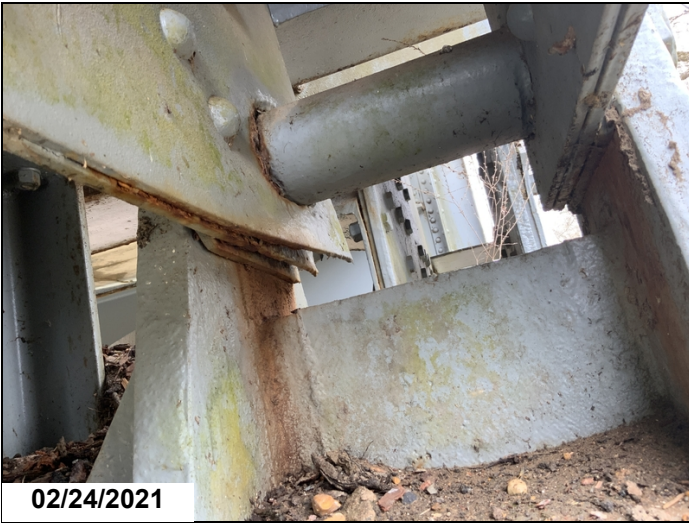
Left side truss 2, L0 pin has section loss

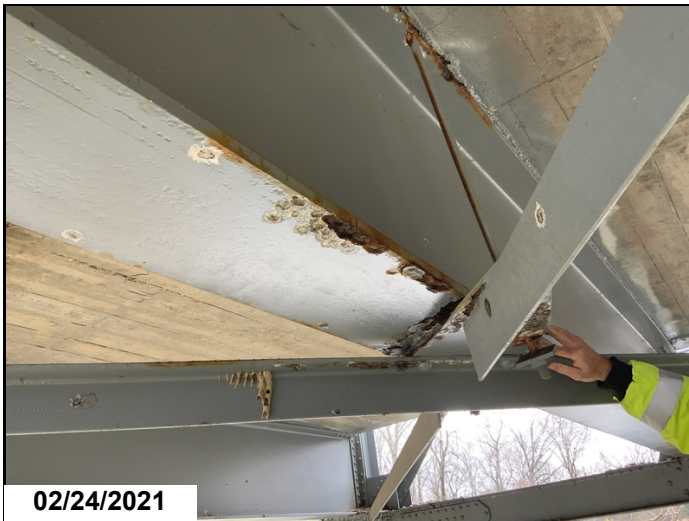
Truss 2, fb 4, cross bracing hanger bolt broke

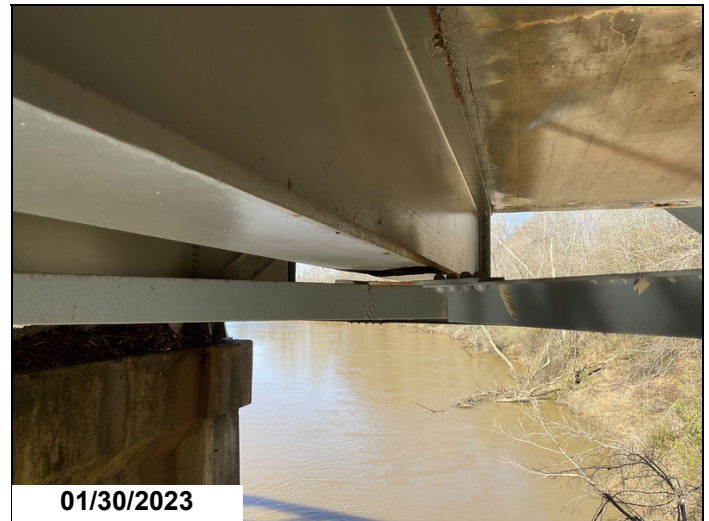
T3, FB 2, lateral brace, bolt missing in connection.

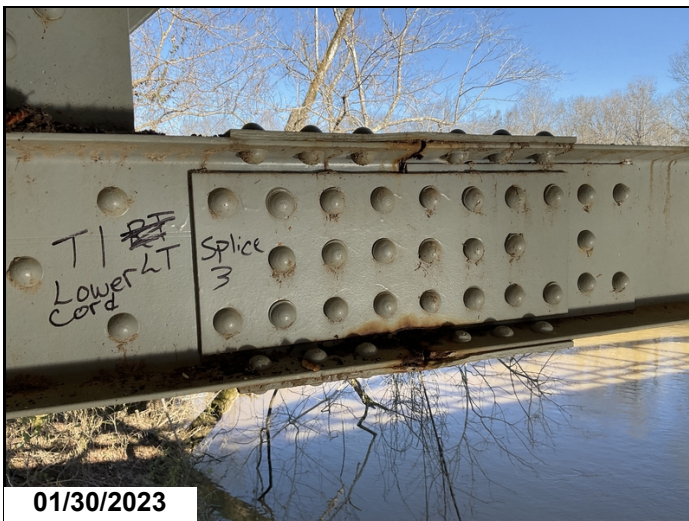
T1 Lower chord, splice 3. All splice plates have pack rust.

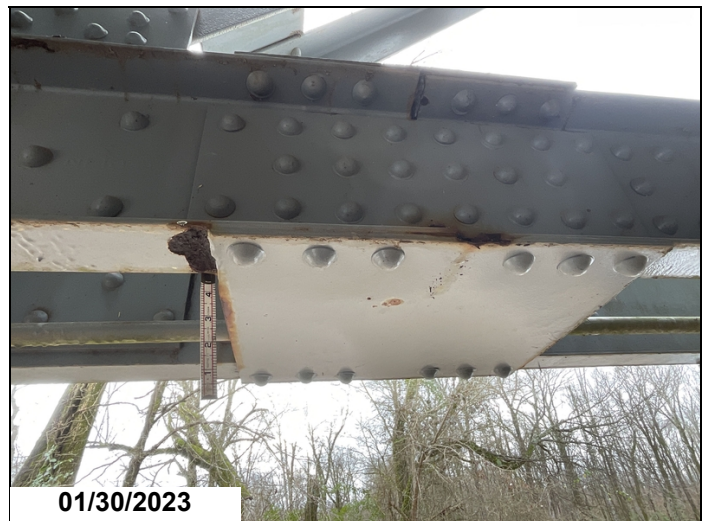
Truss 1, right, splice just ahead of L3. Pack rust at connection plates & bottom flange has section loss upto 1/8" deep.

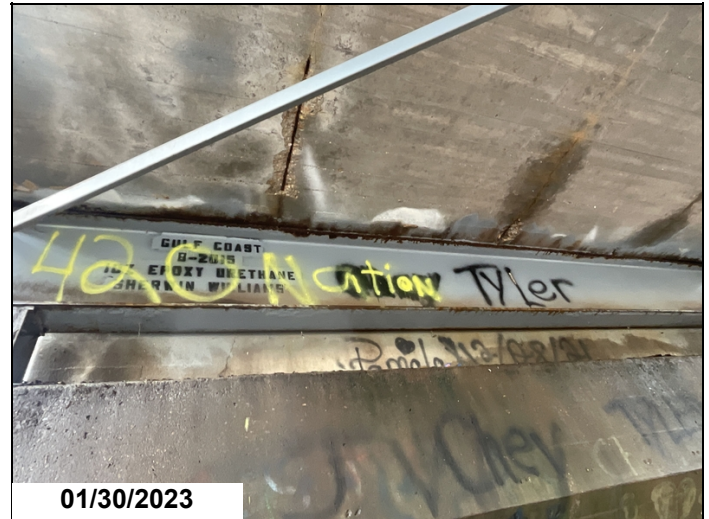
Truss 1, FB 1, corrosion along the flanges.

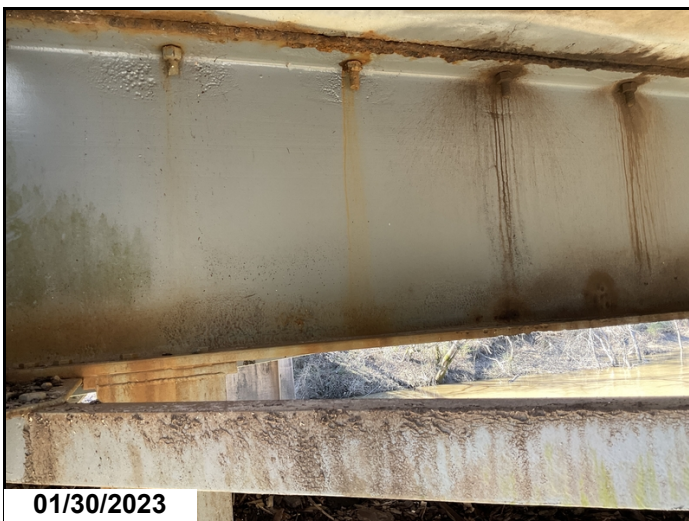
T3, FB1, 3" hole in web.

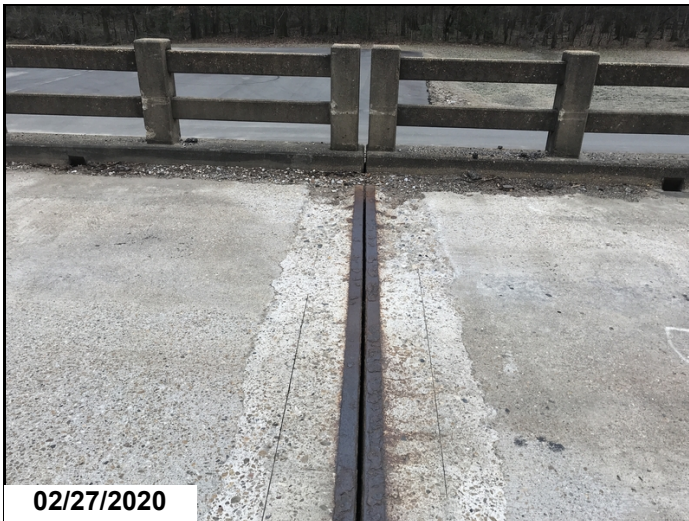
Joint @ bent 3 looking from Lt. to Rt. Concrete on Rt. side from curb back Lt. Both sides of joint has spalled out for about 5' & approx. 2" deep.

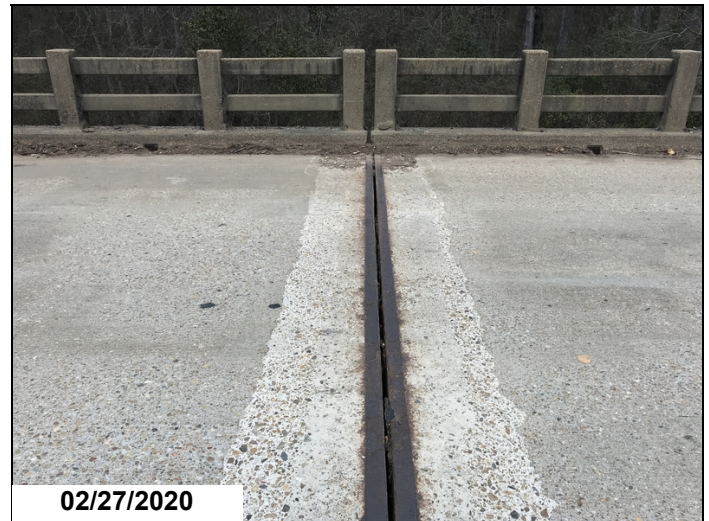
Bent 9 looking from Rt. to Lt. @ joint. Concrete on Lt. Side of the bridge, both sides of the joint have spalled out for about 2' & approx. 1 1/2" deep.
