Asset #01381(Routine, NSTM)

US67 Sec4 Lm 0.01 over LITTLE MISSOURI RIVER

Team Lead: John Parks Inspection Date: 01/24/2023

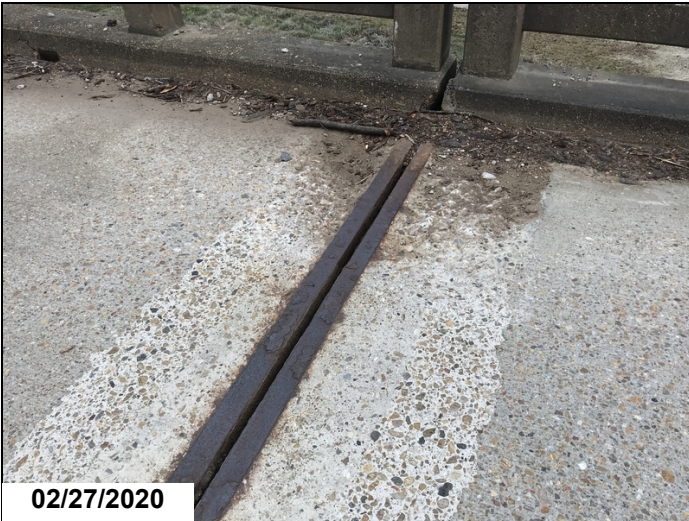
Bent 9 Rt. Side of bridge deck @ joint has spalled out about 3' away from curb into travel lane approx. 2" deep.

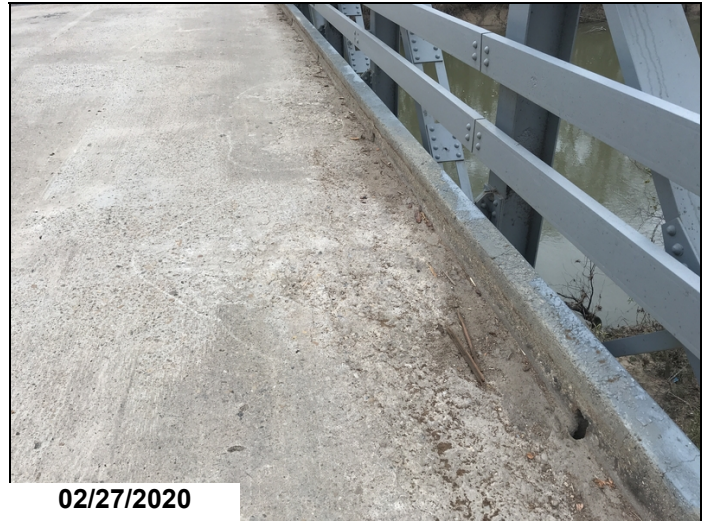
T3 @ midspan from L3 - L5 Lt. in the gutter line is spalled approx. 1" deep.

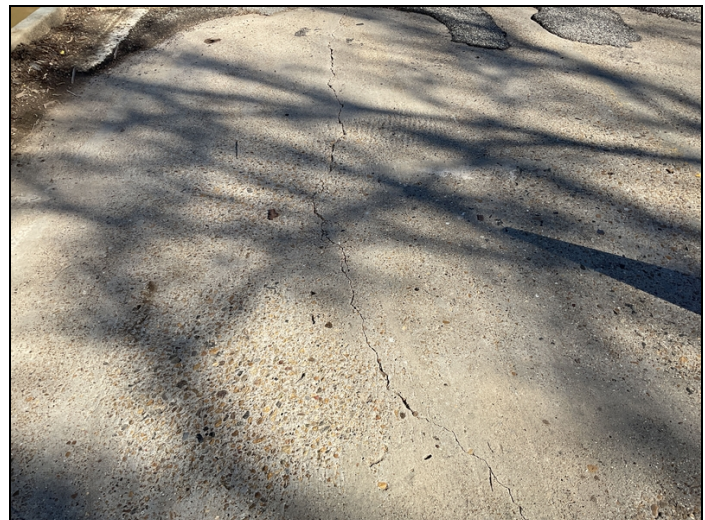
Crack in deck span 11

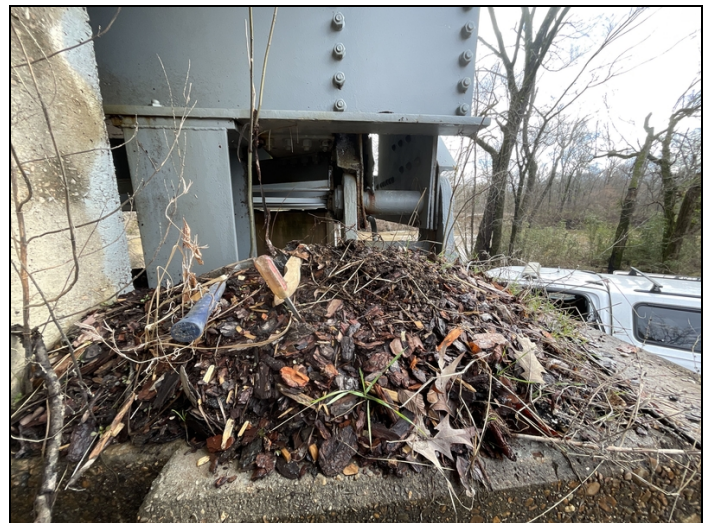
Bent 11, debris built up around the bearings.
