Asset #01381(Underwater)
US67 Sec4 Lm 0.01 over LITTLE MISSOURI RIVER
Location: 2.2 MI S SH 51
Team Lead: Victoria Elliott **Inspection Date:** 03/14/2024

US67 Sec4 Lm 0.01 over LITTLE MISSOURI RIVER

ARDOT Structure # 01381

Underwater Inspection Procedures

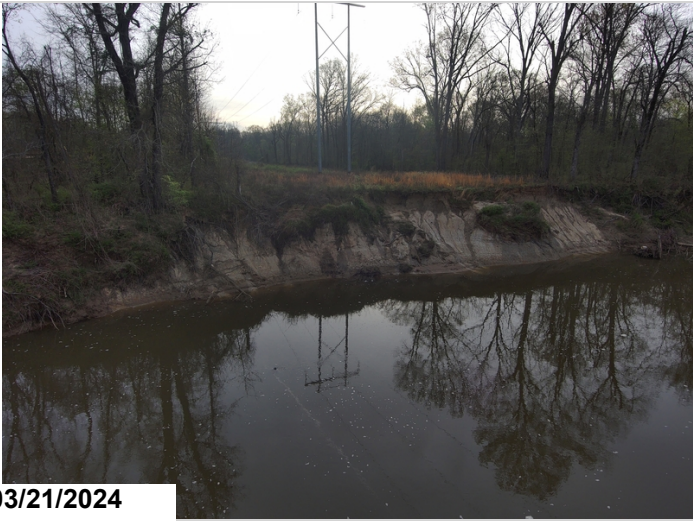
03/18/2024- VLE, NLB, DWG
Overall the channel is in fair condition with cut banks, minor channel migration, and pier scour.

Cut banks right of Pier 3

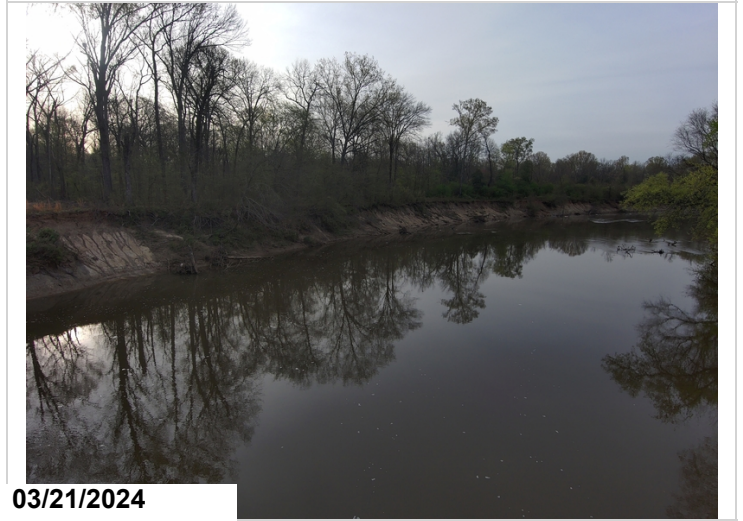
Left Channel cut bank

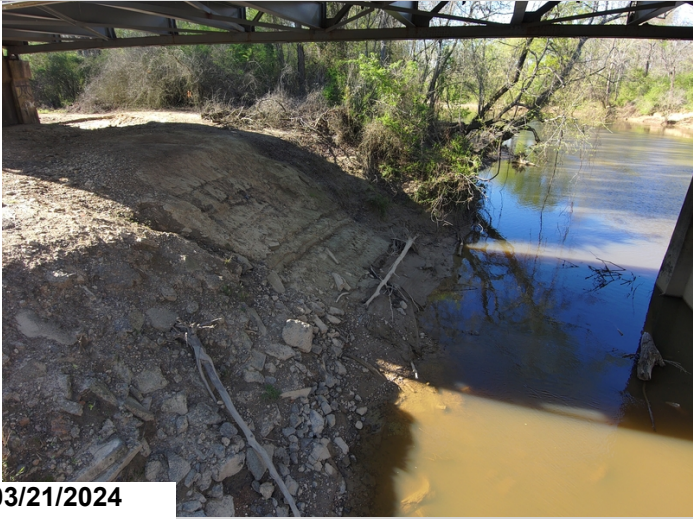
03/18/2024- VLE, NLB
According to plans, Piers 2 & 3 have a bottom of footing elevation of 171.30'. The approximate cover at time of construction was 9' at Pier 2 and Pier 3. The amount of cover left is approximately 6' at Pier 2 and 5' Pier 3. The footings are keyed into rock according to boring logs on plans. Pier scour due to channel migration has caused a widening of the channel directly under the bridge behind Piers 2 & 3. Pile Bents have local scour holes up to 2' deep at various locations.

Pier 2 Back Scour

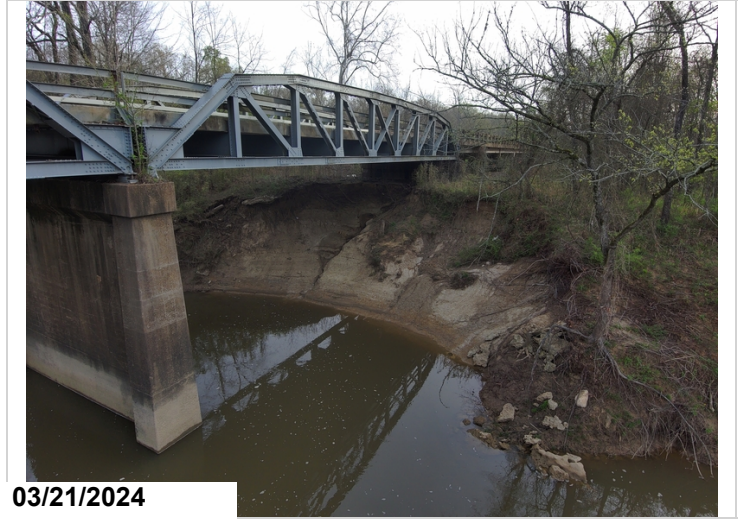
Scour Between Pier 3 and 4

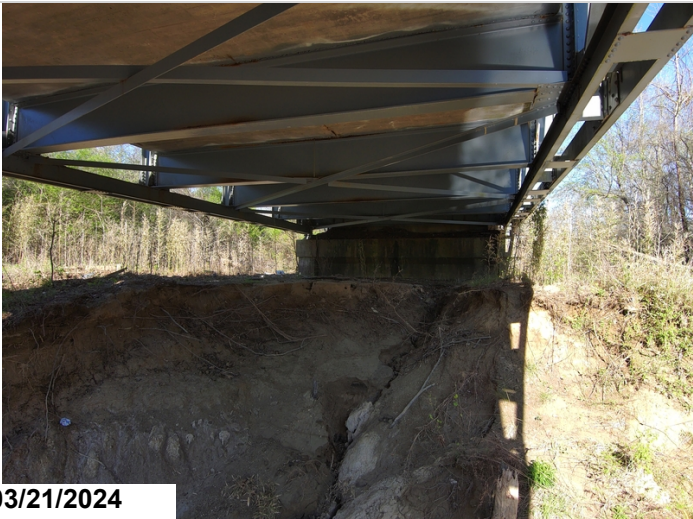
Pier 4 Back Scour
