Asset #01382(Routine)

US 67 S-4 LM 0.31 over MOON LAKE

Location: .31 MI NE OF NEVADA CO

Team Lead: John Parks Inspection Date: 01/09/2023

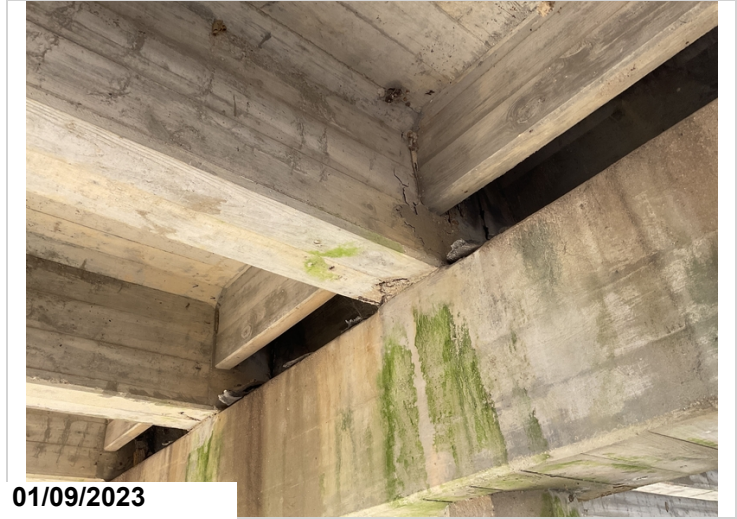
Span 5 girder 2. Spall with exposed rebar.

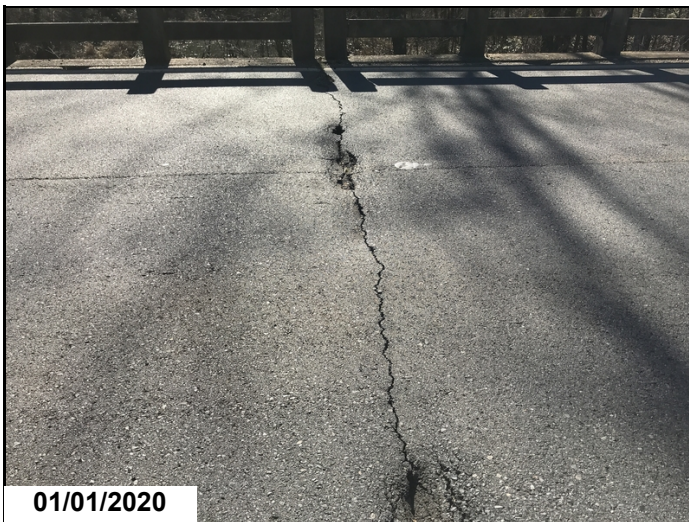
Bent 3 deck @ Joint between Spans 2 & 3, there are holes in the overlay @ the deck joint between Spans 2 & 3, with dirt and debris built up on the cap @ Bt. 3, also there is significant salt contamination to the ahead side of Bt. 3 cap.

01/09/2019 JPR -- there are holes in each travel lane that are allowing dirt, debris, and road salts to get onto the cap.

Bent 3 joint looking from Lt. to Rt.

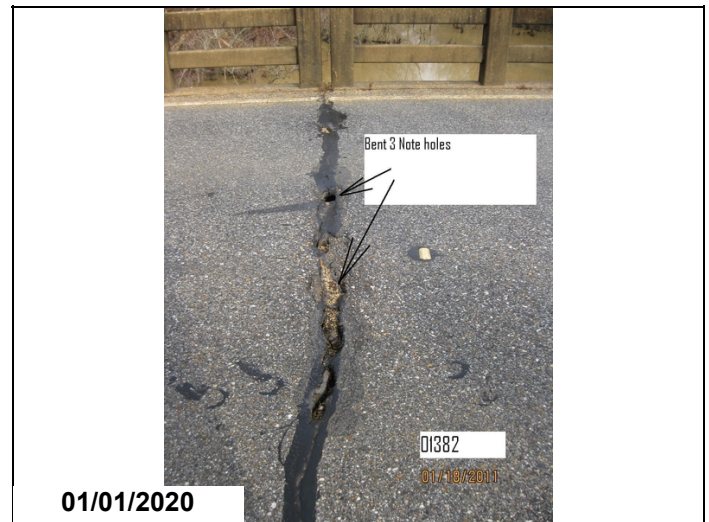
Bent 3, joint between spans 2 & 3 there are holes in the overlay and joint.

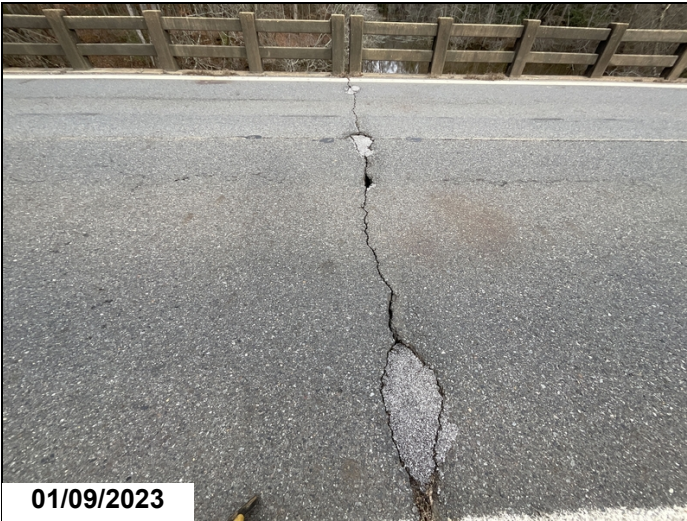
Bent 3, joint between spans 2 & 3 there are holes in the overlay and joint.

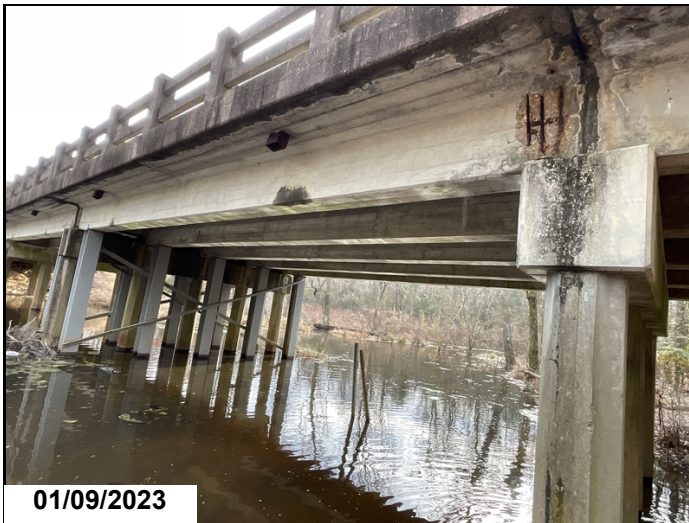
Girder 1 and 5 in all spans, outsides of the girders have spalls with exposed rebar at the beam ends.

Span 2, girder 1, exposed rebar on both ends.

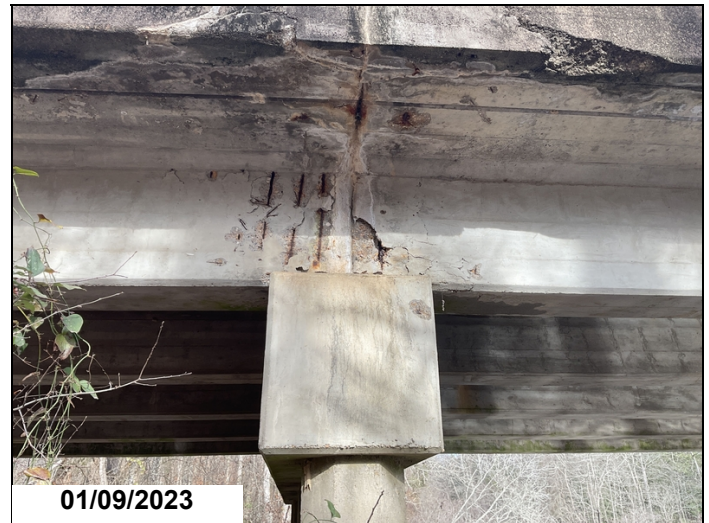
Span 1 & 2, girder 5, @ Bt. 2, spalls with exposed rebar.

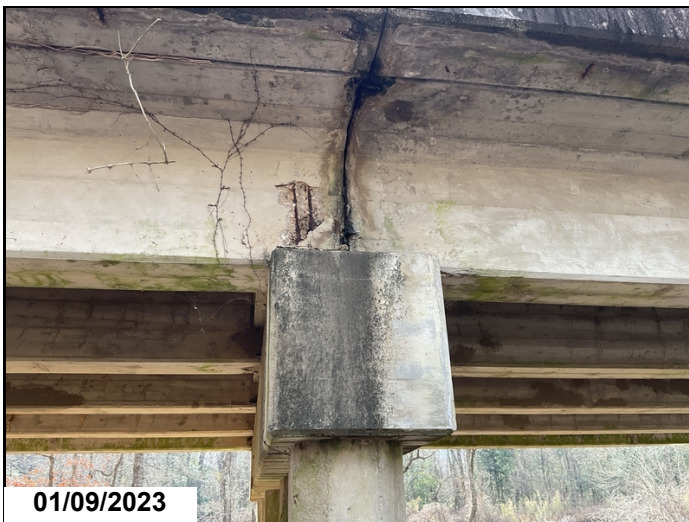
Span 5 girder 1, spall with exposed rebar.
