Route:67 Section:04 Log:0.8

Arnold Road ID:10x67x4xA, Arnold Log mile:0.801

Asset #01383(Routine, Underwater type 2)
US 67 S-4 LM 0.80 over LITTLE MISSOURI RELIEF
Location: .80 MI NE OF NEVADA CO
Team Lead: Rickie Bratton Inspection Date: 05/21/2024

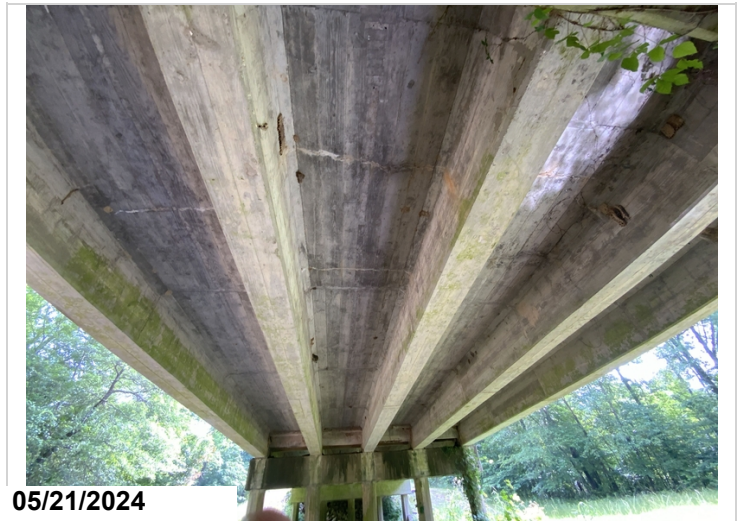
Span 12 under surface overview

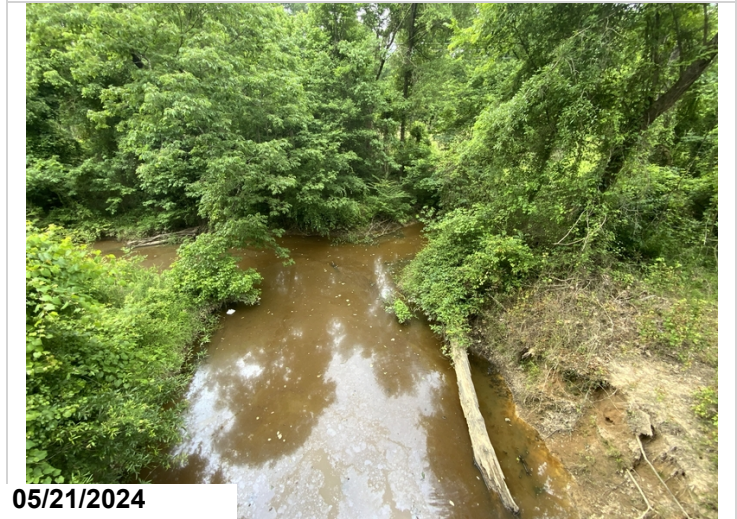
Channel downstream right side.

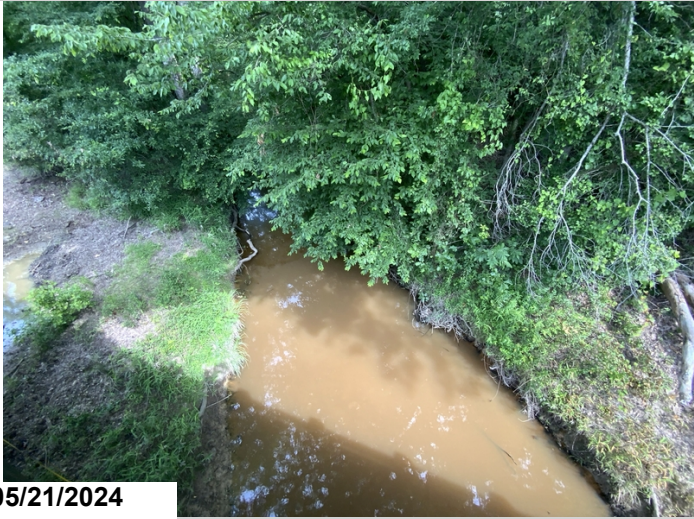
Channel upstream left side.

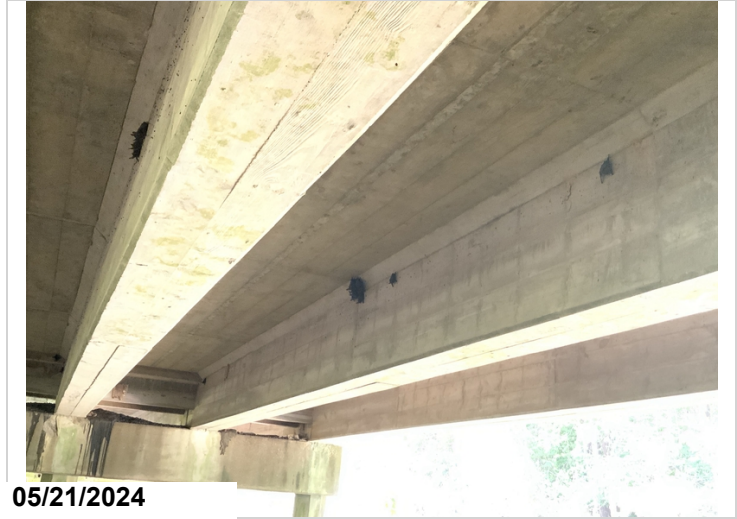
A-45 - Bats Present (1 - Yes)
Span 7 bay 2 and 3.

Bats present span 7

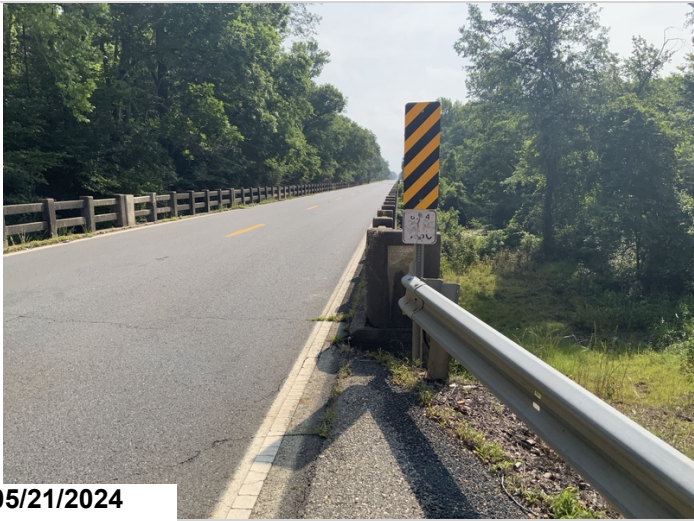
A-63 - Missing/Incorrect Log Mile Signage (Y)
Log mile signs at both ends of bridge are illegible.

Log mile signs at both ends of bridge are illegible.

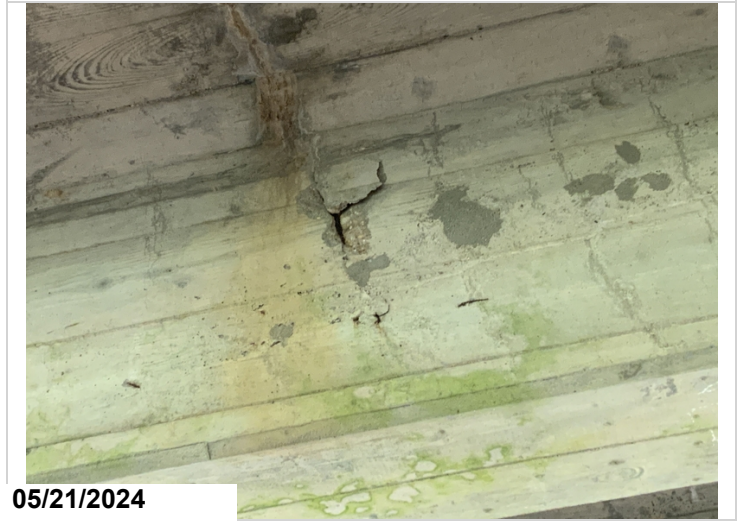
Span 13 girder 2 right side exposed rebar.

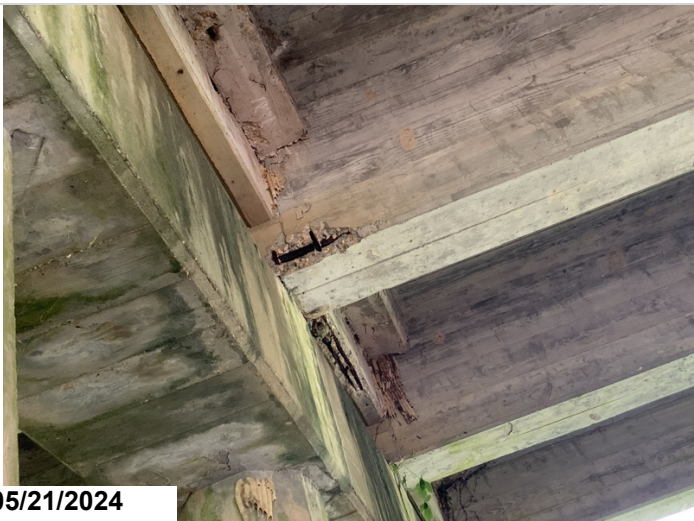
Bent 13 span 12 girder 3 exposed steel.

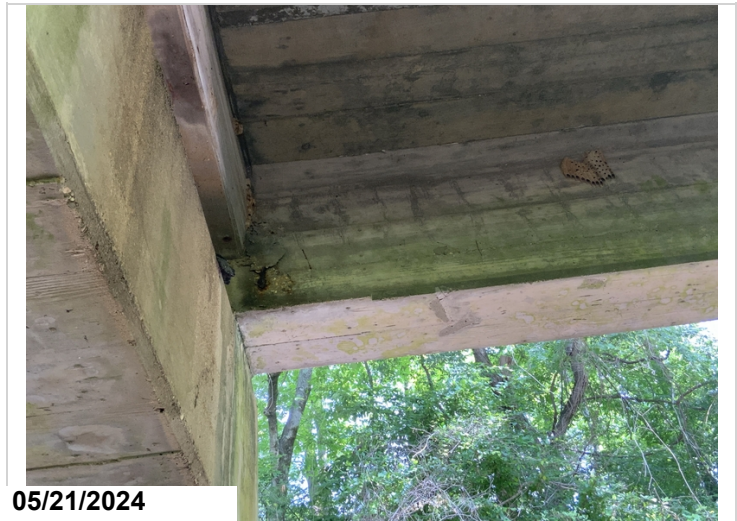
Span 5 girder 1 has exposed rebar.

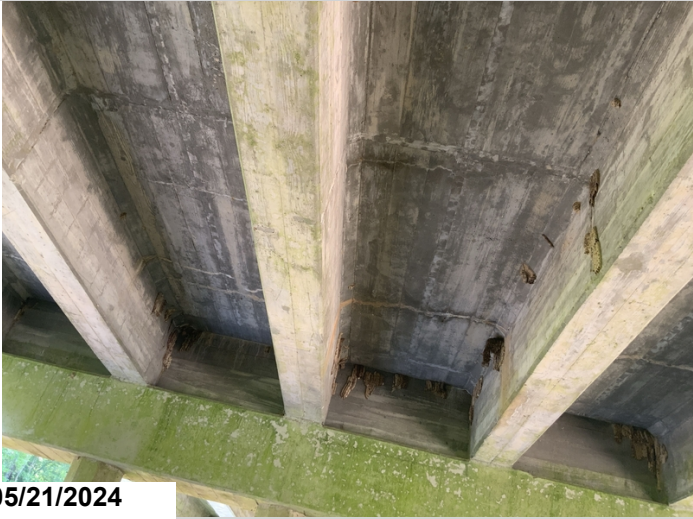
Span 4 has efflorescence.

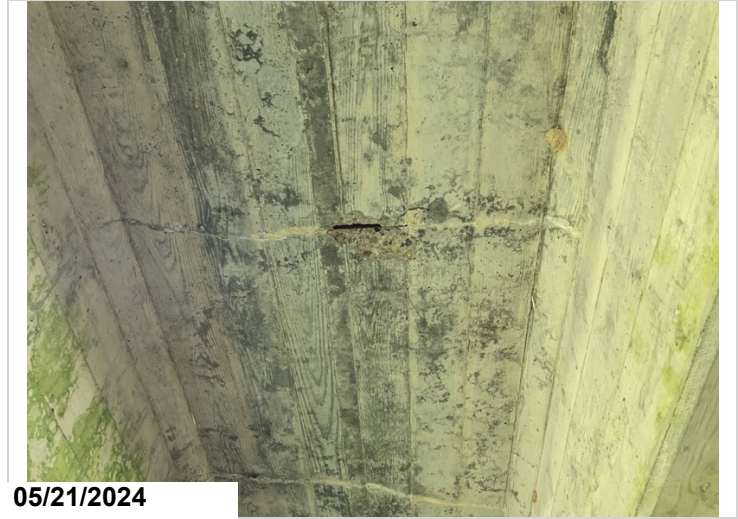
Span 13 bay 1 exposed rebar

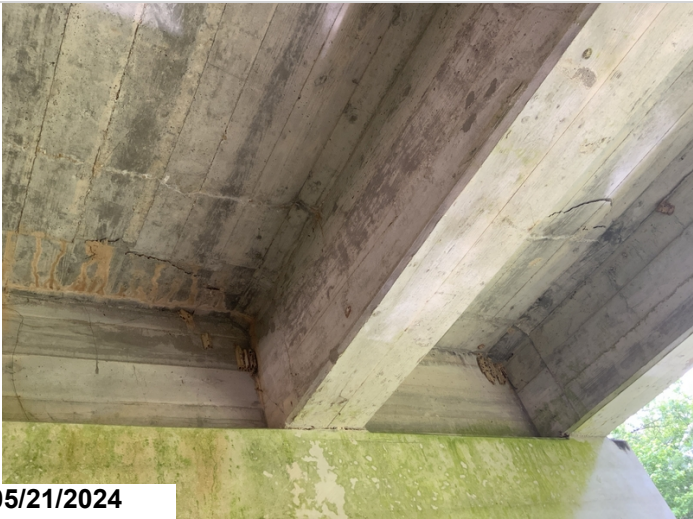
Span 11 under surface has delams.

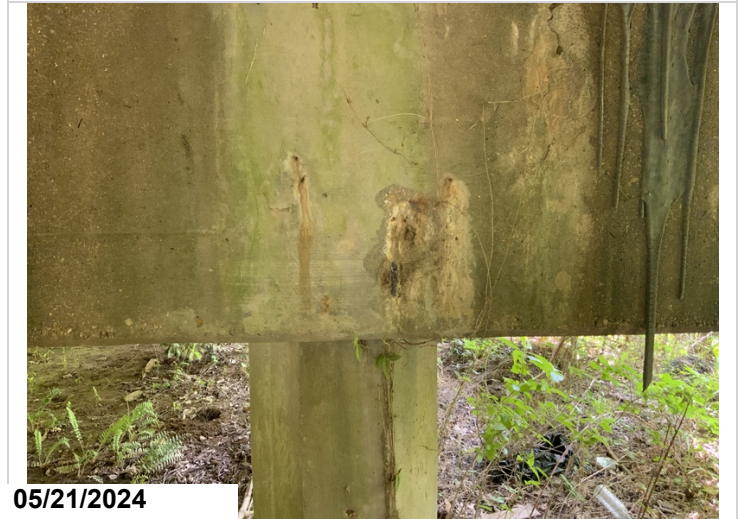
Bent 10 cap back has spall.

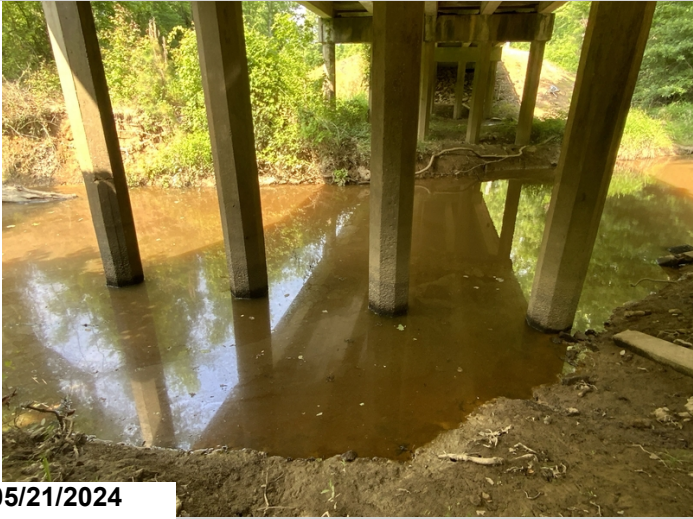
(227) Bent 4 pile have abrasion. Column 2 bent 13 large spall with no exposed steel.							
234	Reinforced Concrete Pier Cap	LF	351	350	1	0	0
1080	Delamination/Spall/Patched Area	LF	1	0	1	0	0
304	Open Expansion Joint	LF	175	175	0	0	0
331	Reinforced Concrete Bridge Railing	LF	1010	1000	0	10	0
7000	Damage	LF	10	0	0	10	0

Bent 4 pile have abrasion

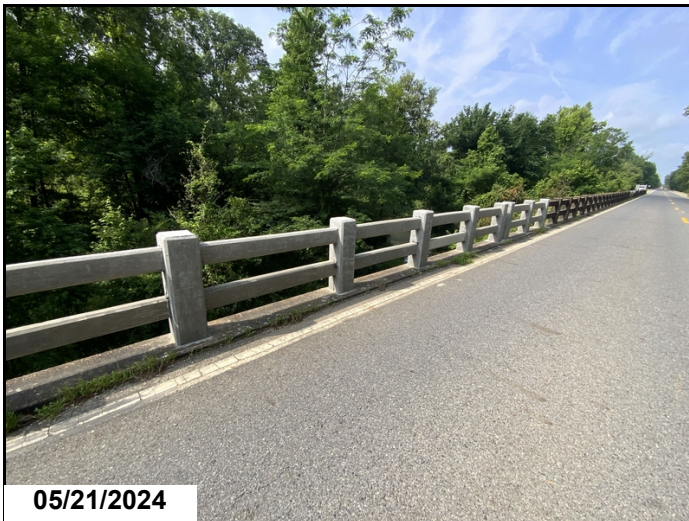
Span 9, Lt. side concrete rail @ Bt. 10 collision damage.

Rail damage has been repaired by state forces.

Rail damage has been repaired by state forces.

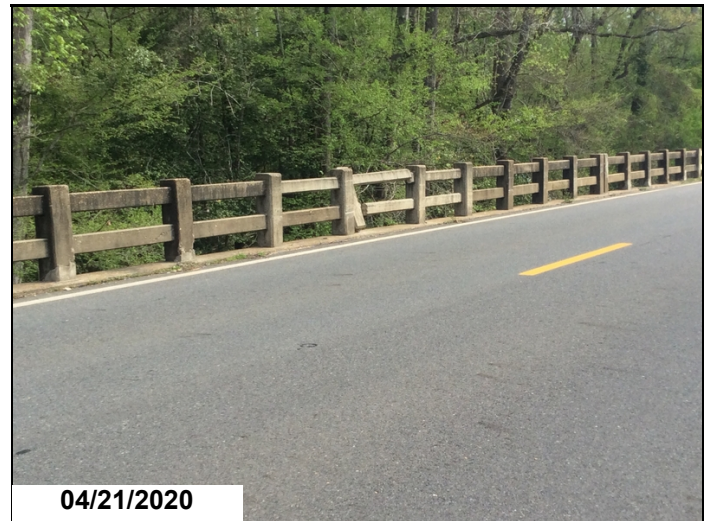
Rail damage left side

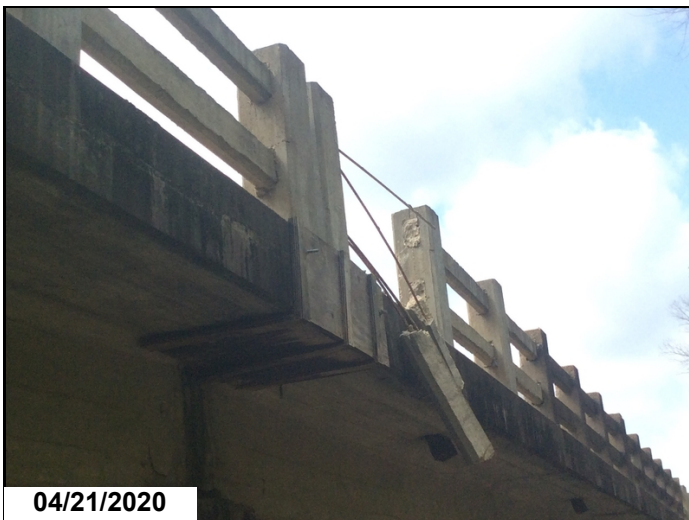
Span 9, Lt. side concrete rail @ Bt. 10 have collision damage.

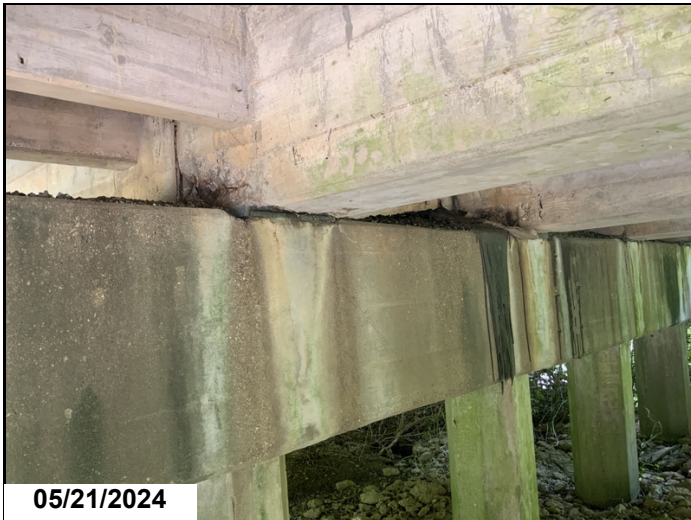
Girder 1-3 @ bent 7 and girder 1 at span 11 spalled with exposed steel @ bearing area.

Girders 2&3 at bent 7 spall with exposed steel at bearing areas.

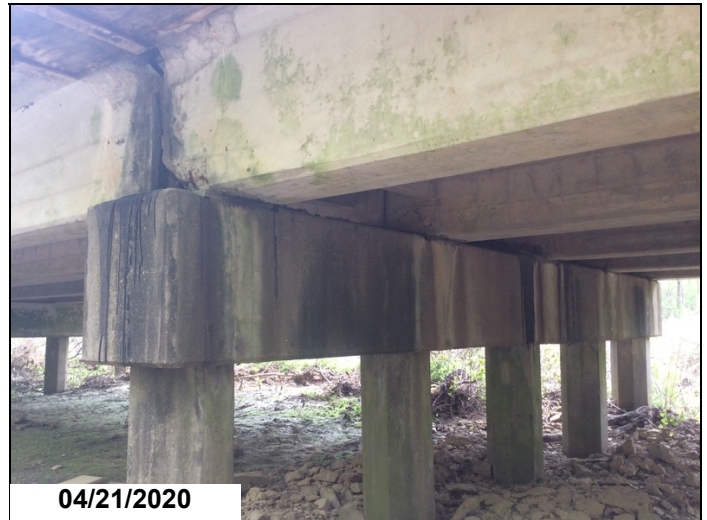
Bent 7 back, girder 1 @ bearing area has spall with exposed steel. Section loss to girder end. Also girder 2 has delamn. on Lt. side & girder 3 has spall over bearing area.

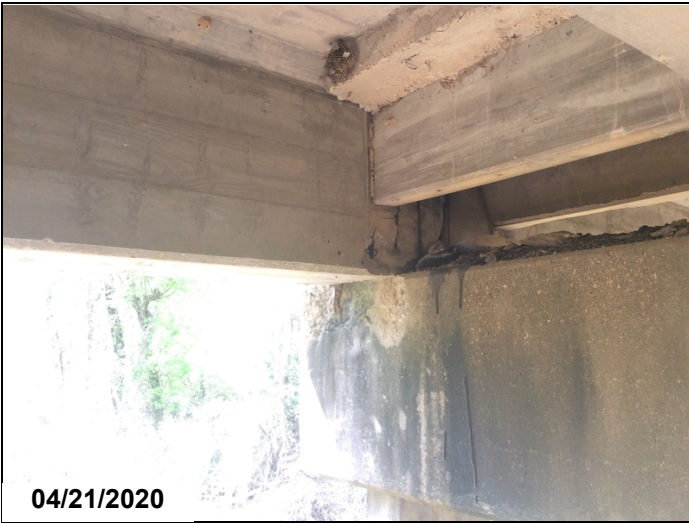
Bent 7, girder 1 ahead, has spall on girder end at bearing area. Also cap Rt. End ahead side has spall with exposed steel.

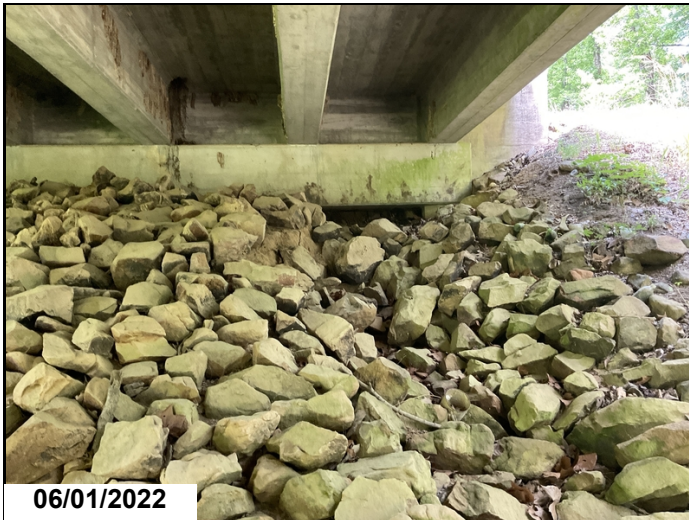
Abutment 1 left side

(215) Water leaking/seeping under the abutment 1 has displaced slope protection (rip-rap).							
227	Reinforced Concrete Pile	EA	65	42	22	1	0
1080	Delamination/Spall/Patched Area	EA	1	0	0	1	0
1190	Abrasion/Wear (PSC/RC)	EA	22	0	22	0	0

Water has seeped under conc. abutment allowing the slope to erode and rip-rap to slump.

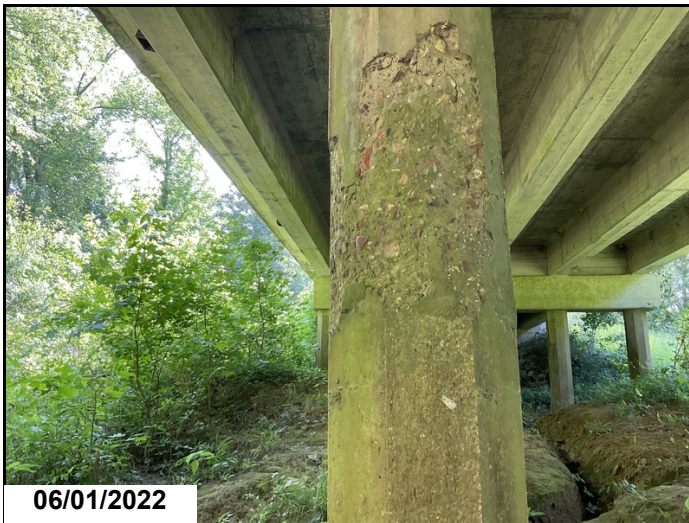
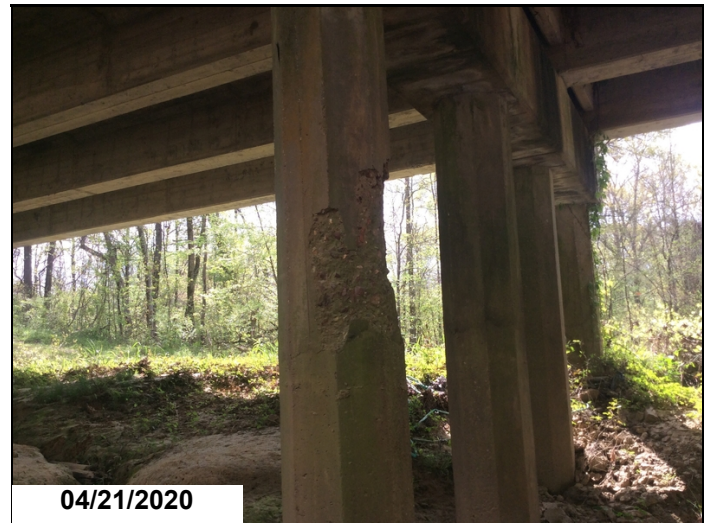
Bt. 13 Pile #2 has a 2' spall on the west face of the piling, no exposed reinforcing steel.

Bent 13 pile 2 spalled

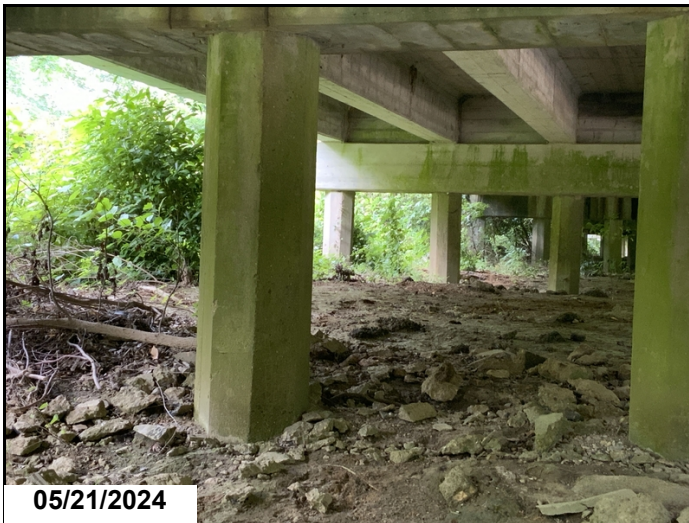
Vegetation both sides

Vegetation growing against and under bridge.

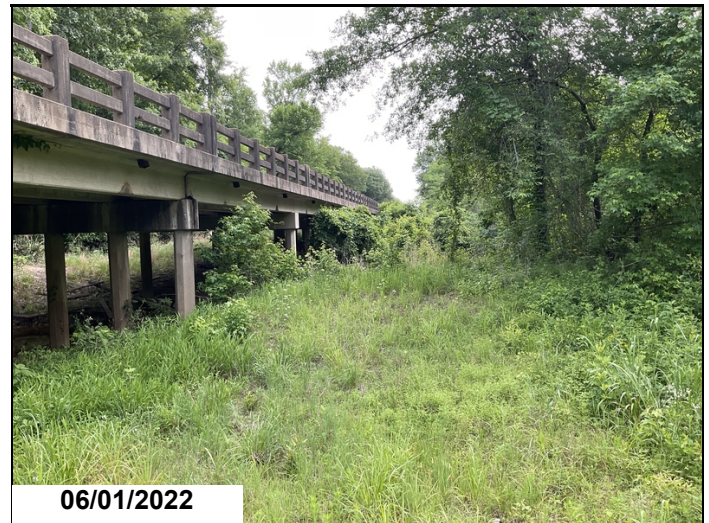
Vegetation both sides

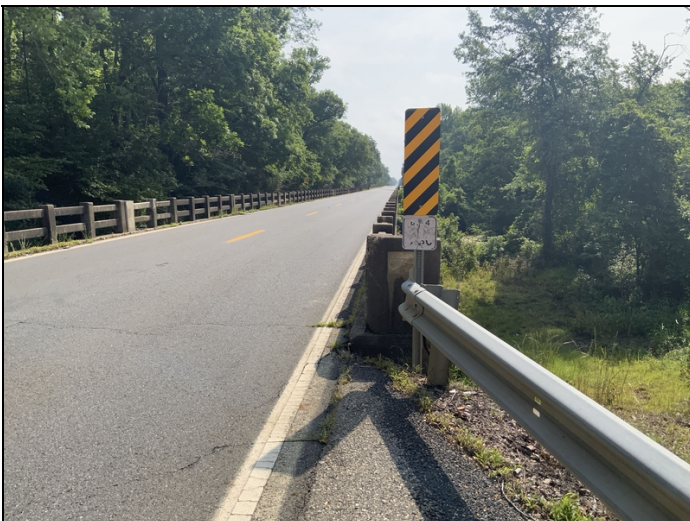
Log mile signs at both ends of bridge are illegible.
