Asset #01384(Routine)

US 67 S-4 LM 1.09 over LITTLE MISSOURI RELIEF

Location: 1.09 MI NE OF NEVADA CO

Team Lead: Todd Russell Inspection Date: 05/31/2022

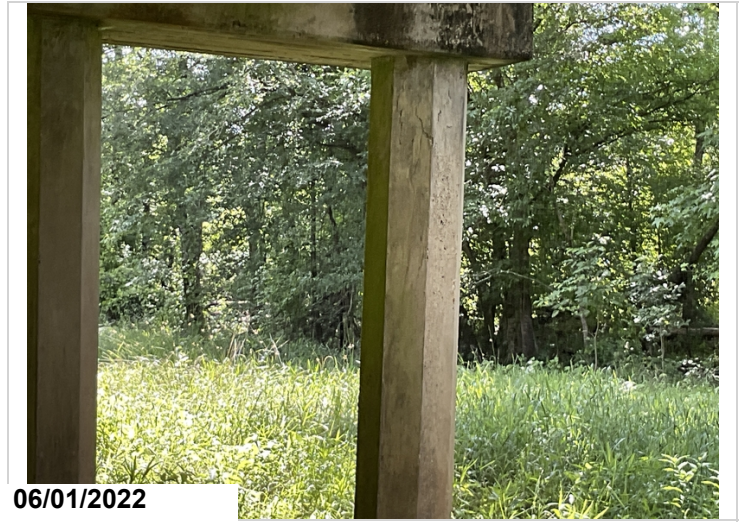
Bent 7 pile 5 cracks

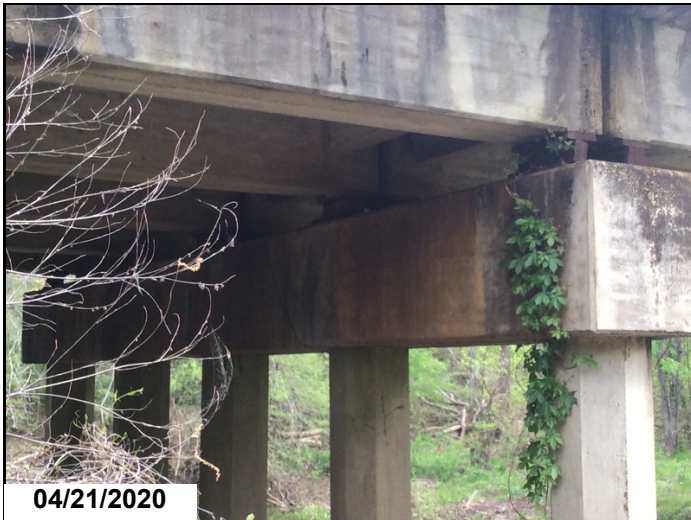
Bearings / plates

Rusty with 100% paint loss, movable are rocked ahead. 04/03/2018 Little or no change since last inspection.

Bt. 2 looking Rt., bearings are rocked ahead & have rust on them.
