Asset #01385(Routine)

US 67 S-4 LM 1.53 over LITTLE MISSOURI RELIEF

Location: 1.53 MI NE OF NEVADA CO

Team Lead: Rickie Bratton Inspection Date: 04/25/2023

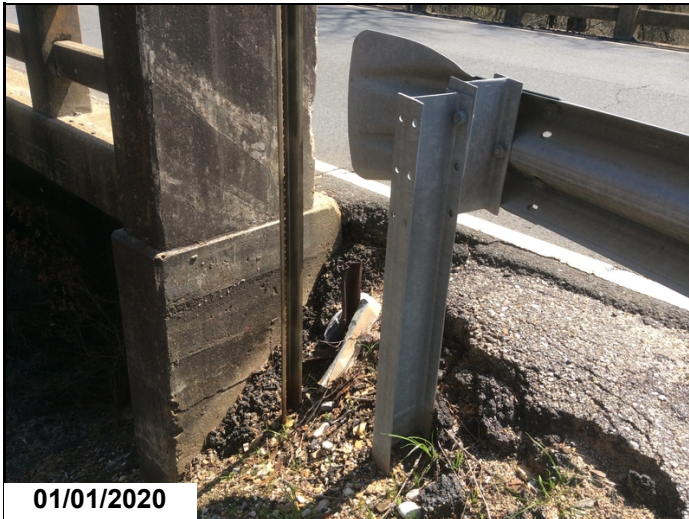
Slope Protection: Some slope erosion abutment 1 left.

Erosion has undercut the slope and shoulder @ the bridge end . This area will soon cut into/under the load path.
03/27/2017 JPR --Abutment 1 left showing hole @ edge of traffic path. Little or no change since last inspection.

Abutment 1 left side slope erosion.

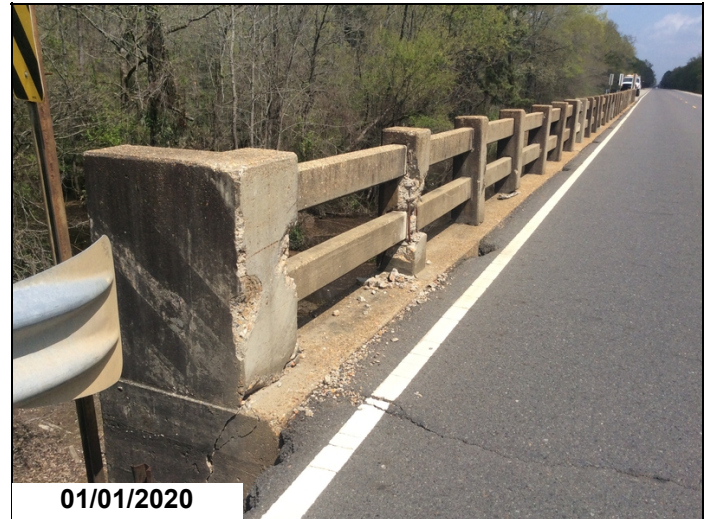
Abutment 1 Lt. slope erosion that is encroaching upon the white line.

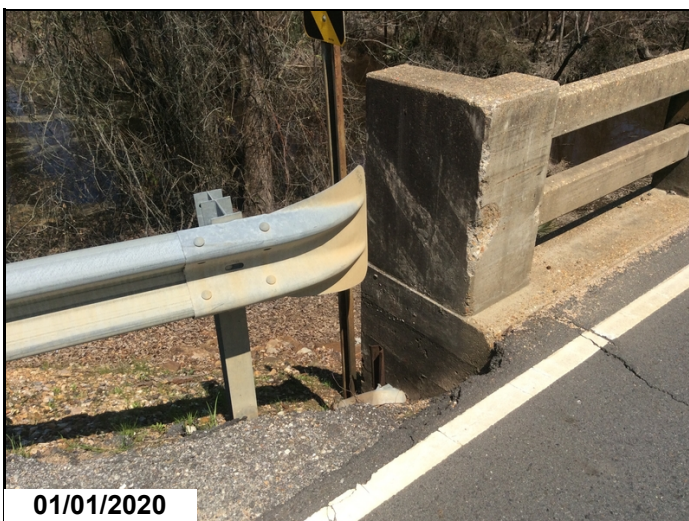
Abutment 1 left showing hole @ edge of traffic path.

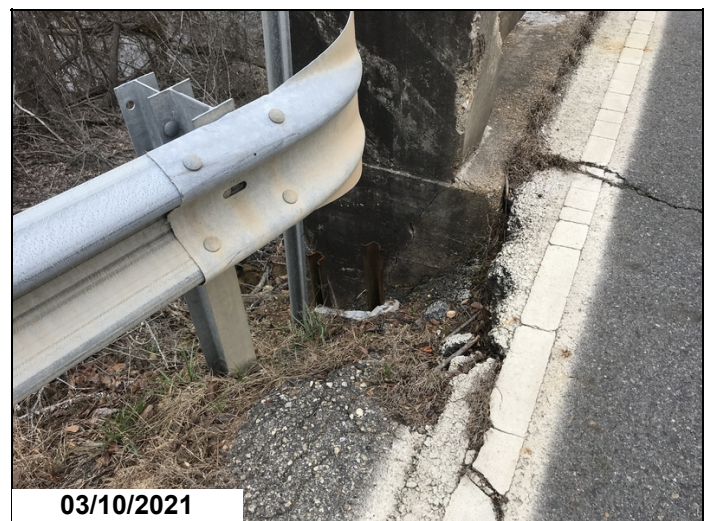
Erosion left side abutment 1

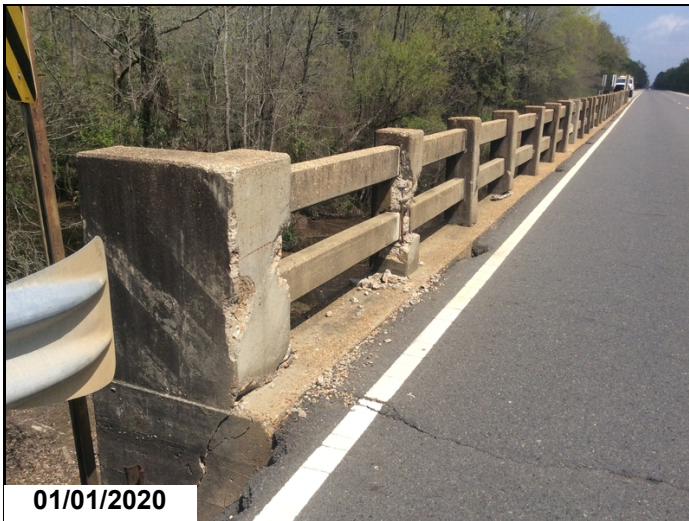
(331) Span 1 Lt starting @ BR end and going through 3rd guardrail post, there is collision damage to guardrail and posts, mainly posts.

Abutment 1 Lt., BR. end post & 1st 3 guardrail posts have collision damage

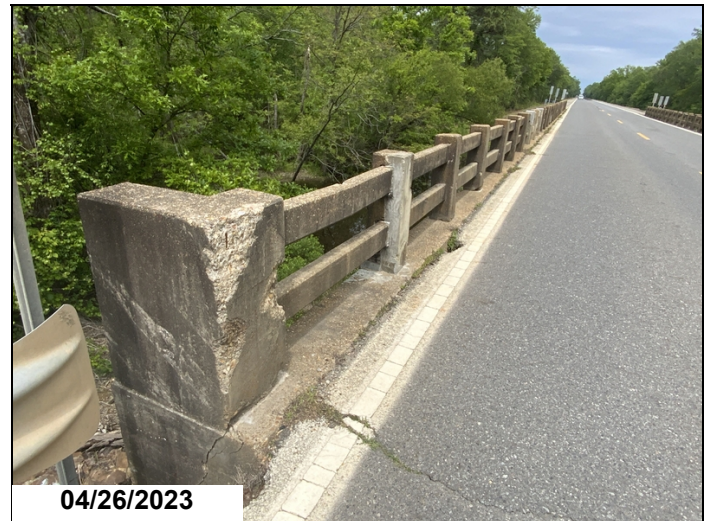
Collision damage has been repaired.

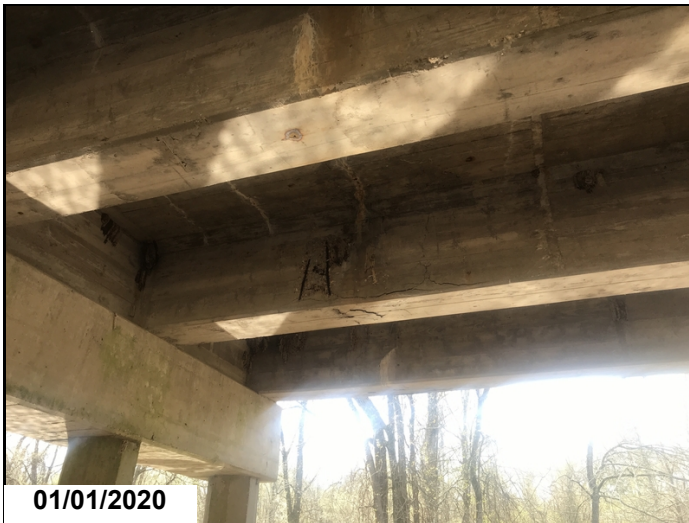
Girders/Beams: Some chips and spalls. G 4 span 4 4' of cracks and 2' Delamination.

Span 4 girders 4 and 5, spalled with exposed rebar.

Span 4 girder 4 cracking and spall with exposed rebar

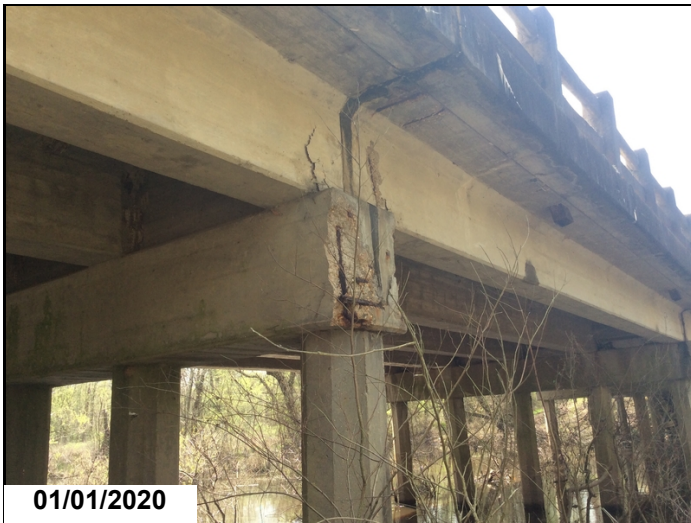
Pier Cap: Bt 2 cap 1' spall with exposed steel. Bt 4 cap 1' spall . Bt 5 cap left side large spall with exposed steel. Moderate + sec. Loss.with exposed steel.

(234) Bent 5 Lt. cap has spall with exposed steel to end of cap. 04/05/2021 JPR -- Reinforced Concrete Pier Cap = (23.17' x 4) = 92.68' or 93'							
304	Open Expansion Joint	LF	54	54	0	0	0

Bent 5 Lt. Cap is spalled on end with exposed steel with section loss.

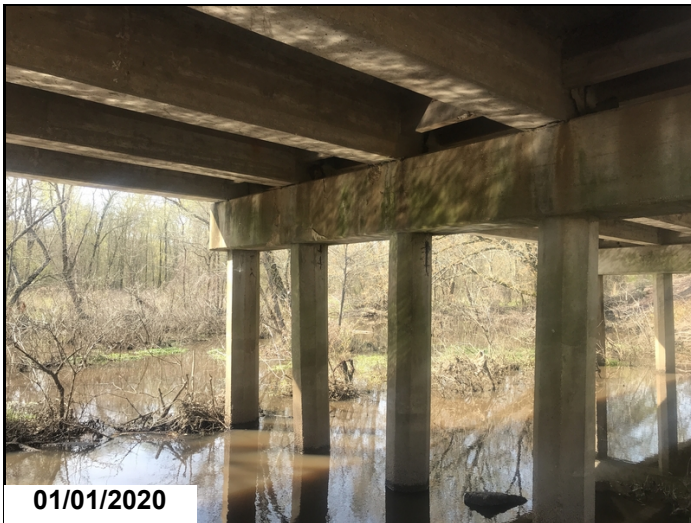
Columns: Some spalls. Bt 4 column 3-4-5 spalls with exposed steel. Moderate sec. Loss.

Bent 4 piles 3-5 have spalled with exposed rebar.

Bent 4 piles 3-5 spalls with exposed rebar
