Asset #01386(Routine, Underwater type 2)

US 67 S-4 LM 2.47 over BOGGY CREEK

Team Lead: Rickie Bratton Inspection Date: 05/21/2024

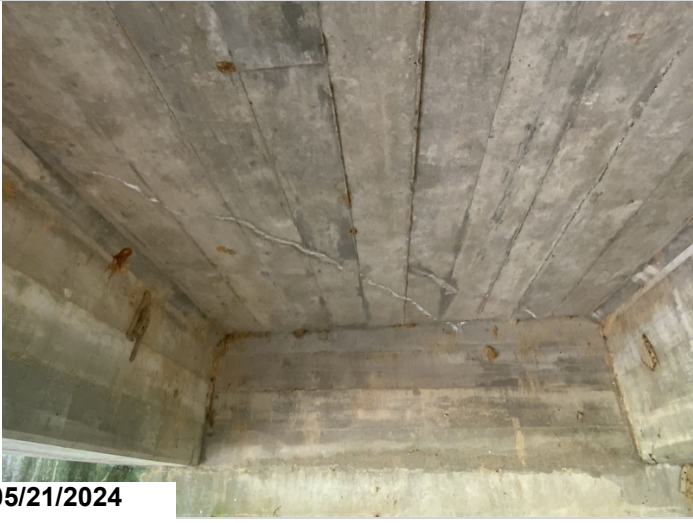
ELEMENTS	DESCRIPTION	UNITS	TOTAL	CS1	CS2	CS3	CS4
16	Reinforced Concrete Top Flange	SF	1050	1039	11	0	0
1120	Efflorescence/Rust Staining	SF	11	0	11	0	0
510	Wearing Surfaces	SF	948	948	0	0	0
(1120-16) Cracks with efflorescence in under surface.							
110	Reinforced Concrete Open Girder/Beam	LF	140	140	0	0	0
215	Reinforced Concrete Abutment	LF	129	109	20	0	0
1130	Cracking (RC and Other)	LF	10	0	10	0	0
7000	Damage	LF	10	0	10	0	0
(215) Bank slumping, erosion. Abutment 1 minor cracks and discolored efflorescence. 04/03/2018 JPR -- Abutment 1 Rt. and Abutment 2 Lt. @ end posts have been damaged by traffic and repaired. Both Abutments have some minor cracking in the abutment walls.							
331	Reinforced Concrete Bridge Railing	LF	70	70	0	0	0

Cracks with efflorescence bay 1.

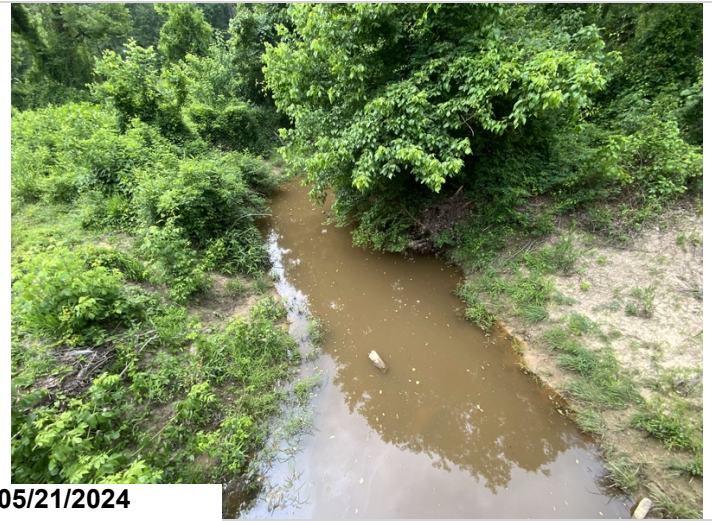
Channel downstream right side.

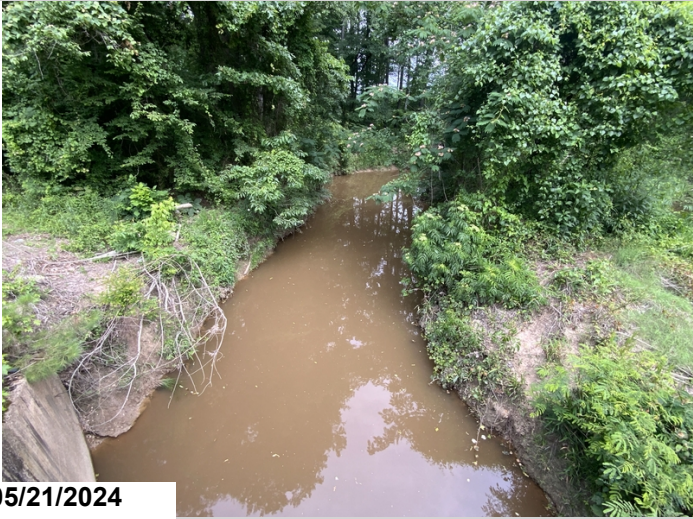
Channel upstream left side.

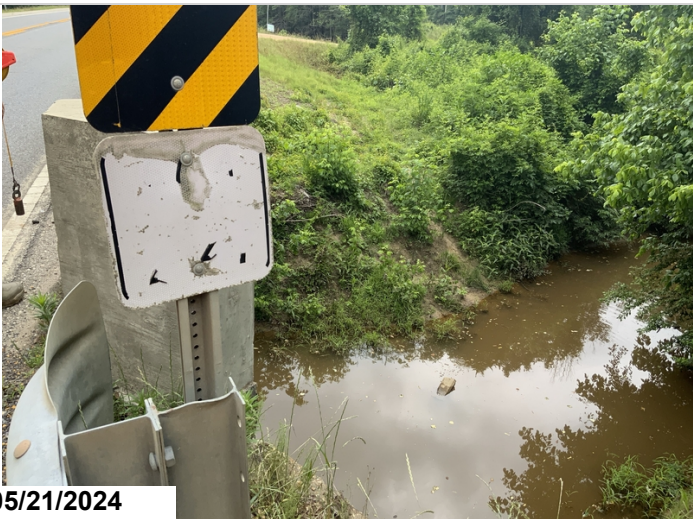
Log mile signs both sides illegible

A-63 - Missing/Incorrect Log Mile Signage (Yes)

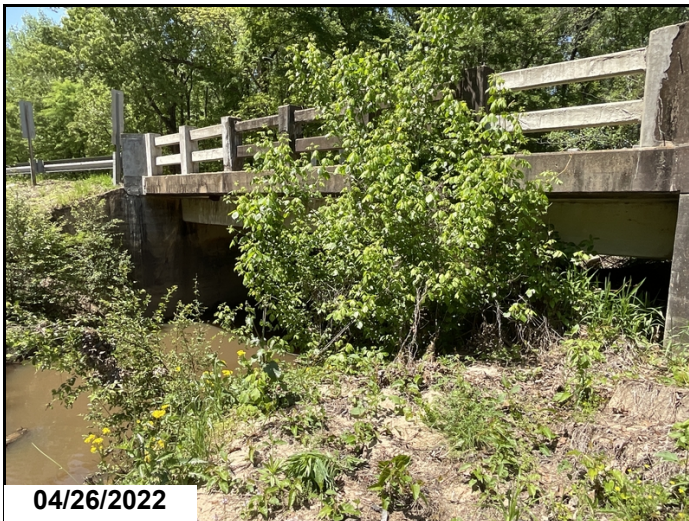
Vegetation growing up beside & back under the bridge.

Type of Work: (Inactive) (Inactive) 1 - Clean

Status: Monitor

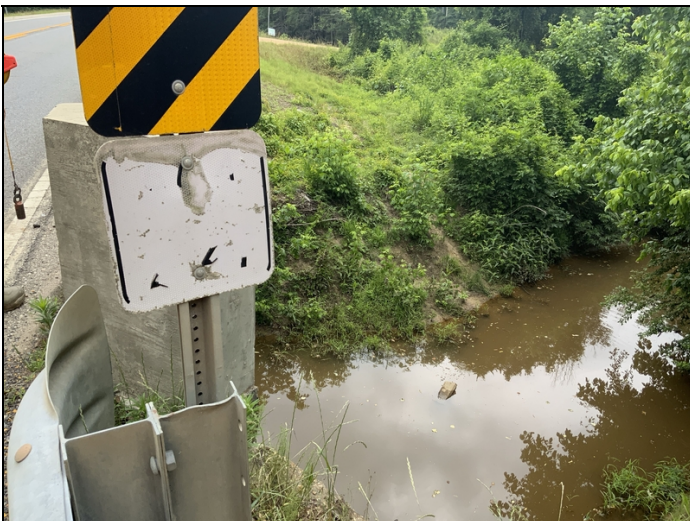
Log mile signs both sides illegible
