Asset #01485(Routine, Underwater type 2)

US 67 S-4 LM5.52 over MCNEELY CREEK

Location: .1 MI SW JCT SH 51

Team Lead: Rickie Bratton Inspection Date: 04/25/2023

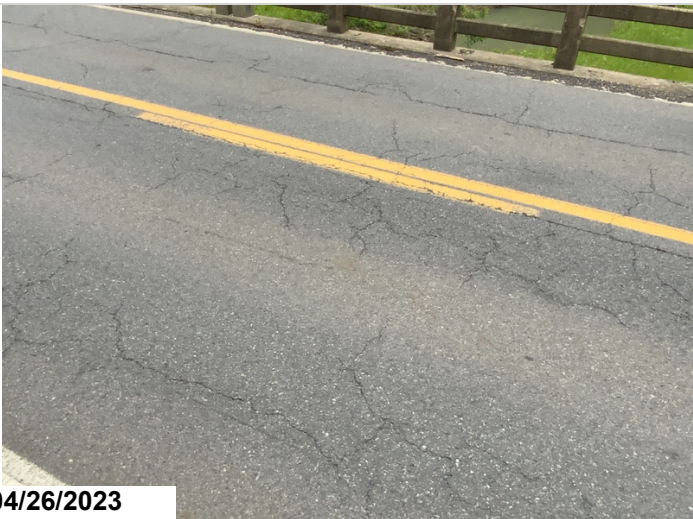
Wearing Surface: AC OL has two full length longitudinal cracks.

Deck all spans cracks in wearing surface.

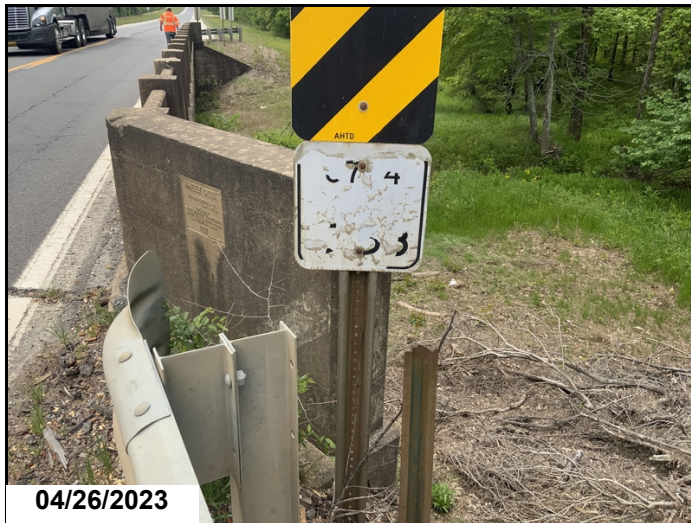
Log mile sign on East end of bridge is illegible.

**Type of Work:** Replace (General)
