Asset #05944(Routine)

US 79 S-5 LM4.61SB over CHAMPAGNOLLE CR

Location: 1 MI W JCT 79&US167B

Team Lead: John Parks Inspection Date: 05/08/2023

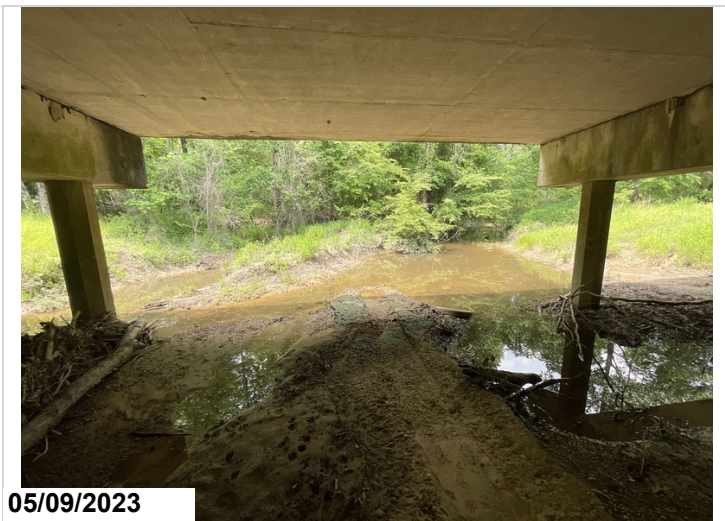
Channels, left side, upstream.

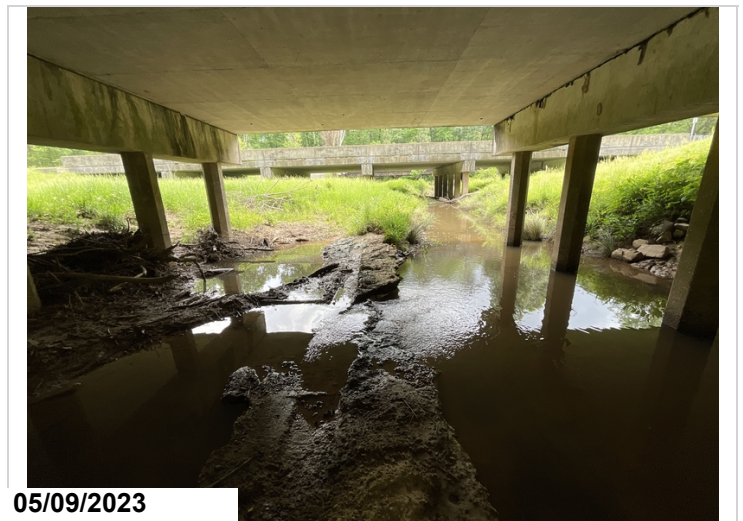
Channel, right side, downstream.

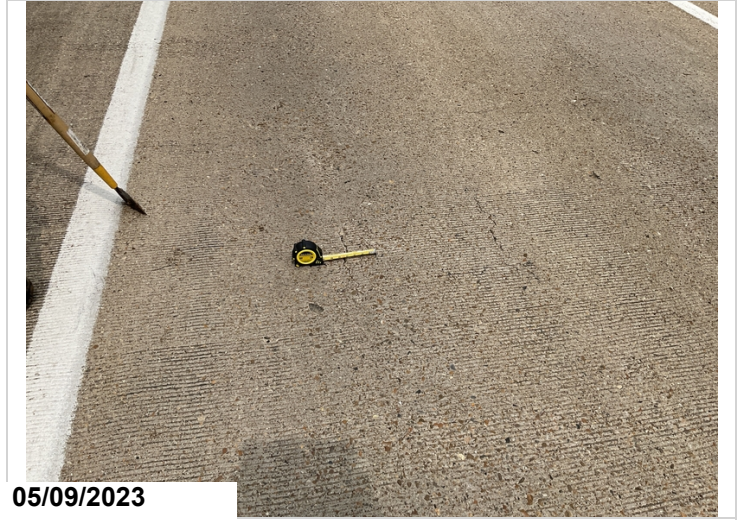
Map cracking upto 0.025" & longitudinal cracking upto 0.030".

Span 1, map cracking upto 0.025" wide.

A-54 - Sealable Deck Cracks (Yes)

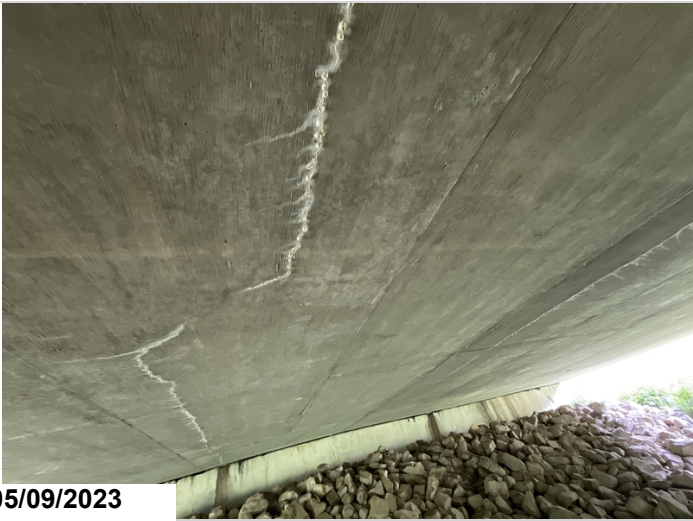
Light efflorescence reflecting through to the bottom of the slab, 2 minor exposed rebar & 1 minor spall.

Span 6 efflorescence

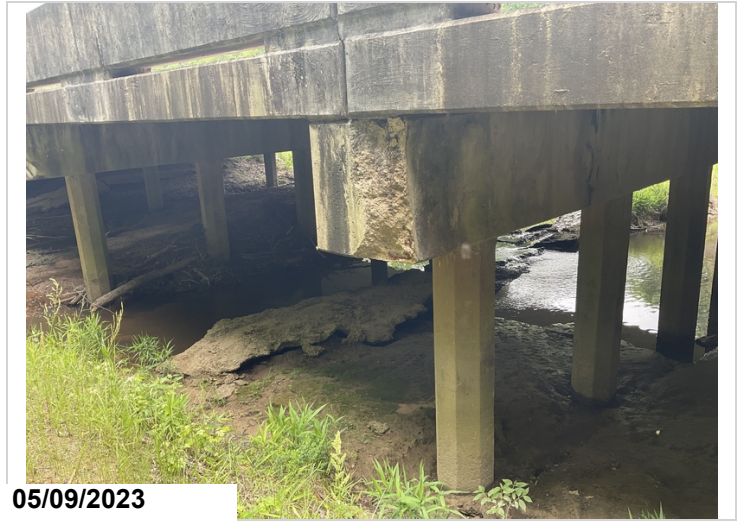
Bent 2, left end of the cap has a spill.

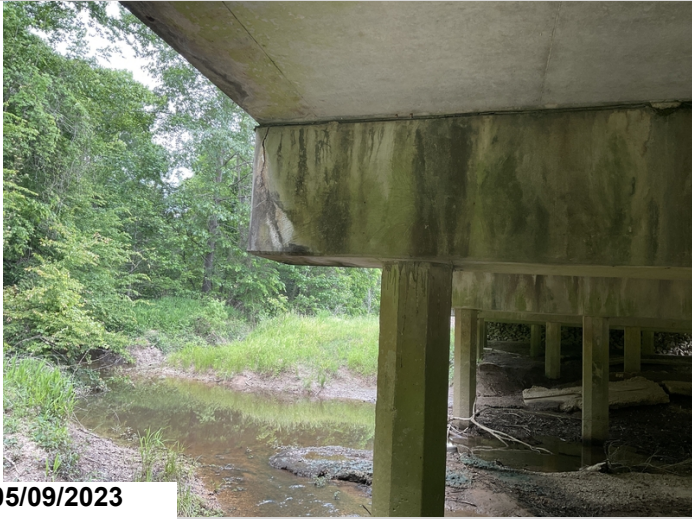
Bent 3, cap left end, vertical cracks 1/4" wide.

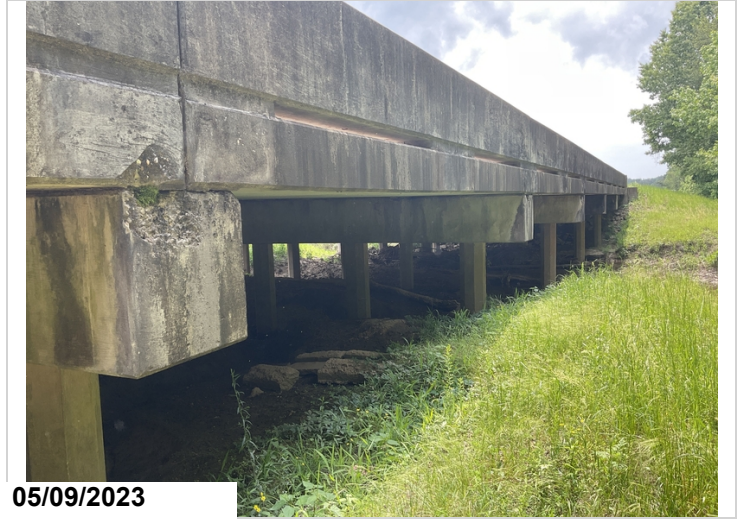
ELEMENTS	DESCRIPTION	UNITS	TOTAL	CS1	CS2	CS3	CS4
Bent 4: - 1' spalls CS2, 2' CS3 Bent 5: -1' spall CS3 Bent 6: -2' spall CS3							
301	Pourable Joint Seal	LF	214	0	214	0	0
2310	Leakage	LF	107	0	107	0	0
2320	Seal Adhesion	LF	107	0	107	0	0
(301) All of the joints have lost adhesion & are being filled with non compressible materials.							
331	Reinforced Concrete Bridge Railing	LF	300	300	0	0	0

Bent 4, 5, & 6, left end of caps have spalls.

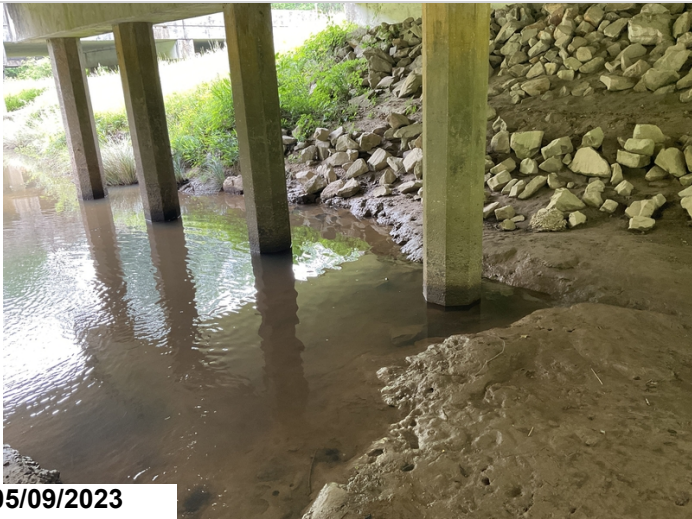
Minor local scour around all the piles.

Bent 2, local scour @ piles 3-6

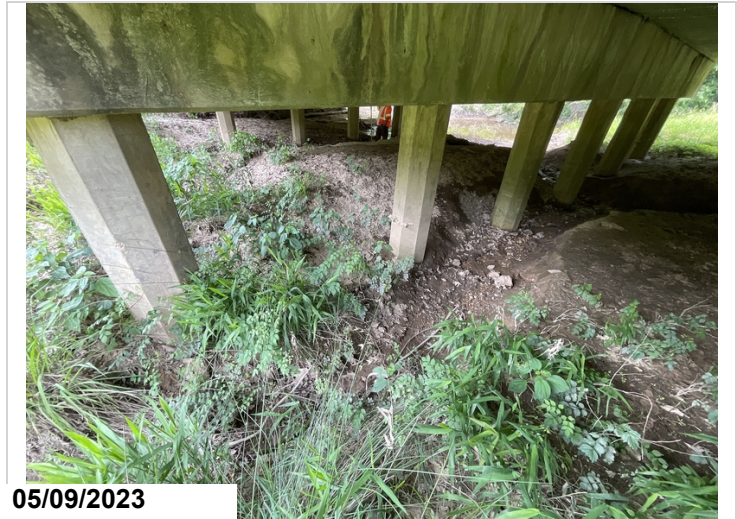
Bent 5, local scour at piles 2- 6.

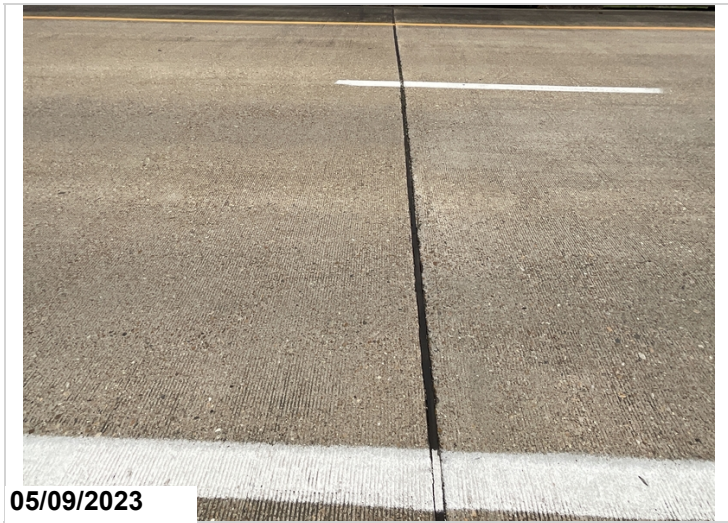
Bent 2, joint seal, debris impaction

A-59 - Joint Repair Needed (Yes)

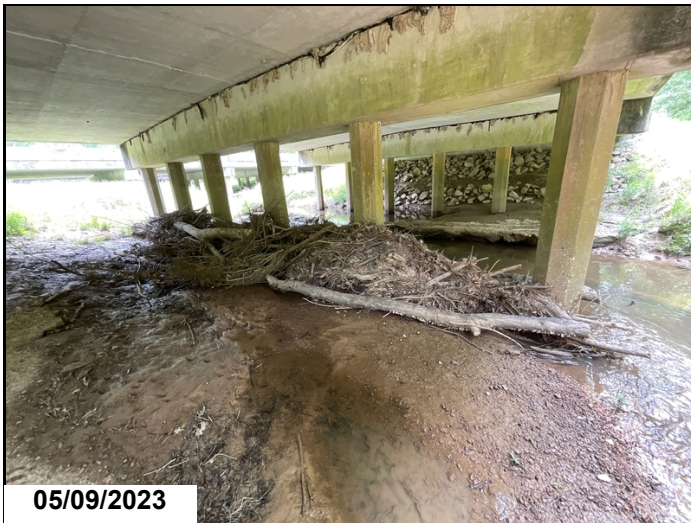
Bent 3, logs & drift have washed up against the piles.

Type of Work: Channel Work/Drift Removal

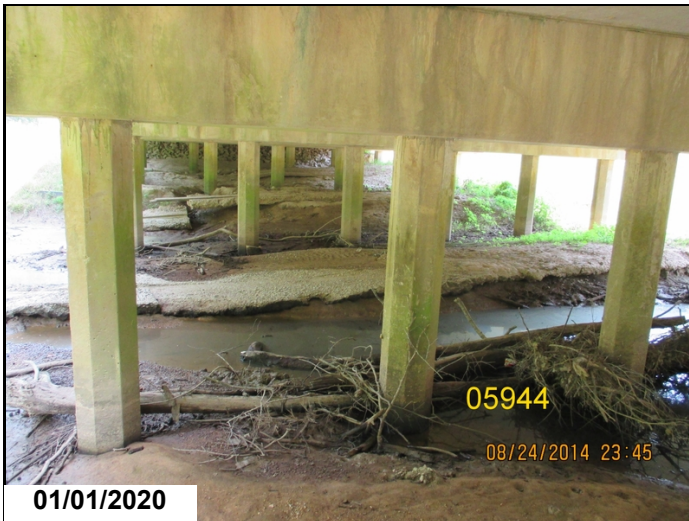
Local scour bents 3-6

Scour @ Bt's. 3,4, & 5.

Type of Work: Repair (General)

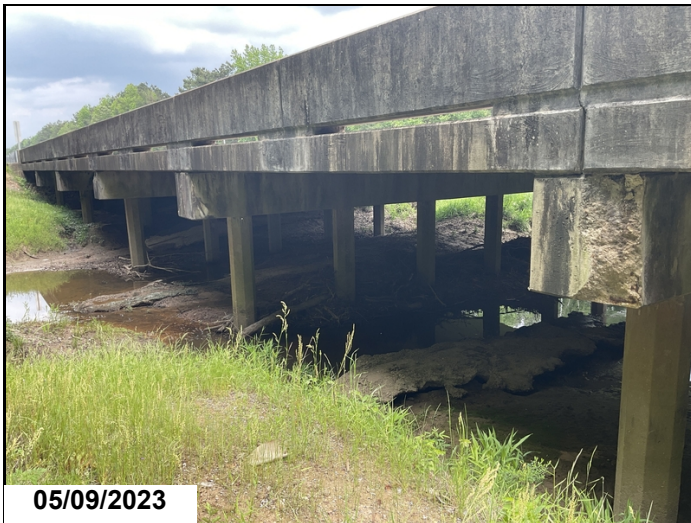
Bent 2 - 6, the left end of each cap has a large spall or crack.

Type of Work: Repair (General)
