Asset #A5944(Routine, Underwater type 2)
US79 NB S5 LM4.60 over CHAMPAGNOLLE CREEK
Location: 4.69 MI NE OUACHITA CO LI
Team Lead: John Parks Inspection Date: 05/08/2023

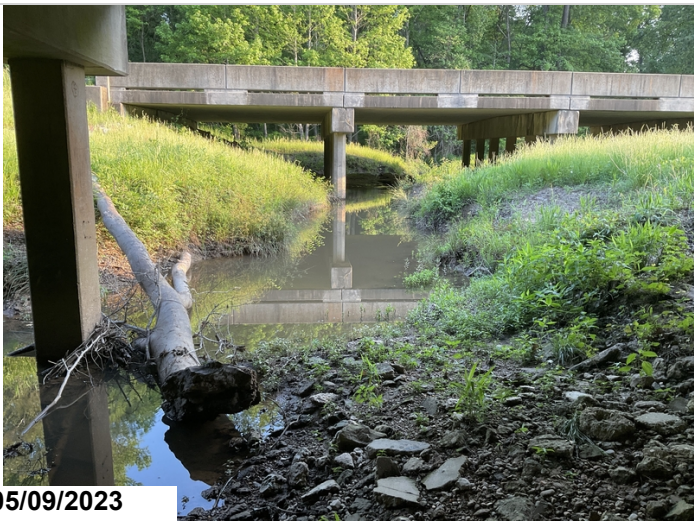
61 - Channel/Channel Protection (6 - Bank is beginning to slump. River control devices and embankment protection have widespread minor damage. There is minor stream bed movement evident. Debris is restricting the channel slightly.)
Banks are slumping and debris in channel.

Left side channel

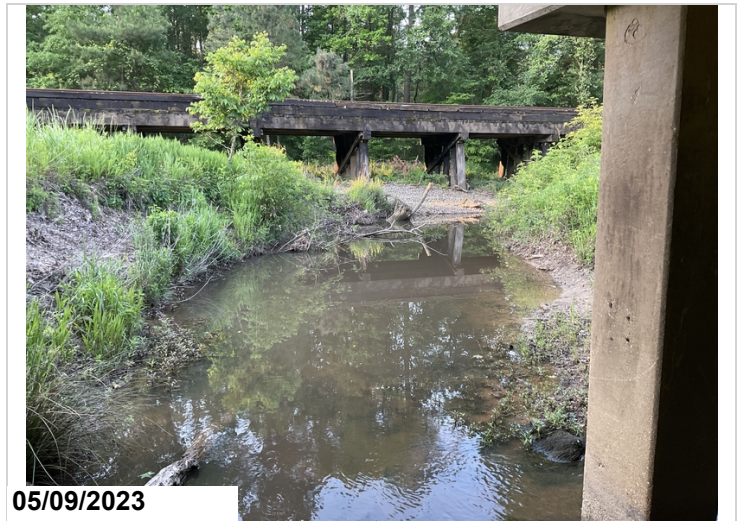
Right side channel

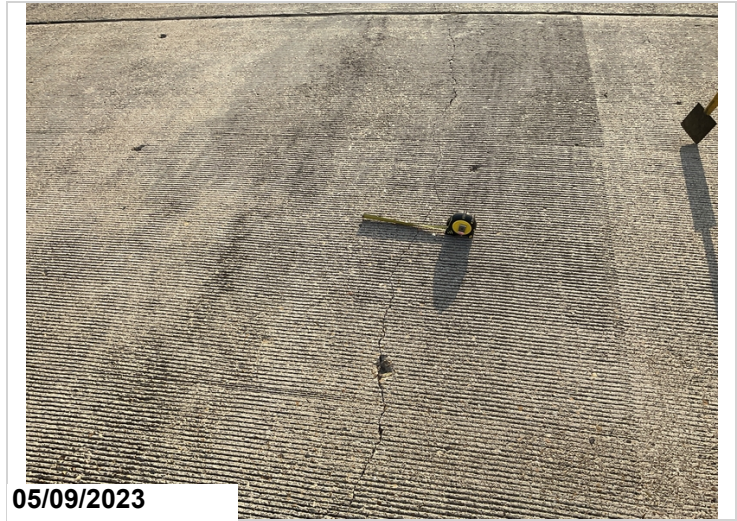
Longitudinal cracks up to 0.030" and light abrasion right wheel path right lane.

Typical deck cracks upto 0.030".

A-54 - Sealable Deck Cracks (Yes)

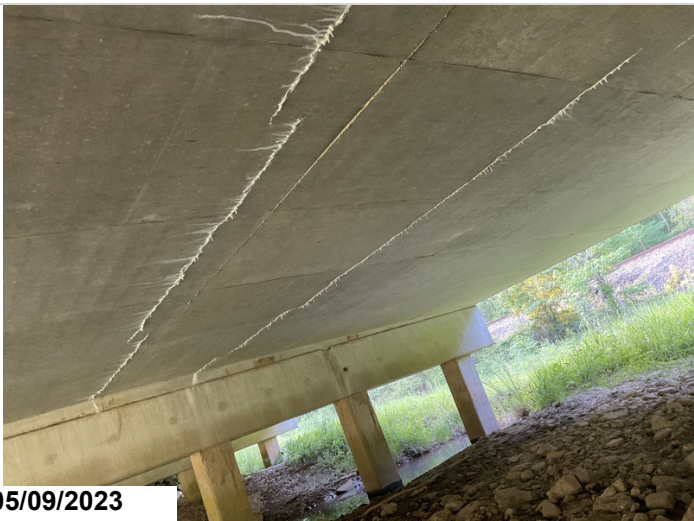
(38) Span 1: -75' of eff CS: 2 Span 2: -25' of eff CS: 2 Span 3: -15' of eff CS: 2 - 8' of delam CS: 2 Span 4: -50' eff CS: 3 Span 5: -40' of eff CS: 3 -2' of spall CS: 3 -1' of exposed rebar CS: 2 Span 6: -80' of eff CS: 2 All span -50' of abrasion Longitudinal cracks up to 0.030" wide entire length with efflorescence reflecting to the bottom of slab.								
215	Reinforced Concrete Abutment		LF	126	126	0	0	0
227	Reinforced Concrete Pile		EA	30	13	17	0	0
1190	Abrasion/Wear (PSC/RC)		EA	6	0	6	0	0
6000	Scour		EA	11	0	11	0	0

Span 4 efflorescence

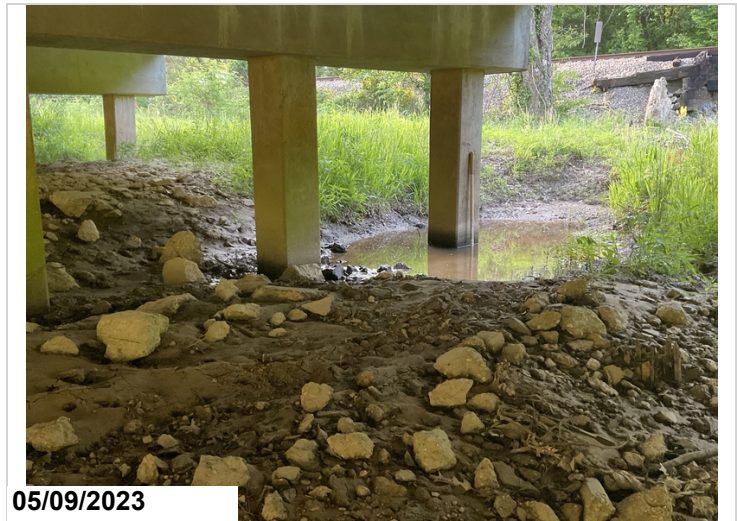
Bents 2-6 minor local scour around piles.

(227) Bent 3: -All 6 abrasion CS: 2 Bent 4: -4 scour CS: 2 Bent 5: -6 scour CS: 2 Bent 6: -1 scour CS: 2								
234	Reinforced Concrete Pier Cap		LF	301	298	1	2	0
1080	Delamination/Spall/Patched Area		LF	3	0	1	2	0

Bent 4 pile 6 local scour

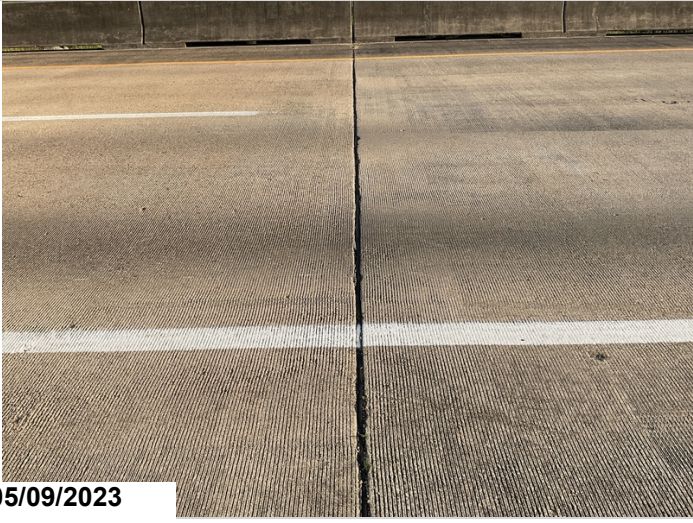
ELEMENTS	DESCRIPTION	UNITS	TOTAL	CS1	CS2	CS3	CS4
301	Pourable Joint Seal	LF	214	94	120	0	0
2320	Seal Adhesion	LF	80	0	80	0	0
2350	Debris Impaction	LF	40	0	40	0	0
(301) Joint material is loosing adhesion and becoming impacted with debris.							
331	Reinforced Concrete Bridge Railing	LF	300	300	0	0	0

Typical joint material

A-59 - Joint Repair Needed (Yes)

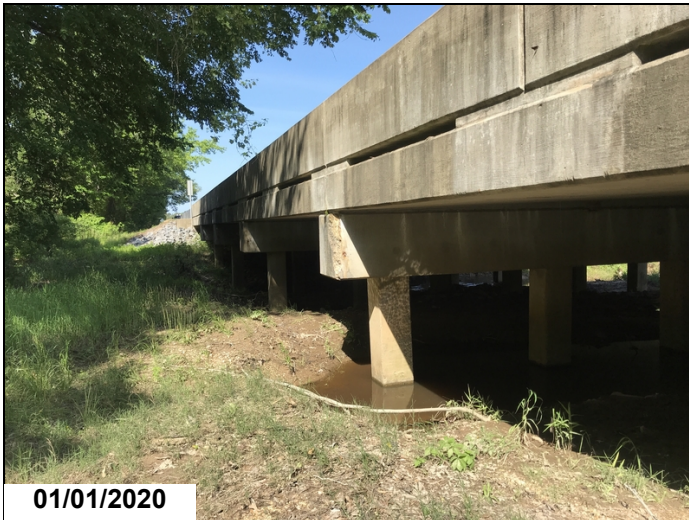
01/01/2020

Bent 2 left end of cap has a large spall.
Bent 5 Cap, right end has a large spall.

Bent 5 Rt. Looking back @ spall on ahead side of cap.

Type of Work: Substructure Repair

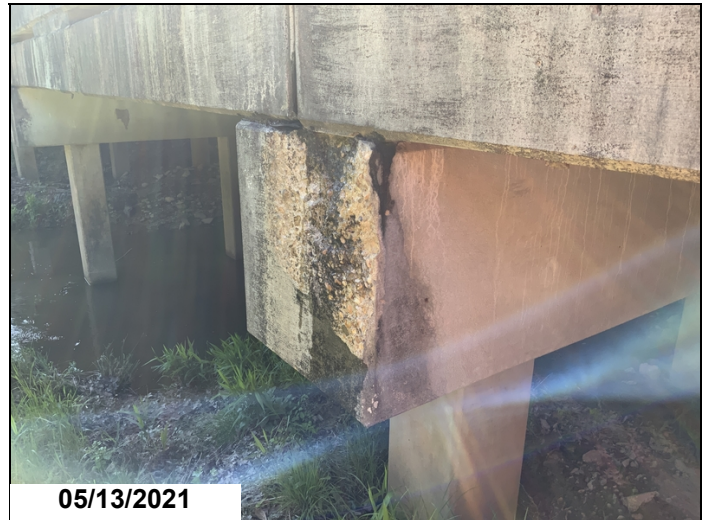
05/13/2021

(234) Bent 2: - 1' spall CS: 3 Bent 5: - 1' spall CS: 2 - 1' spall CS: 3

Bent 2 left end of cap spalled

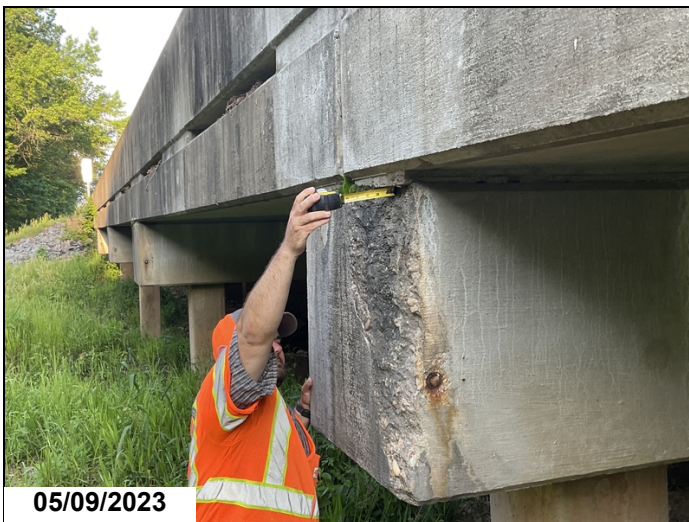
05/09/2023

Bent 5 right end of cap spalled

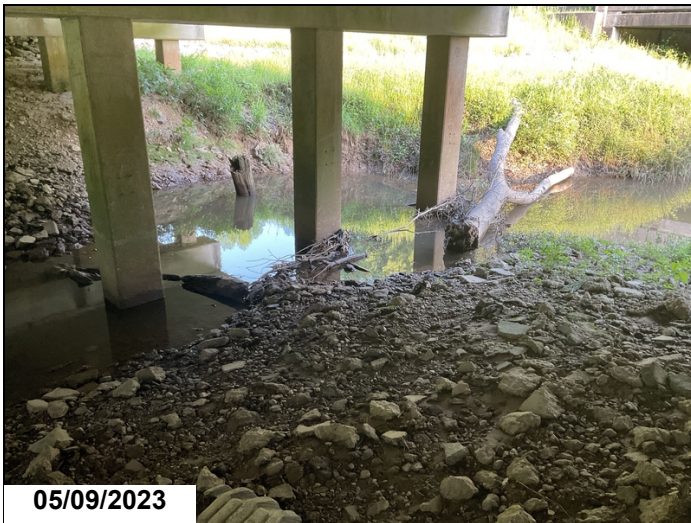
Bent 3 pile have logs and debris washed up against them.

Drift at bent 3

Type of Work: Channel Work/Drift Removal
