Bridge 06535 Inspection Report

Asset #06535(Routine, Underwater type 2)

SH 19 S1 LM 7.58 over HORSEHEAD CRK RELIEF

Team Lead: Rickie Bratton Inspection Date: 09/30/2025

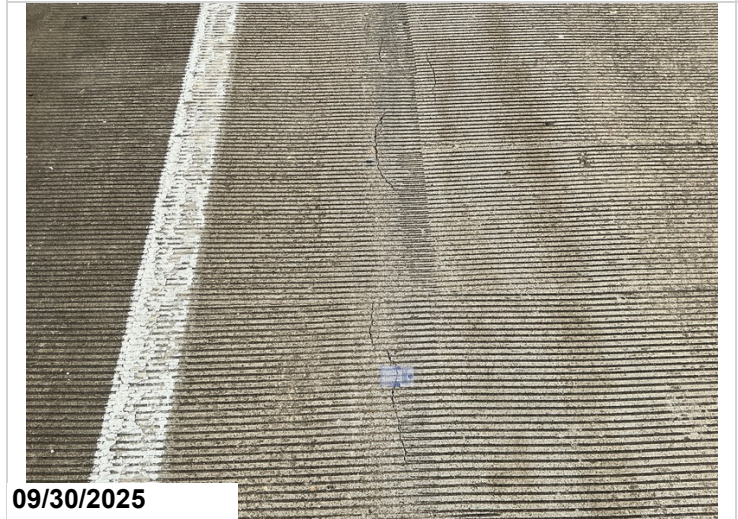
(16) Top of deck has longitudinal and diagonal cracks, up to 0.070 Max. Undersurface has a few light spots of efflorescence. See notes in Defects. (1120-16) Span 1 Bay 1 - efflorescence 6' CS2 Span 8 Bay 3 - efflorescence 3' CS2 (1130-16) Top of Deck Span 1 - 25' diagonal cracking CS2 - 70' longitudinal cracking CS2 Span 2 - 13' diagonal cracking CS2 - 105' longitudinal cracking CS2 Span 3 - 6' diagonal cracking CS2 - 105' longitudinal cracking CS2 Span 4 - 63' longitudinal cracking CS2 - 7' in CS3 Span 5 - 70' longitudinal cracking CS2 Span 6 - 8' diagonal cracks CS2 Span 7 - 6' diagonal cracking CS2 - 35' longitudinal cracking CS2 Span 8 - 30' diagonal cracking CS2 - 70' longitudinal cracking CS2							
110	Reinforced Concrete Open Girder/Beam	LF	1120	1120	0	0	0

Span 4, longitudinal cracks 0.070 5'

A-54 - Sealable Deck Cracks (Yes)

A-61 - Polymer Overlay Advised (Yes)

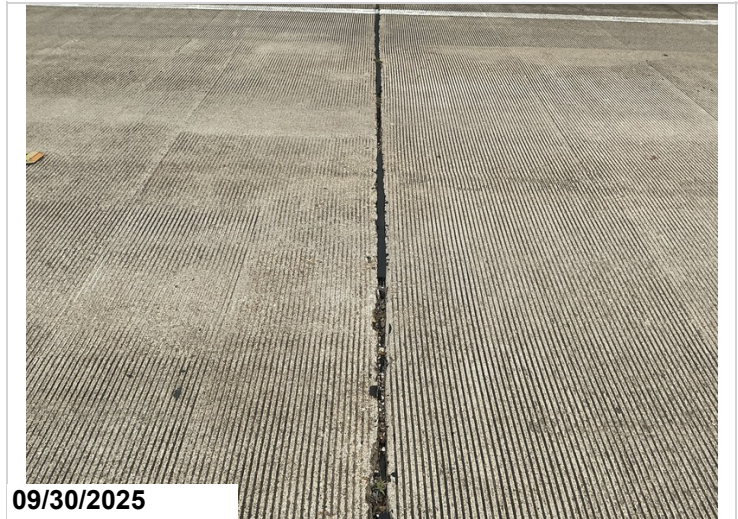
(234) -Bent 3 cap back spalls at keyways 2' CS3. - Bent 5 cap back spalls 2' CS3 - Bent 6 cap back delam 1' CS2 - cap ahead delams 2' CS2 - Bent 7 cap back spalls 2' CS3 - cap ahead spalls 2' CS3							
301	Pourable Joint Seal	LF	230	0	0	224	6
2320	Seal Adhesion	LF	230	0	0	224	6

(301) Joint seals have lost adhesion and are becoming impacted with non-compressible material.

Bent 5 joint missing 6'

A-59 - Joint Repair Needed (Yes)

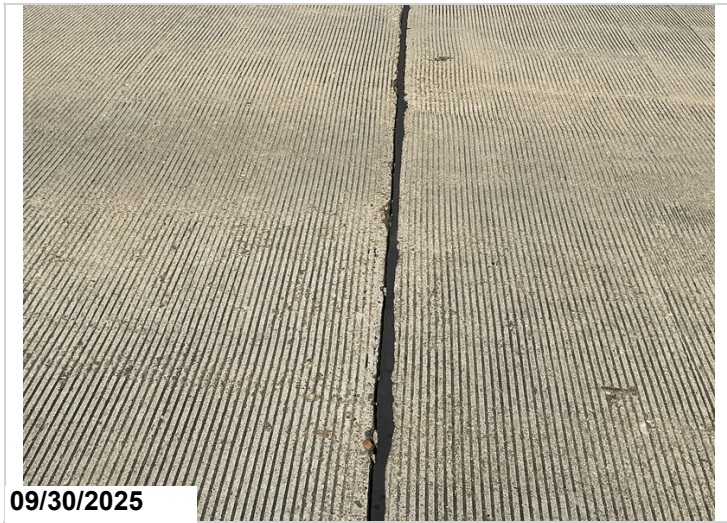
Bent 2 joint, lost adhesion

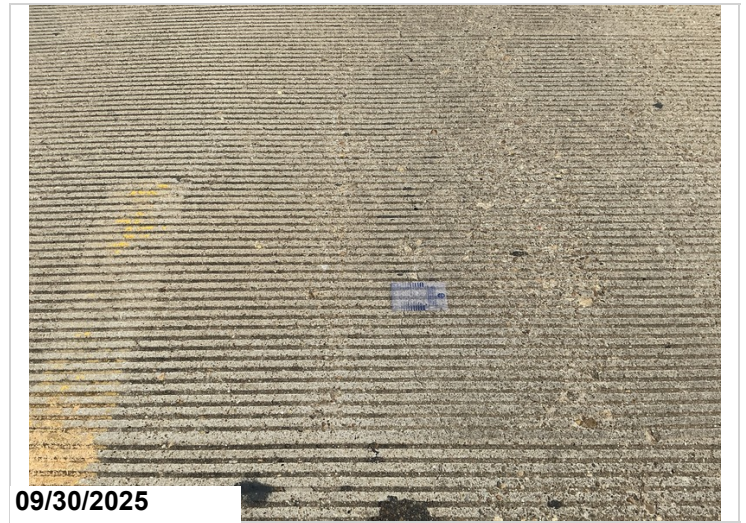
Span 1, longitudinal cracks 0.020.

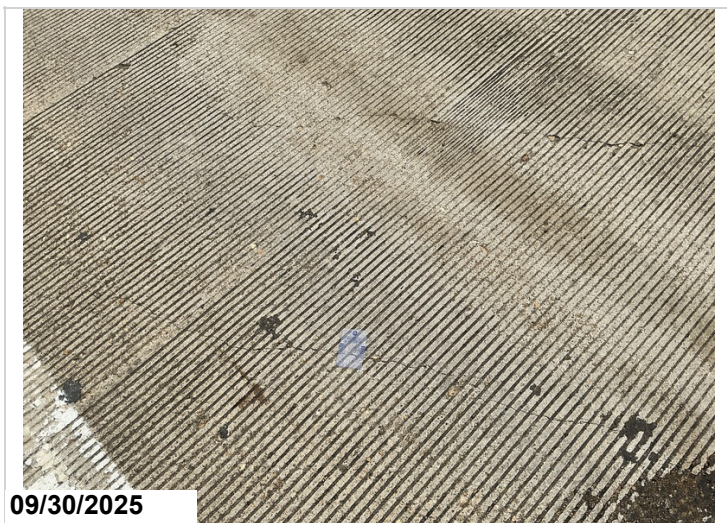
Span 1, diagonal cracks, 0.030.

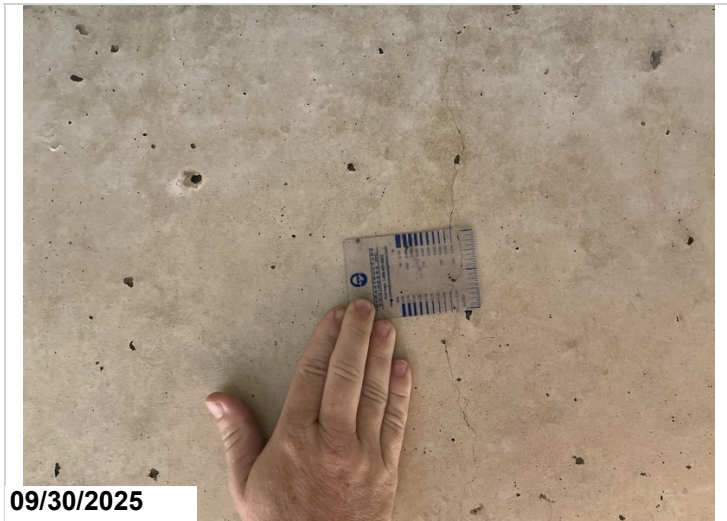
(110) Girders have hairline vertical cracks ranging from, 0.012-0.015							
215	Reinforced Concrete Abutment	LF	84	84	0	0	0
227	Reinforced Concrete Pile	EA	28	15	13	0	0
1080	Delamination/Spall/Patched Area	EA	2	0	2	0	0
1190	Abrasion/Wear (PSC/RC)	EA	7	0	7	0	0
6000	Scour	EA	4	0	4	0	0

All girders have vertical cracks

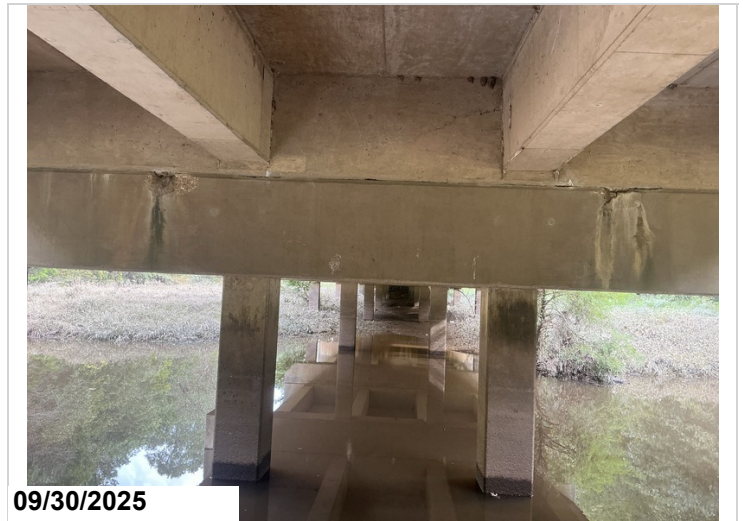
Bent 3 cap back spalls at keyways 2' CS3.

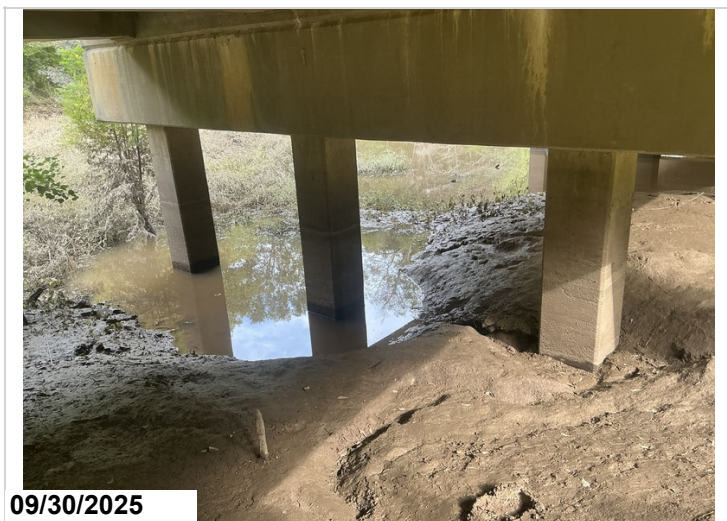
Local isolated areas of scour around piles.

(227) -Bent 2 all piles light abrasion 4 in CS2 - piles 1&2 local scour CS2 -Bent 3 All piles light abrasion - pile 1 ahead small spall CS2 - Bent 7 piles 1 and 2 local scour.							
234	Reinforced Concrete Pier Cap	LF	230	219	3	8	0
1080	Delamination/Spall/Patched Area	LF	11	0	3	8	0

Bent 2 piles 1&2 local scour CS2

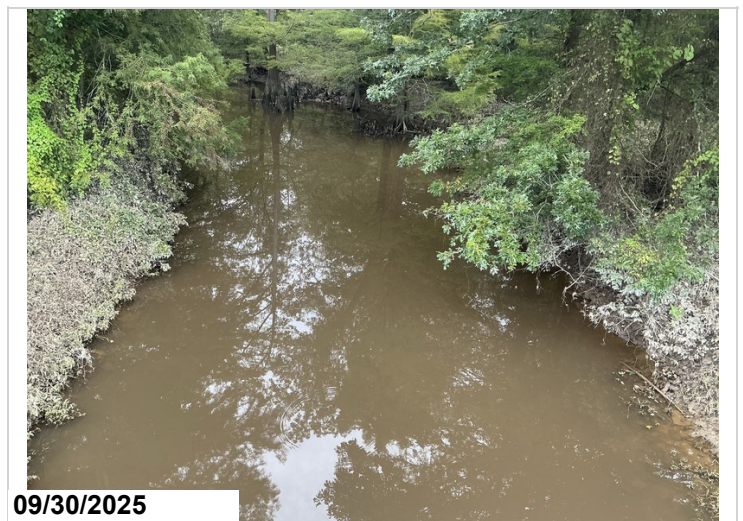
Right side upstream.

Banks are slumping and there is debris in stream.

A-64 - Vegetation Removal Requested (Yes)

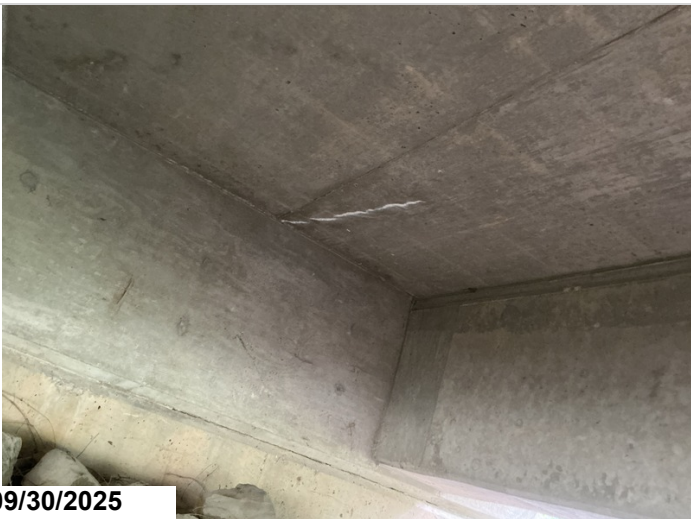
Span 8 bay 3 efflorescence 3' CS2
