Bridge 06536 Inspection Report

SH 19 S-1 LM 7.67 over HORSEHEAD CRK

Team Lead: Rickie Bratton Inspection Date: 09/30/2025

Inspection Photos and Notes

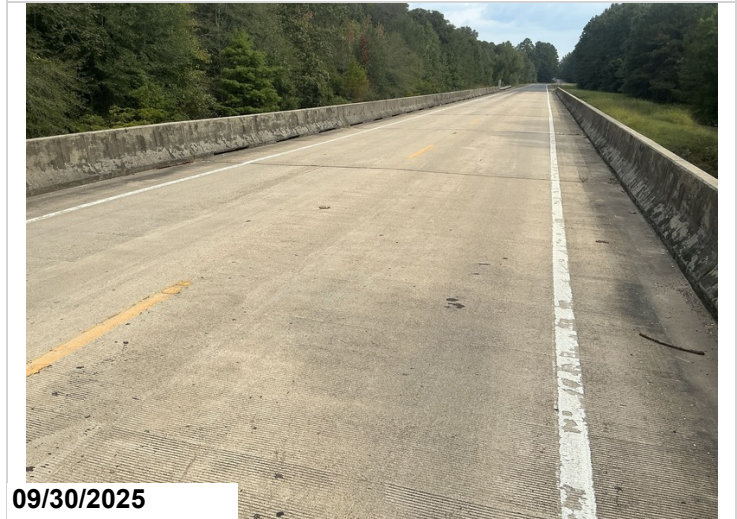
Overall, the deck is in good condition. Diagonal and longitudinal cracks.

Deck overview

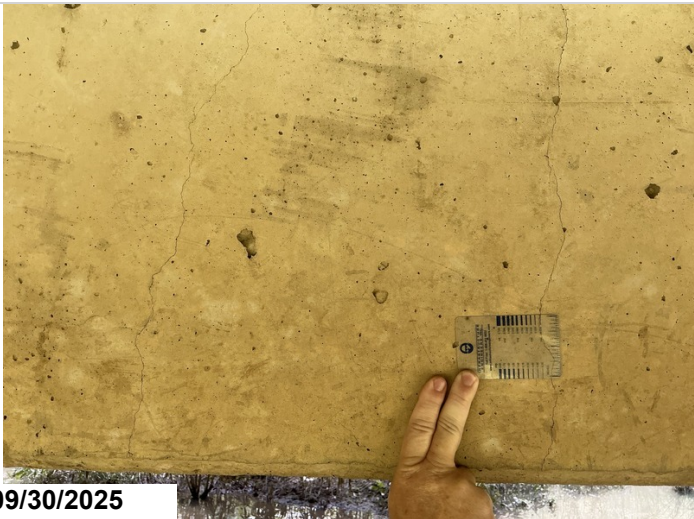
Overall, the superstructure is in good condition, vertical hairline cracks in girders.

Vertical hairline cracks in girders common all spans

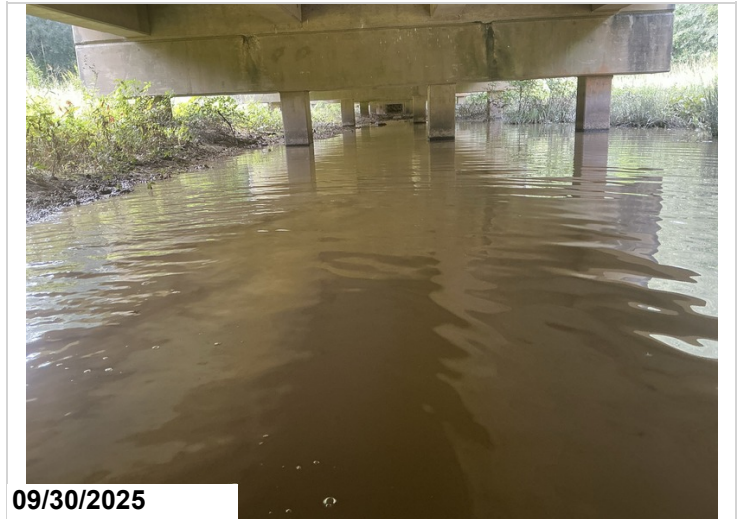
Local scour piles 1-3 throughout spans 8&9

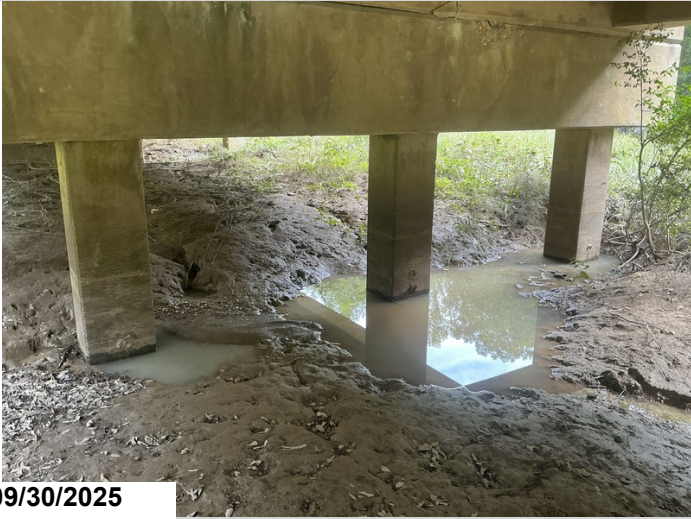
Bent 5 piles 2-4 local scour CS2

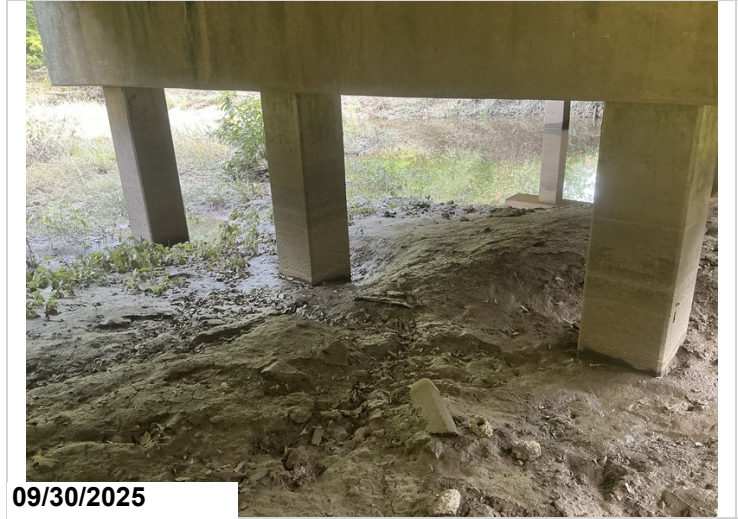
Bent 3 pile 1 local scour

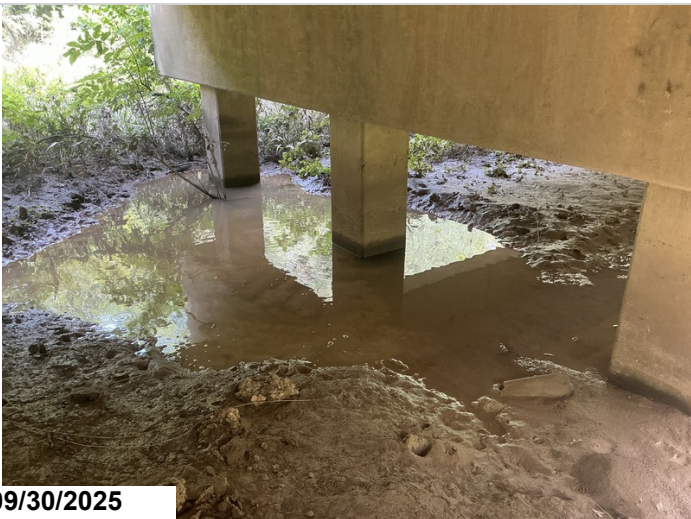
Bent 2 piles 1&2 local scour CS2

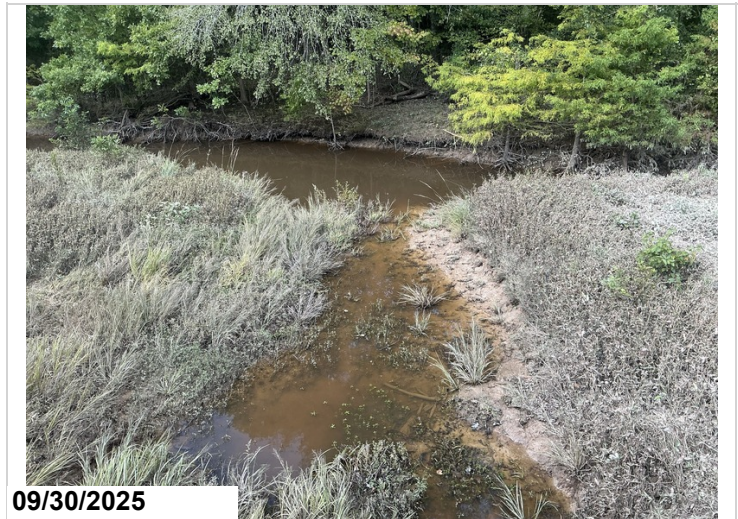
Downstream channel overview left side

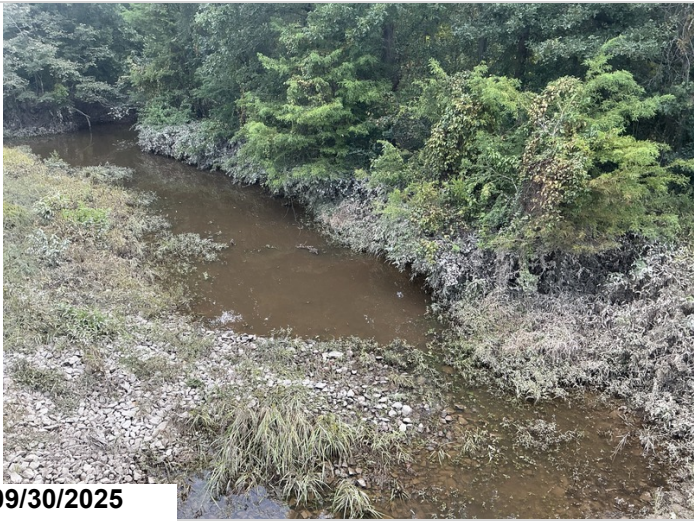
Upstream channel overview right side

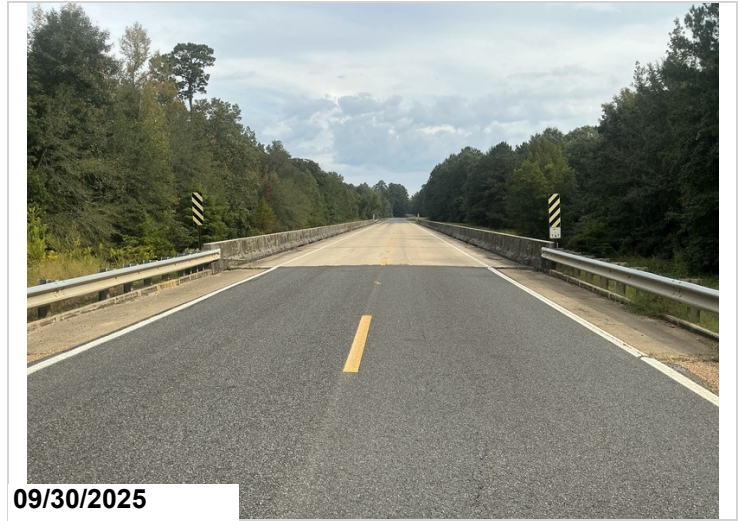
Approach roadway Northbound

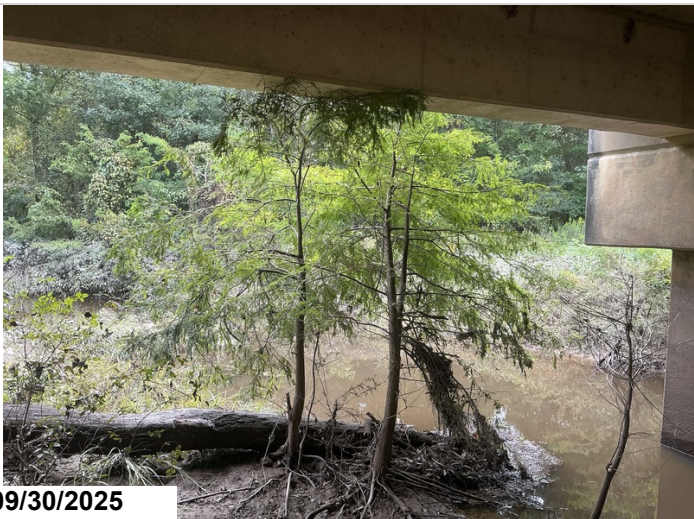
Span 4 right side trees growing under bridge

A-64 - Vegetation Removal Requested (Yes)

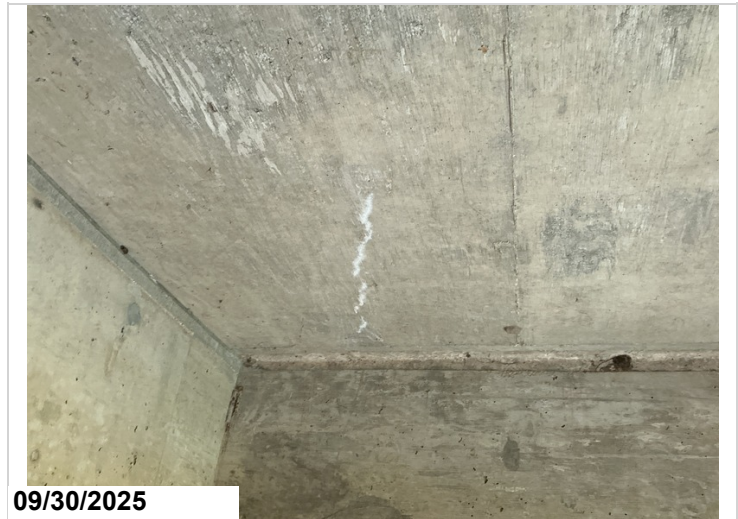
Span 1 Bay 3 efflorescence 3' CS2

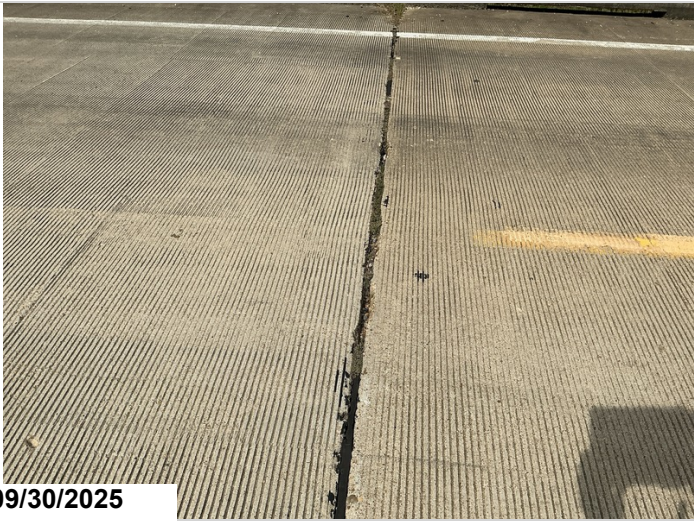
(301) All joint seal has lost bond and is leaking. Bent 7: -6' missing CS4 Bent 8: -6' missing CS4 Bent 8:

Bent 9 joint missing 9' CS4

A-59 - Joint Repair Needed (Yes)

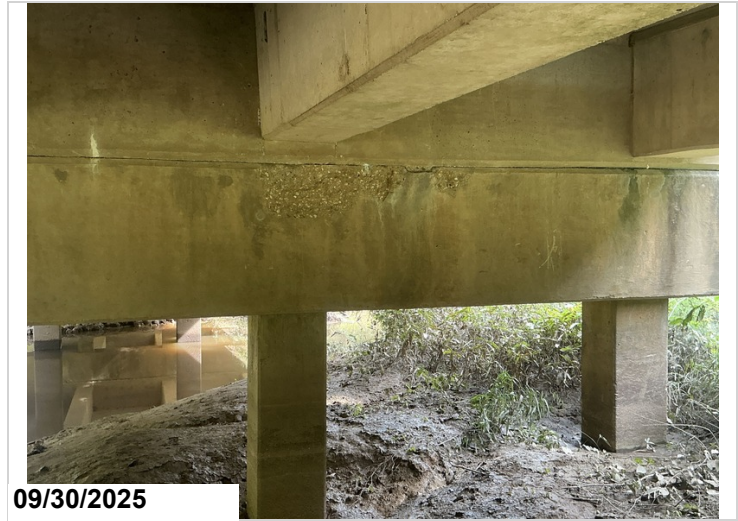
Bent 3 cap back spall 4' CS3

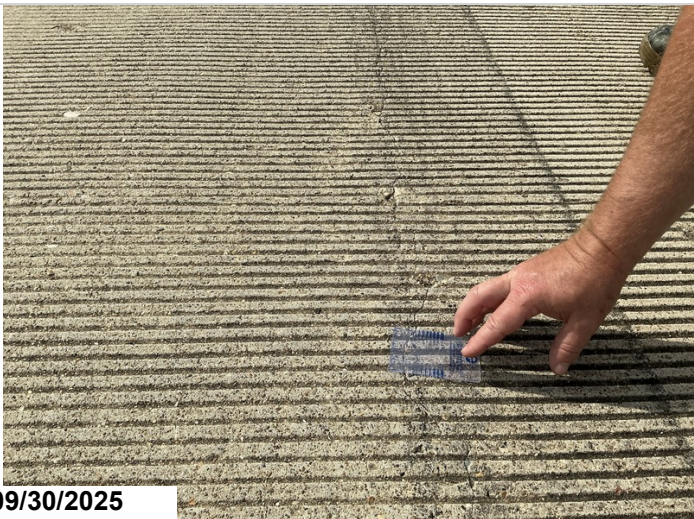
Span 7 longitudinal crack 35' up to 0.040"

A-54 - Sealable Deck Cracks (Yes)

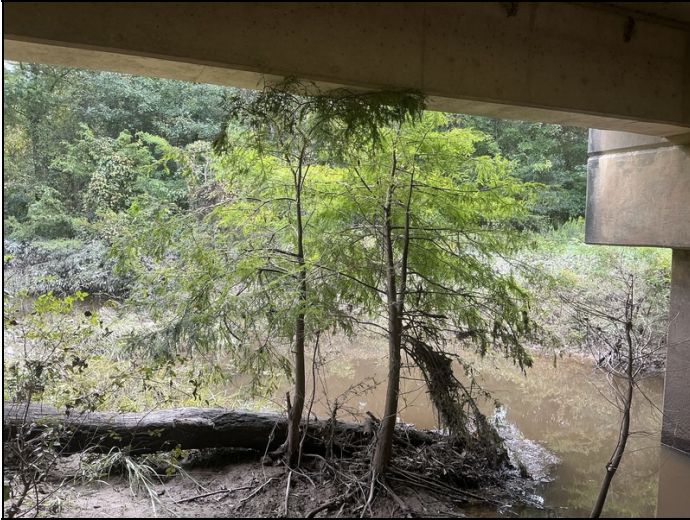
Span 4 right side trees growing under bridge
