Bridge 06642 Inspection Report

Asset #06642(Routine, Underwater type 2)

SH 19 S-1 LM 16.20 over Nations Creek

Team Lead: John Parks Inspection Date: 07/31/2023

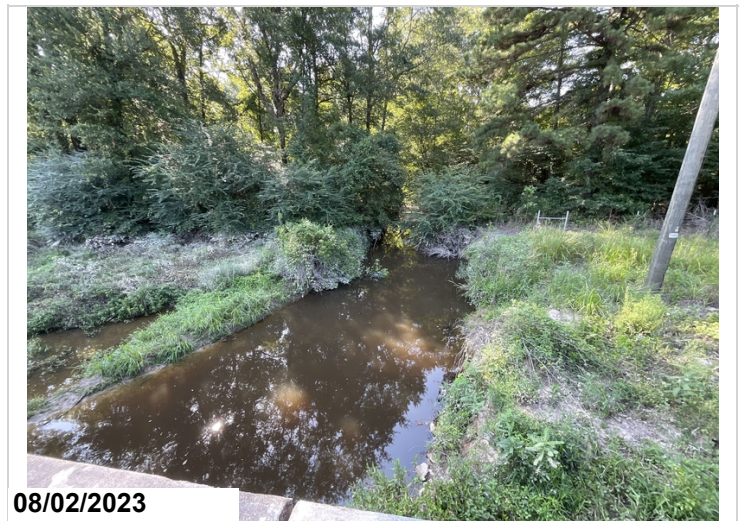
Channel right side.

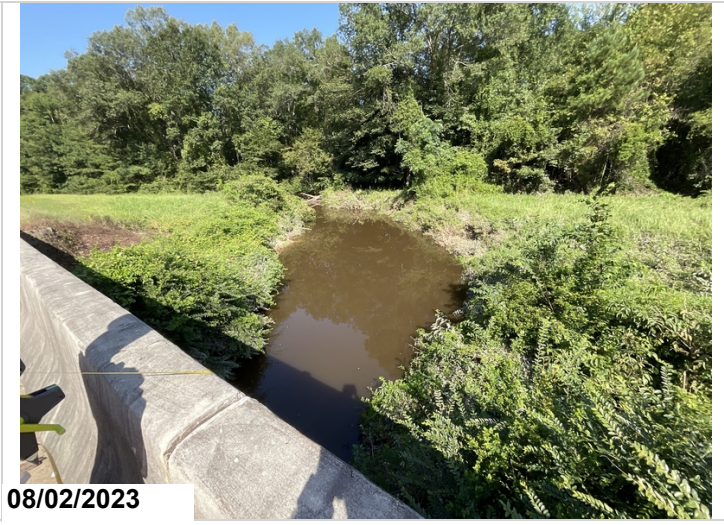
Channel left side

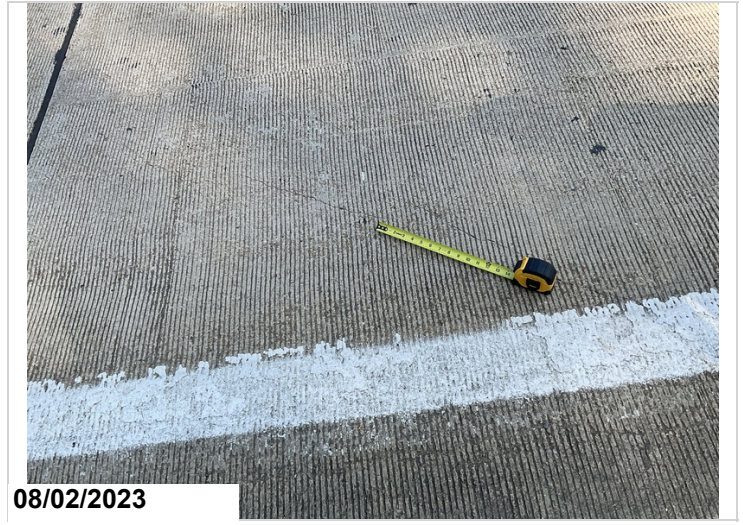
(16) Span 1: - 22' Efflorescence on the bottom of the Top Flange. CS2 - 30' Cracking on the top of the Top Flange. CS2 Span 2: -2' Efflorescence on the bottom of the Top Flange. CS2 - 30' Cracking on the top of the Top Flange. CS2 Span 3: -3' Efflorescence on the bottom of the Top Flange. CS2 -75' Cracking on the top of the Top Flange. CS2 Span 4: -3' Efflorescence on the bottom of the Top Flange. CS2 -25' Cracking on the top of the Top Flange. CS2 Span 5: -4' Efflorescence on the bottom of the Top Flange. CS2 -50' Cracking on the top of the Top Flange. CS2 Span 6: -12' Efflorescence on the bottom of the Top Flange. CS2 -50' Cracking on the top of the Top Flange. CS2 -1' spall in the top of the Top Flange, mid span 4' right of center line. CS2							
110	Reinforced Concrete Open Girder/Beam	LF	600	600	0	0	0
215	Reinforced Concrete Abutment	LF	107	107	0	0	0
227	Reinforced Concrete Pile	EA	20	20	0	0	0

Deck cracks span 6 up to 0.020"

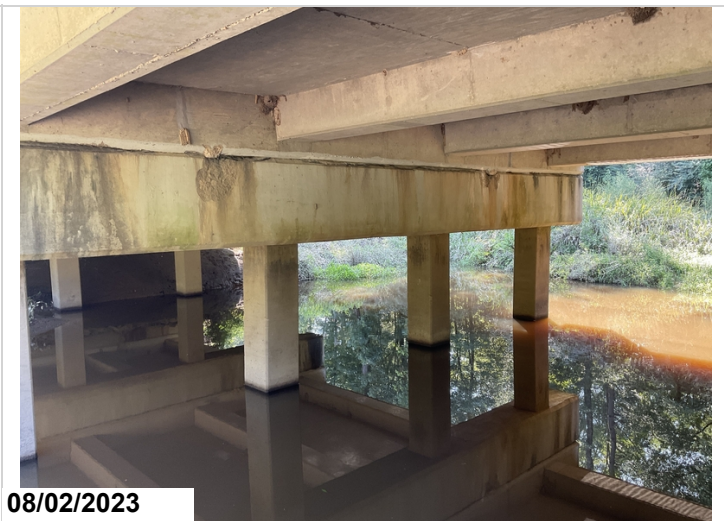
234	Reinforced Concrete Pier Cap	LF	174	166	2	6	0
1080	Delamination/Spall/Patched Area	LF	8	0	2	6	0
(234) Bent 4: -Back side of the cap, below left keyway, 2' diam. x 2" deep spall. 2' CS3 -Back side of the cap, below the right keyway, 10" diam. x 2" deep spall. 1' CS2 Bent 5: -Back side of the cap, below both keyways, 2' diam. x 2" deep spall. 4' CS3 Bent 6: -Back side of the cap, below left keyway, 10" diam. x 2" deep spall. 1' CS2.							
301	Pourable Joint Seal	LF	174	0	174	0	0
2320	Seal Adhesion	LF	174	0	174	0	0

Bent 5 cap back spalls

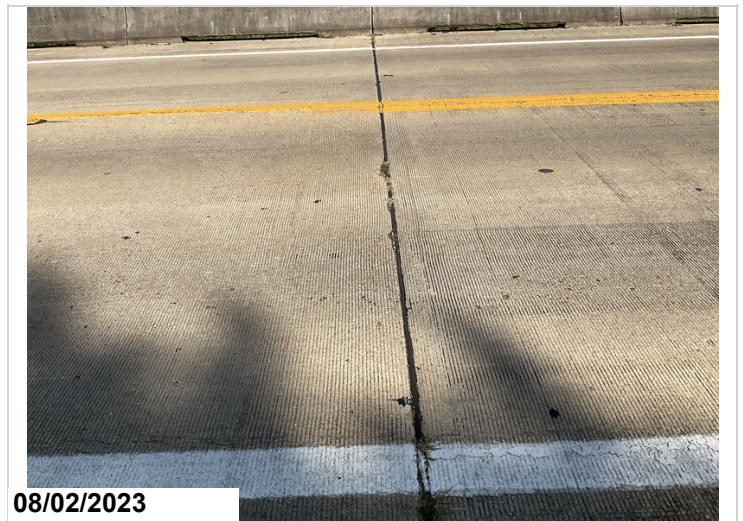
(301) Losing bond with adjacent deck							
331	Reinforced Concrete Bridge Railing	LF	300	282	18	0	0
1080	Delamination/Spall/Patched Area	LF	6	0	6	0	0

Joint material Bent 4 worn
