## Bridge 06643 Inspection Report

**Asset #06643**(Routine, Underwater type 2)

**SH 19 S-1 LM 16.36 over Nations Crk Relief**

**Team Lead: John Parks Inspection Date: 07/31/2023**

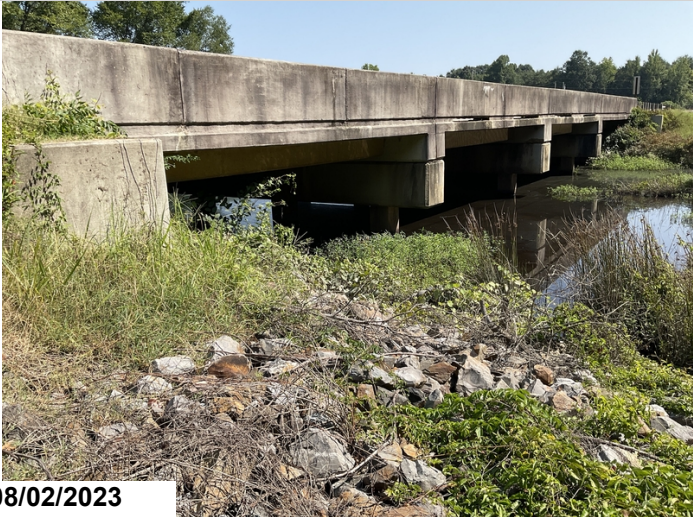
Elevation

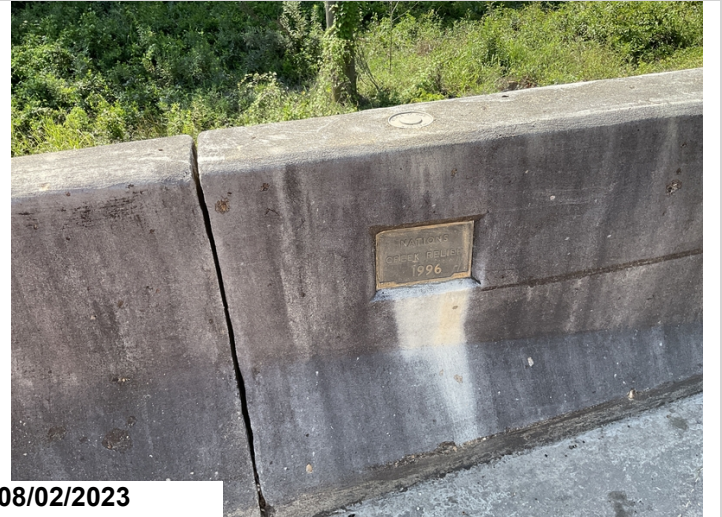
Name plate

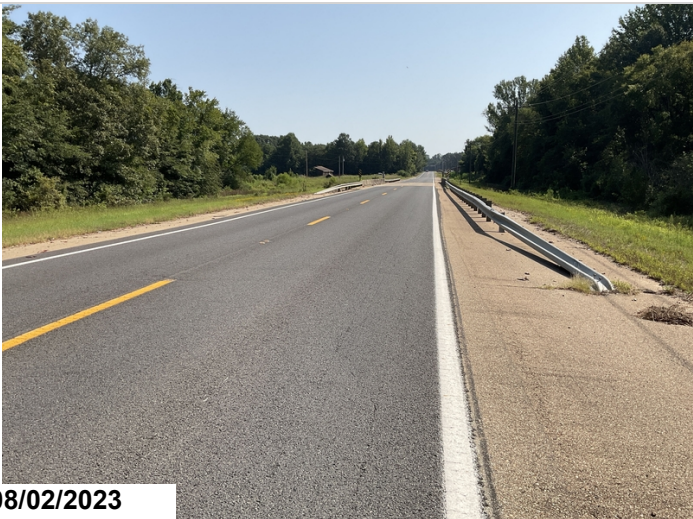
Approach

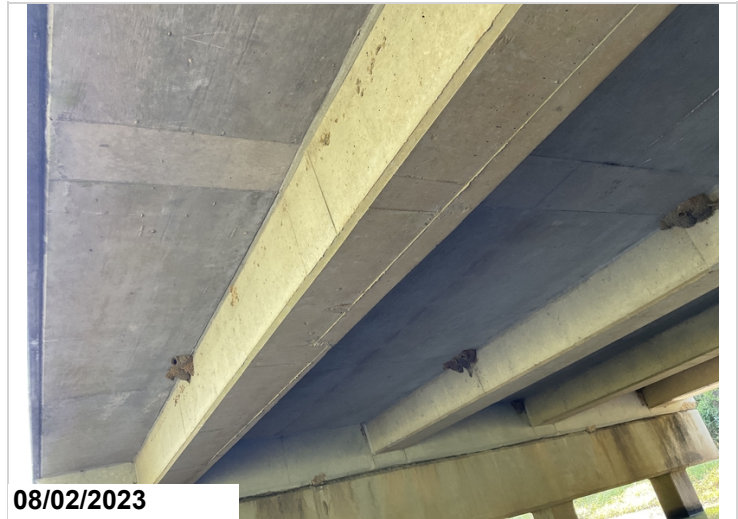
Deck Underview

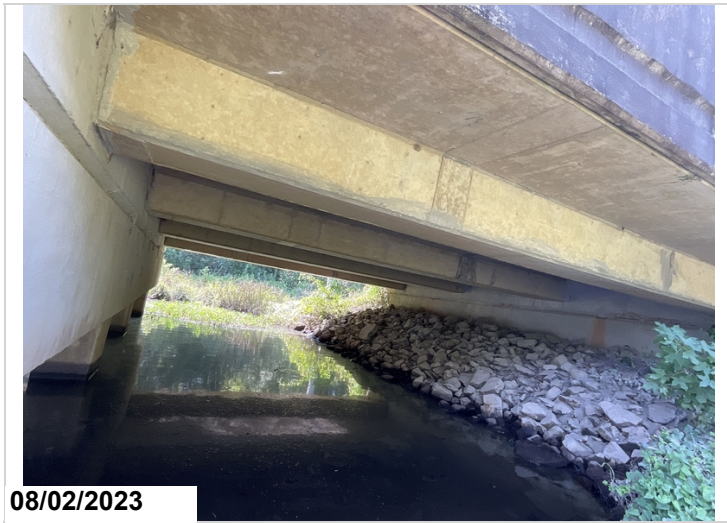
Typical superstructure

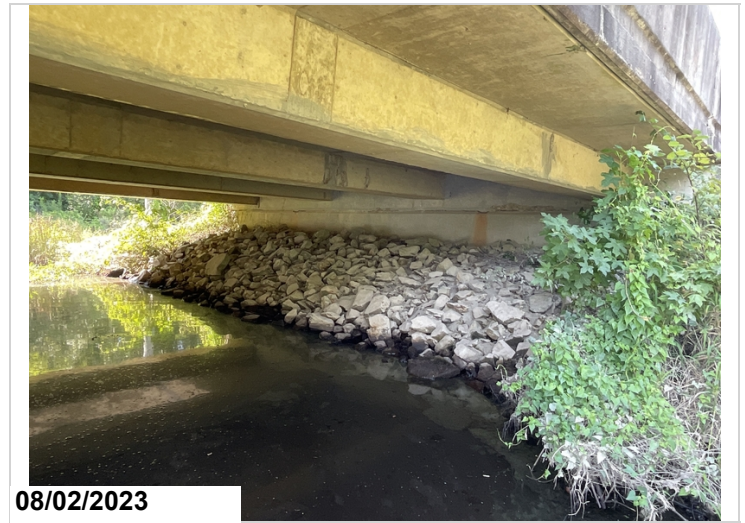
Typical substructure

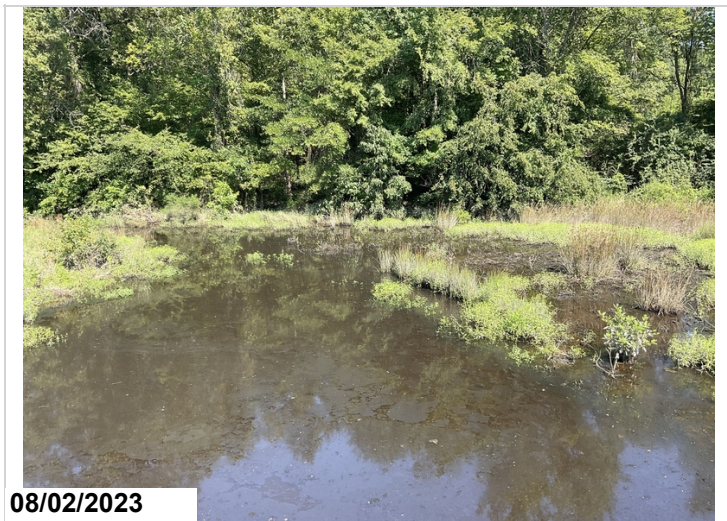
Channel left side

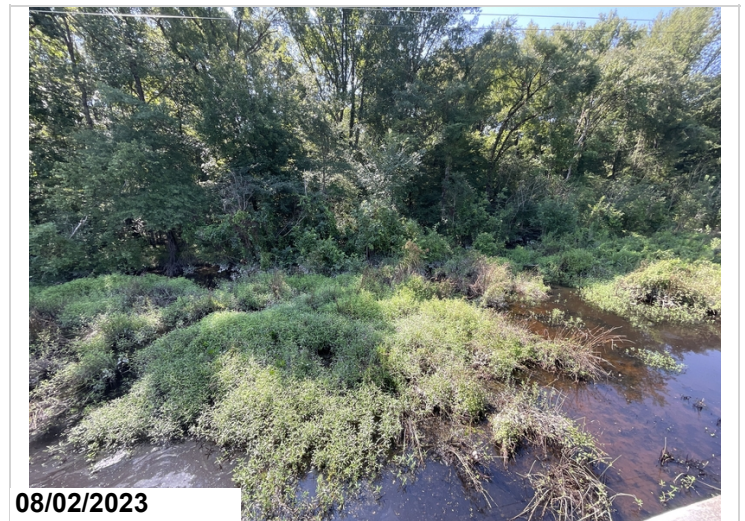
Channel right side

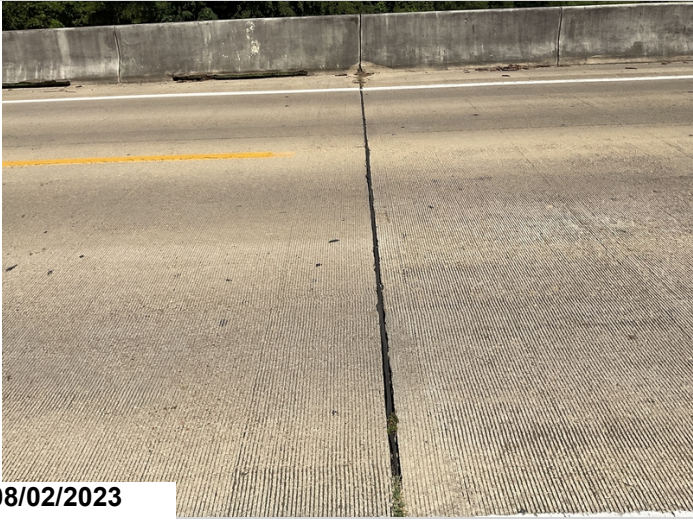
Bent 4, joint material has loss of adhesion.

**A-59 - Joint Repair Needed (Yes)**

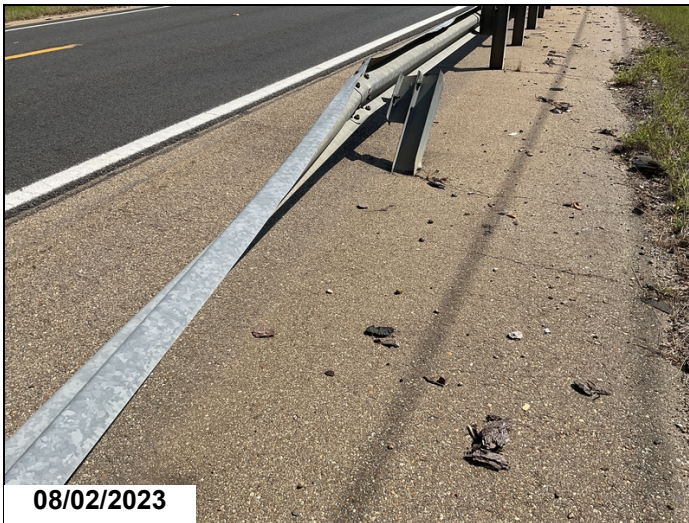
The right approach guard rail at the Bent 1 end has been damaged.

Rail damage

**Type of Work:** Repair (General)
