Bridge 06799 Inspection Report

SH 19 S1 L 0.06 over Cypress Creek

Location: .06 MI N. LA. St Line

Team Lead: John Parks Inspection Date: 04/12/2023

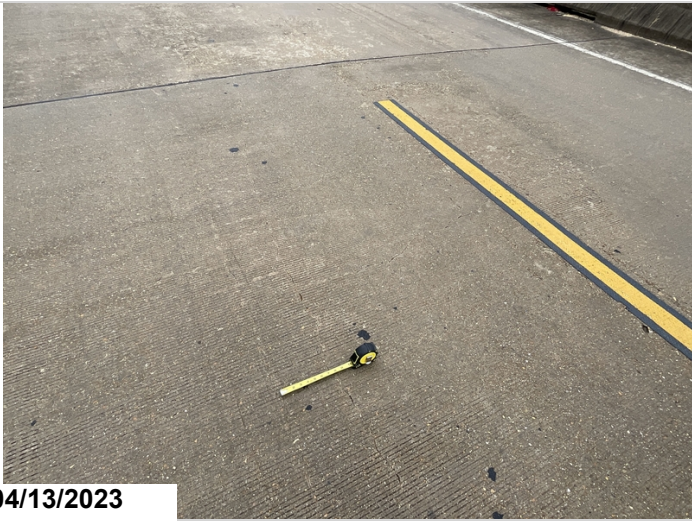
Wearing Surface: All spans have sealable deck cracks.

Deck cracks upto 0.030".

A-54 - Sealable Deck Cracks (Yes)

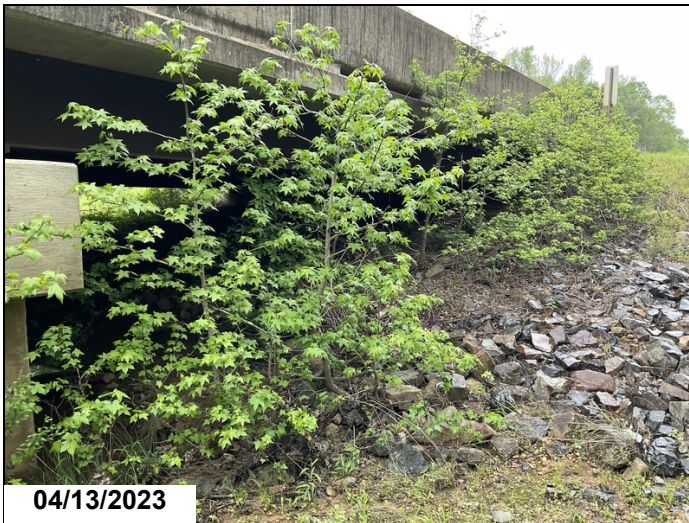
Trees are growing against the bridge.

A-64 - Vegetation Removal Requested
