Bridge 00827 Inspection Report

Asset #00827 (Routine)

US 79 S-3 LM 0.54 over CREEK

Team Lead: Rickie Bratton Inspection Date: 08/05/2024

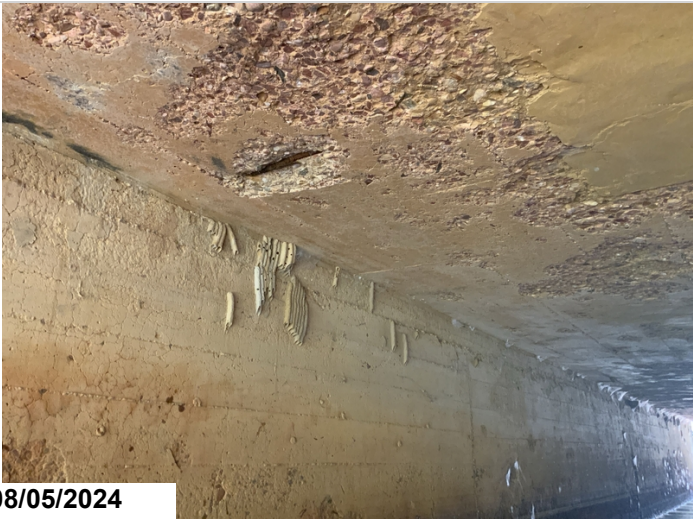
62 - Culverts (5 - Moderate to major deterioration or disintegration, extensive cracking and leaching or spalls on concrete or masonry walls and slabs. Minor settlement or misalignment. Noticeable scouring or erosion at curtain walls, wingwalls or pipes. Metal culverts have significant distortion and deflection in one section, significant corrosion or deep pitting.) Fair condition - Culvert has large scaled and pitted areas due to an oil fire inside the structure. Soffit of both spans have spalls/delams and exposed rebar. Divider wall has map cracking and abrasion.

Barrel 2 soffit has exposed rebar.

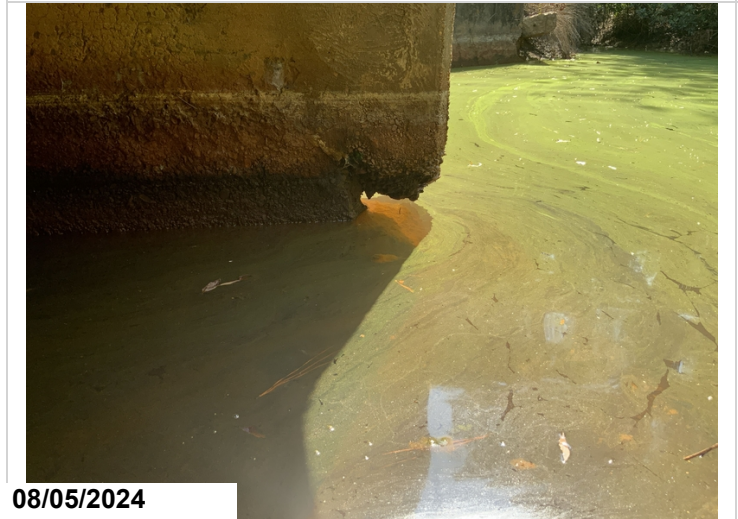
Divider wall outlet end 6" section of severe abrasion.

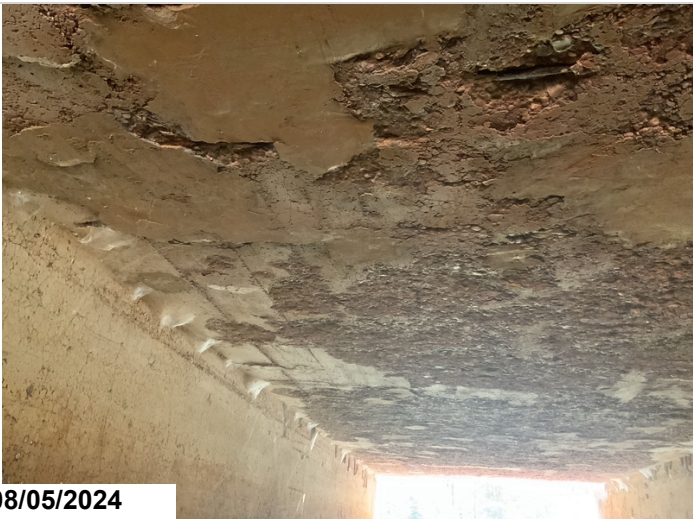
Barrel 1 exposed rebar in soffit

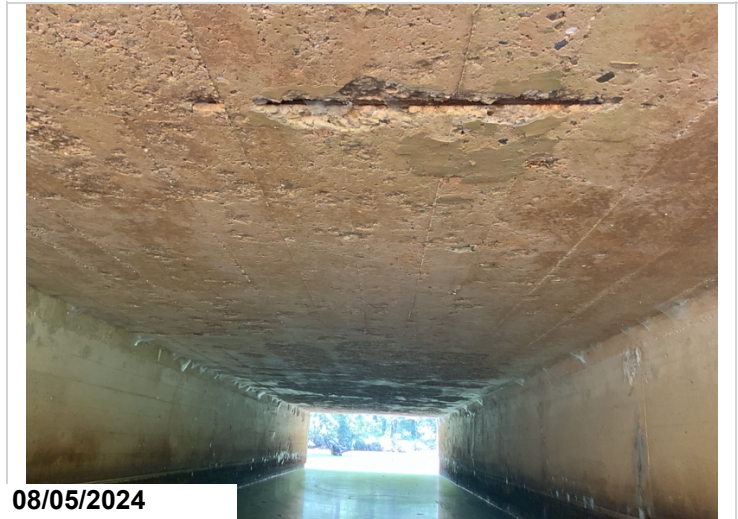
Barrel 1 soffit exposed rebar.

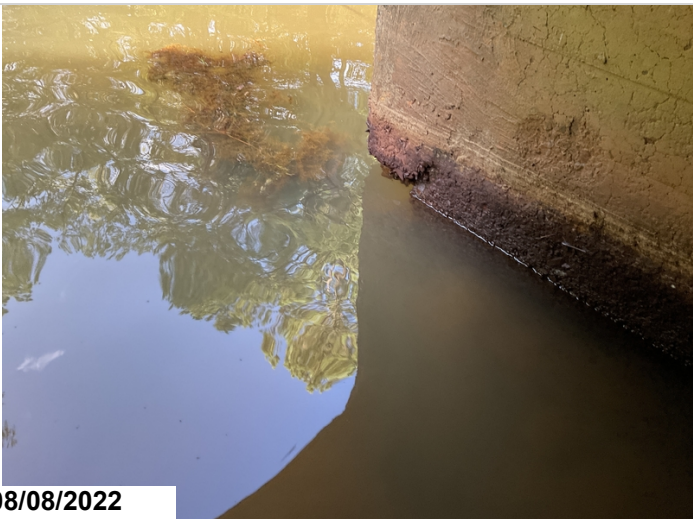
Right end of the center wall, large spall.

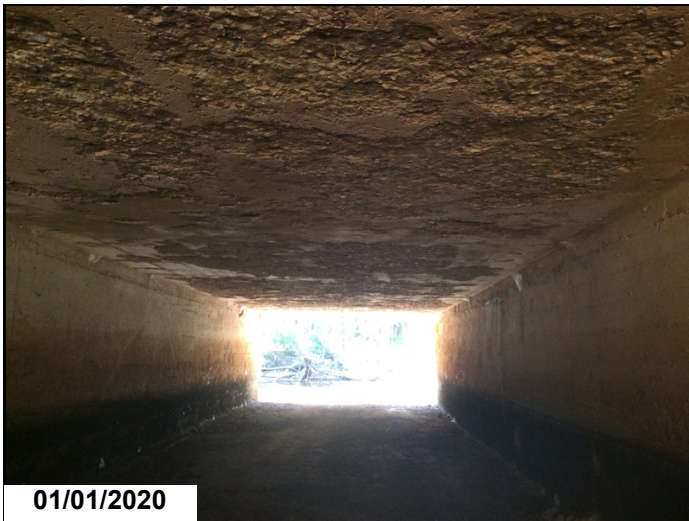
Barrels 1 and 2 have spalls in soffit due to fire damage.

Box Culvert barrel 1 spalls in the Soffit of the top.

Type of Work: Repair (General)

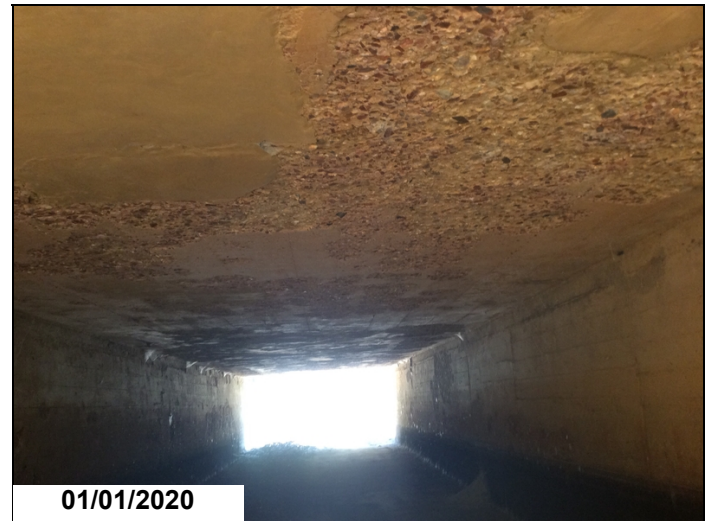
Box Culvert barrel 2, looking from Rt. @ Soffit of box Culvert top has spalls over most of the top. P

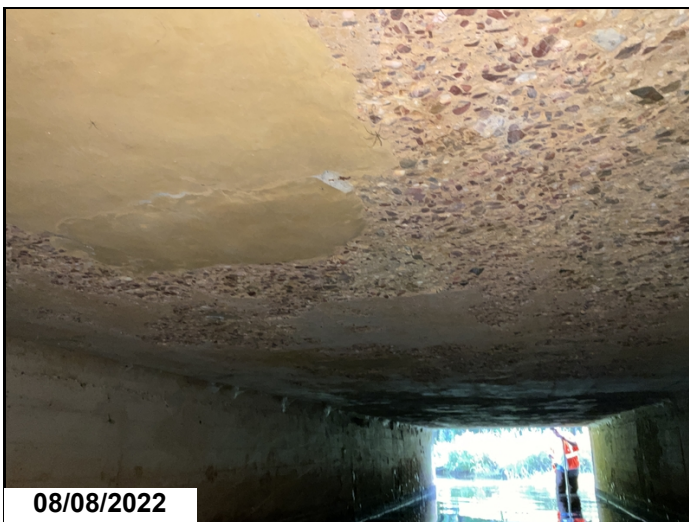
Spalling on the top of the box in barrel 2.

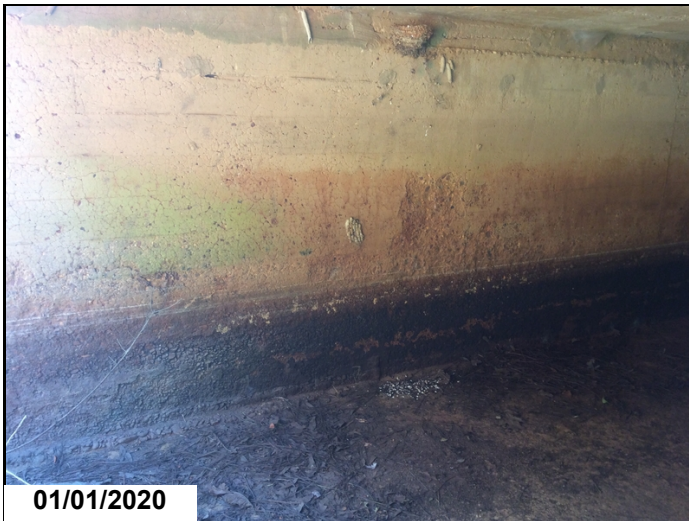
01/01/2020

Box Culvert barrel 1 looking ahead at center wall has map cracking for entire length of the wall, with some minor spalls

Type of Work: Repair (General)

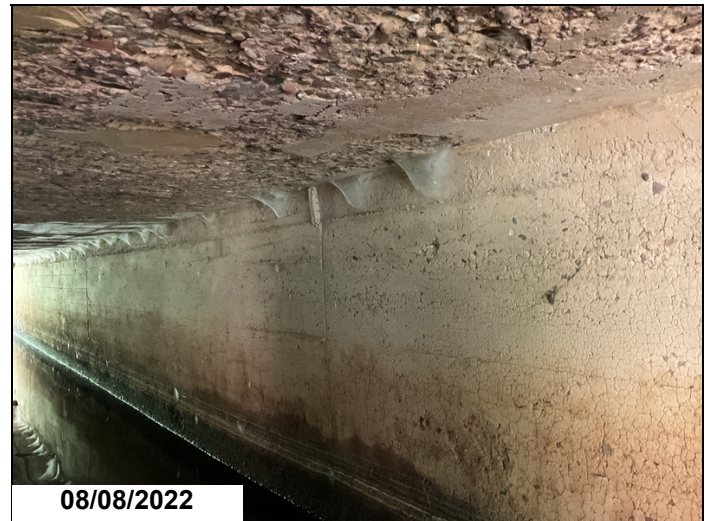
08/08/2022

Barrel 1, spalls on the top & map cracking on the center wall.
