Bridge 02354 Inspection Report

US 79 S-3 LM 5.62 over GUM CREEK

Location: 2.5 MI NE JCT SH 57

Team Lead: Rickie Bratton Inspection Date: 08/05/2024

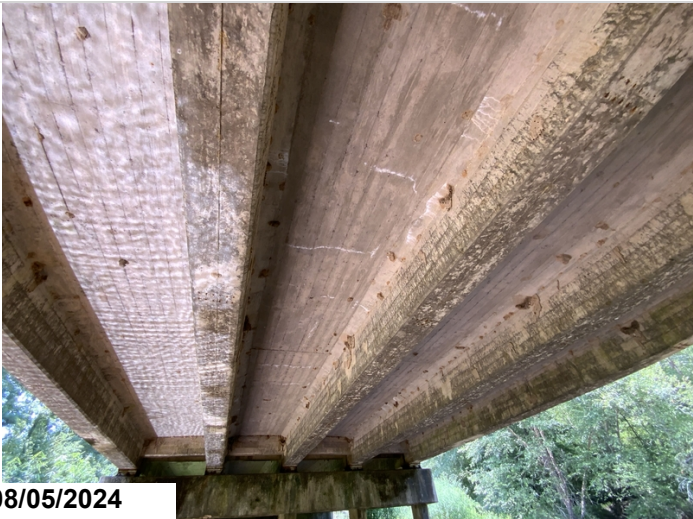
Span 3 looking back bottom surface overview

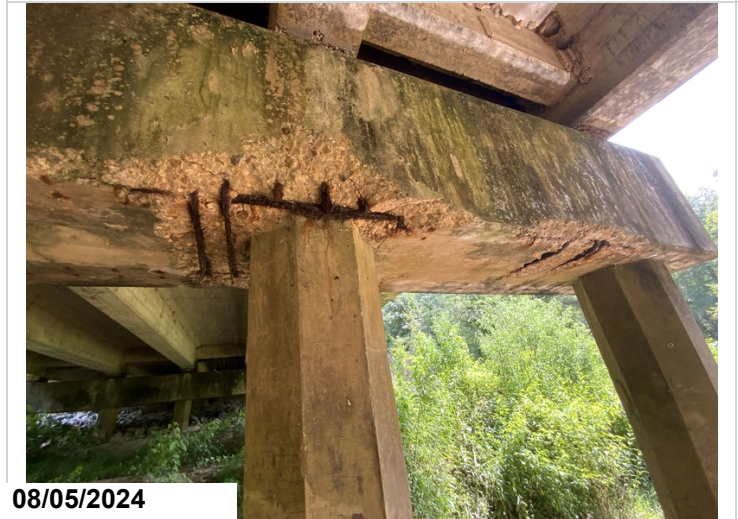
(234) Bent 4 pier cap has a spalled area with exposed steel @ column 4 , and a spalled area between columns 4 & 5.							
304	Open Expansion Joint	LF	125	125	0	0	0
311	Movable Bearing	EA	25	0	0	25	0
1000	Corrosion	EA	15	0	0	15	0
2210	Movement	EA	10	0	0	10	0

Bent 4 cap bottom exposed rebar

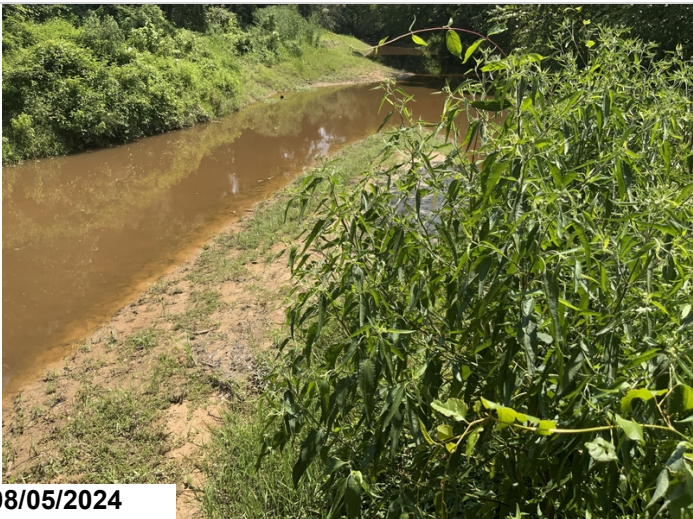
Channel downstream overview left side.

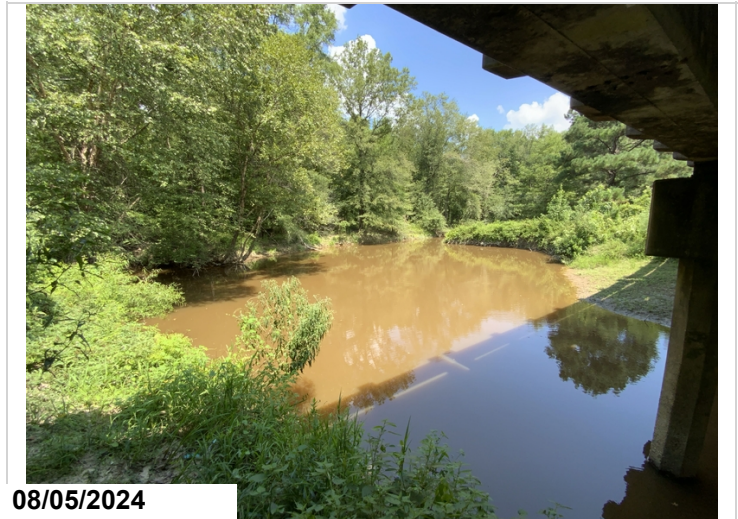
Scour action is eroding away the bank of the channel 50' upstream of the bridge.

Channel upstream overview right side

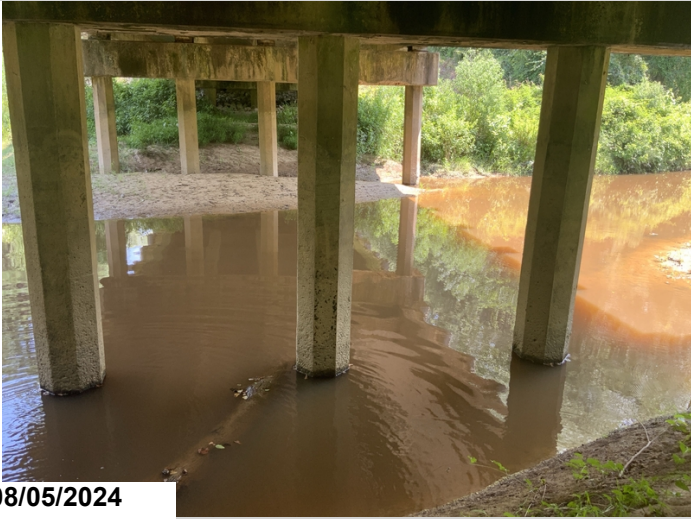
Bents 3&4 pile have abrasion.

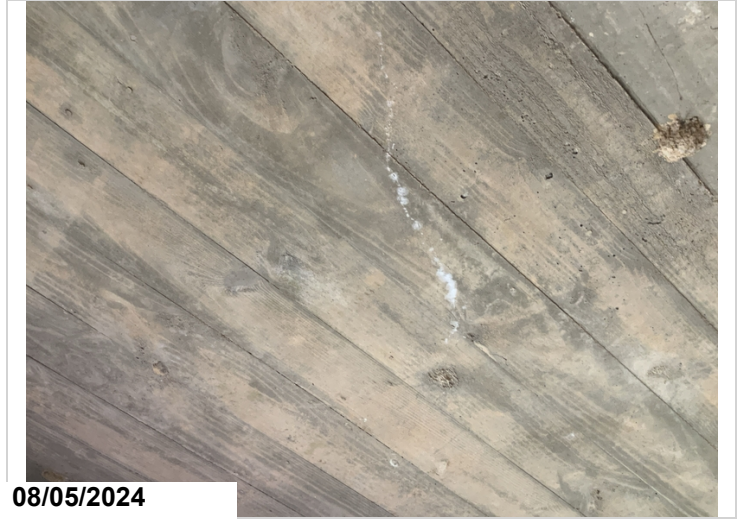
Good condition - overlay has cracks of joint, undersurface has cracks with light efflorescence.

Span 1 bay 4 bottom surface has efflorescence. Common all spans.

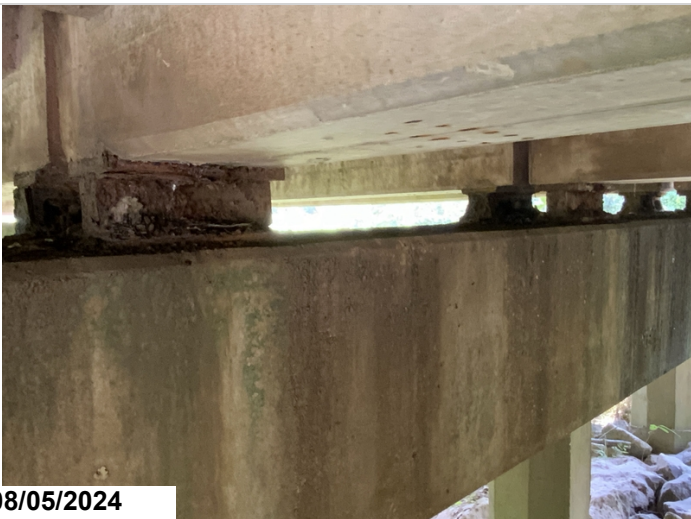
satisfactory condition. Bearings rocked and rusty. Plates are rusty also.

Bearings and plates all bents active corrosion

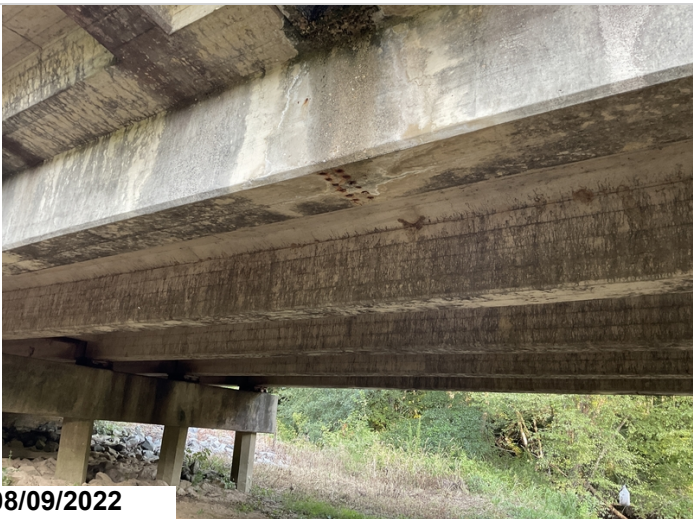
Typical view of the girders

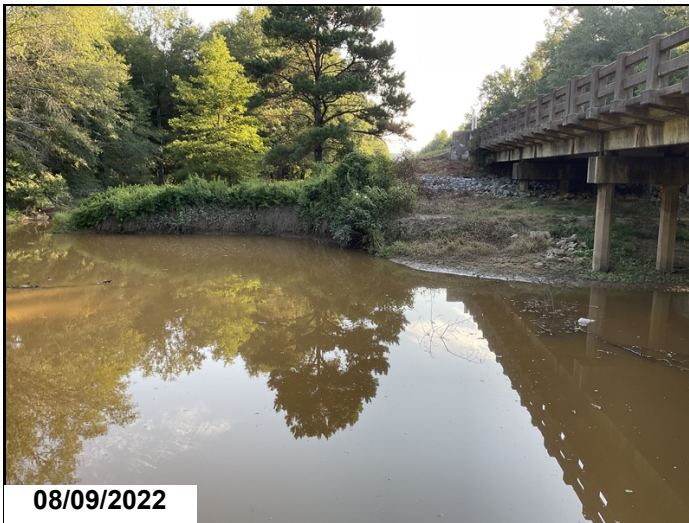
Scour action is eroding away the bank of the channel 50' upstream of the bridge.

Priority: C - Important

Type of Work: Repair (General)

Status: Monitor

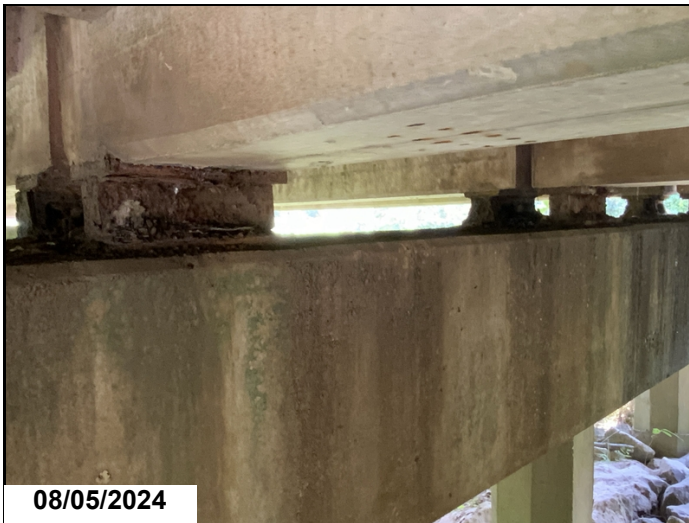
All bearings and pads have 100% paint failure and rust.

Bearings and plates all bents active corrosion

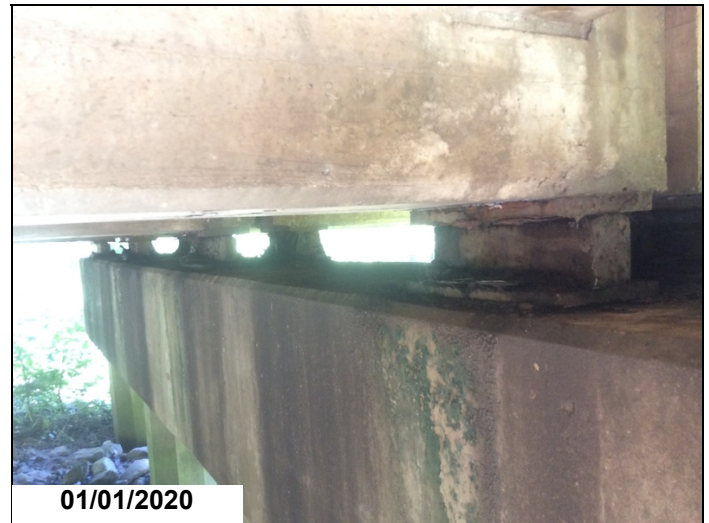
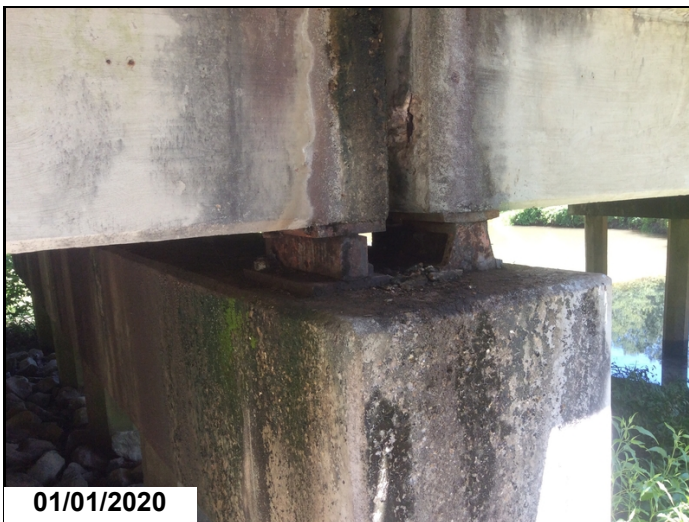
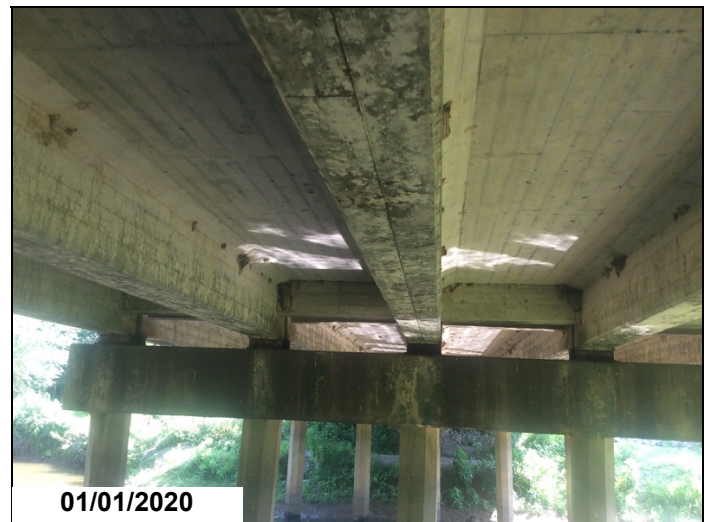
Bt. 3, looking ahead at bearings.

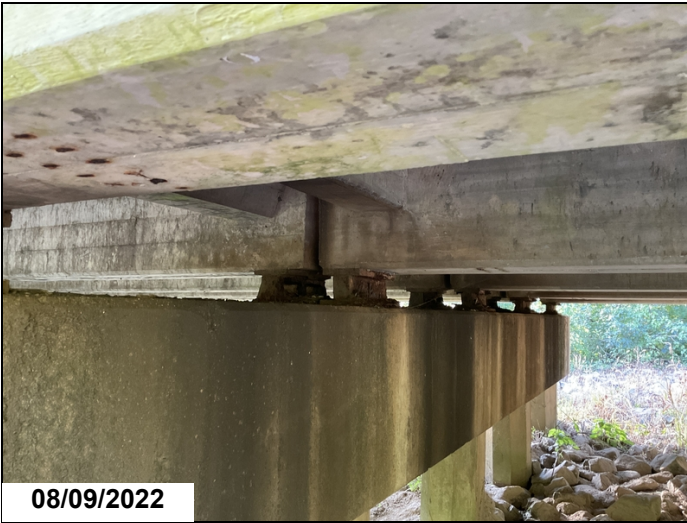
Bt. 2, masonry plates have layering rust, all bearings have corrosion.

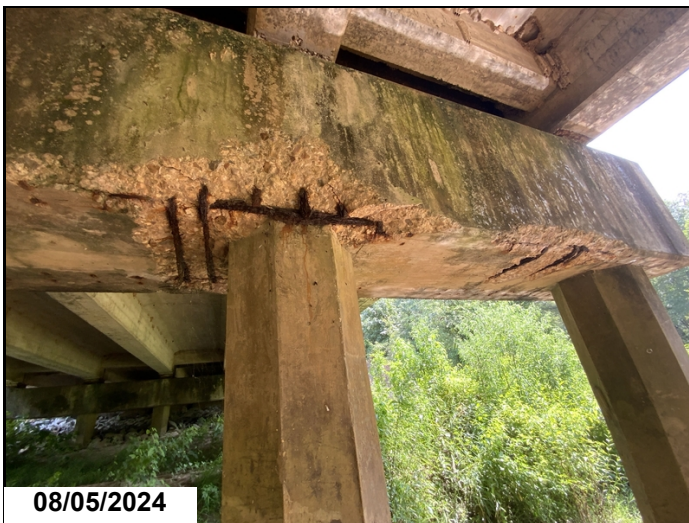
Bent 4 cap has 4' spall with exposed rebar. 07/26/2018 JPR -- There are 2 spalls on Bt. 4, 1 @ pile #4 and one between piles 4 & 5.

Bent 4 cap bottom exposed rebar

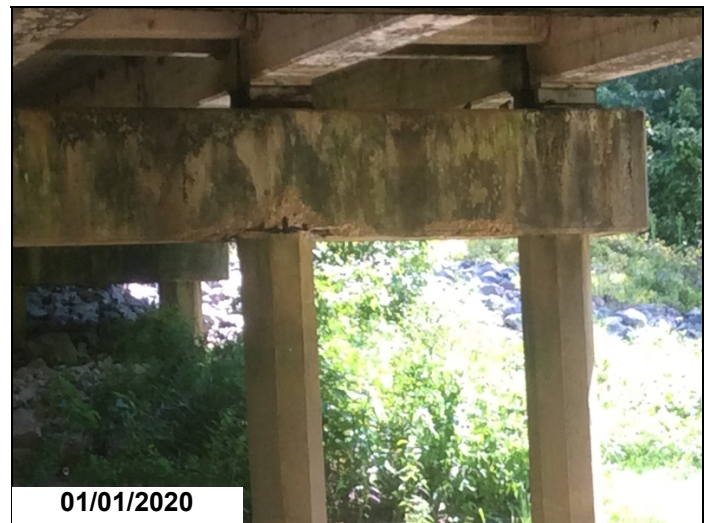
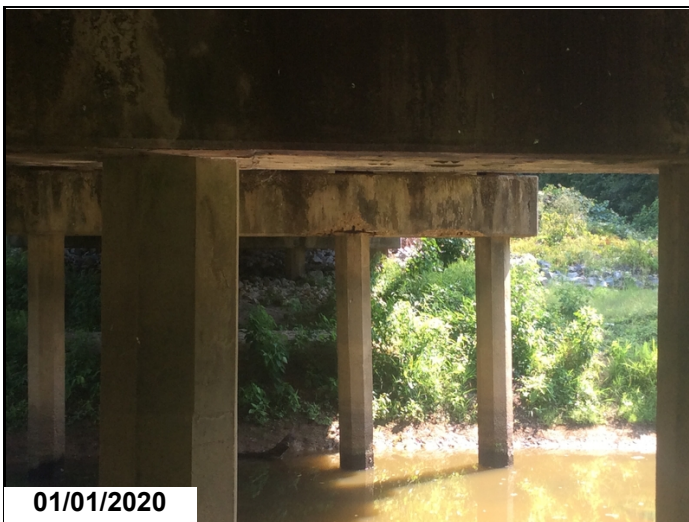
Bent 4 cap spalled

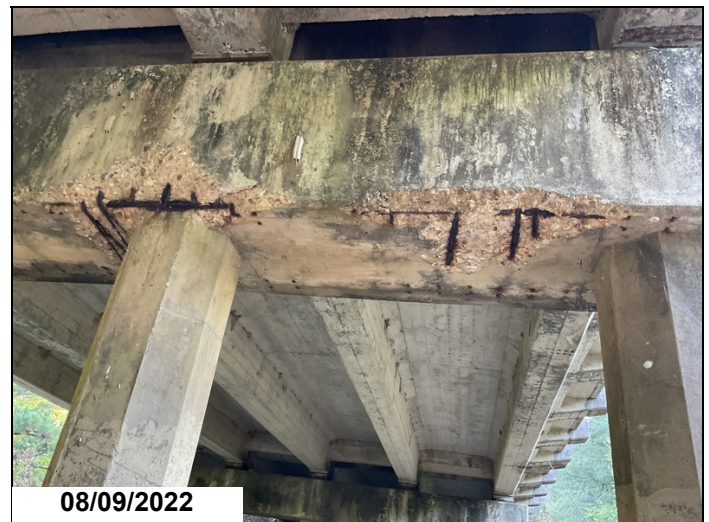
Bt. 4, back side of cap, @ pile 4 & 5, spall with exposed rebar.
