Bridge 02356 Inspection Report

Asset #02356(Routine)

US 79 S-3 LM 7.79 over CYPRESS CREEK

Team Lead: Rickie Bratton Inspection Date: 08/05/2024

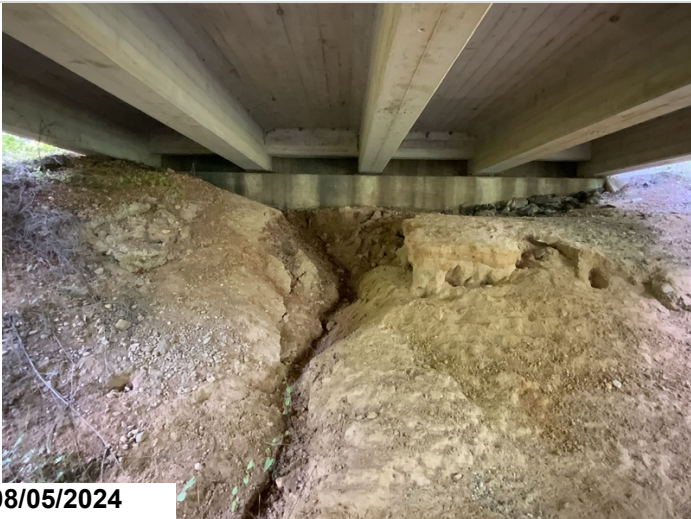
Abutment 1 slope erosion.

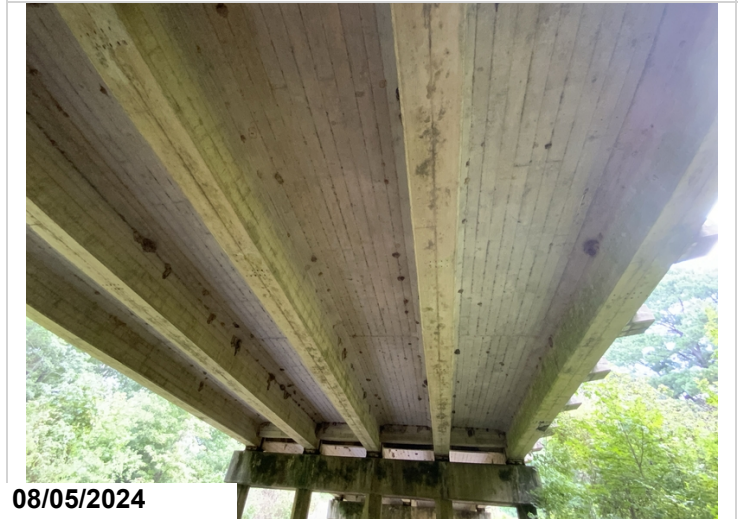
Span 2 bottom surface overview

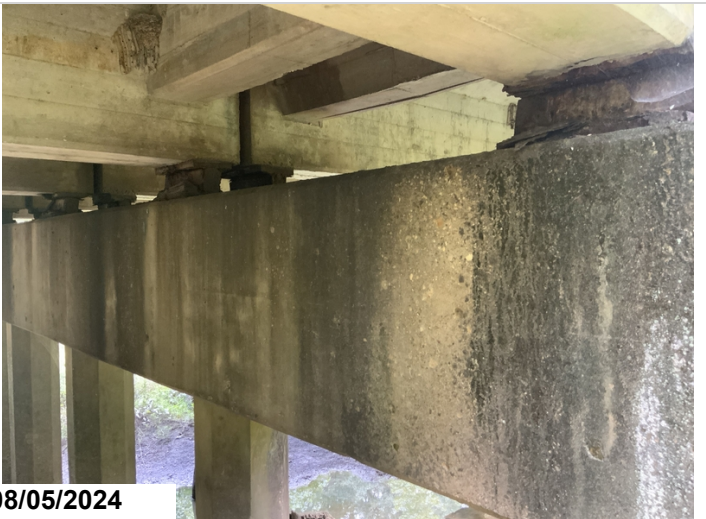
Satisfactory condition - Bearings have pack rust and are rocked forward.

(311) Rusty and rocked ahead and back							
313	Fixed Bearing	EA	20	0	20	0	0
1000	Corrosion	EA	20	0	20	0	0
(313) Rusty							
330	Metal Bridge Railing	LF	60	60	0	0	0
515	Steel Protective Coating	SF	120	120	0	0	0
331	Reinforced Concrete Bridge Railing	LF	276	274	2	0	0
7000	Damage	LF	2	0	2	0	0

Bent 2 bearings active corrosion common all bents

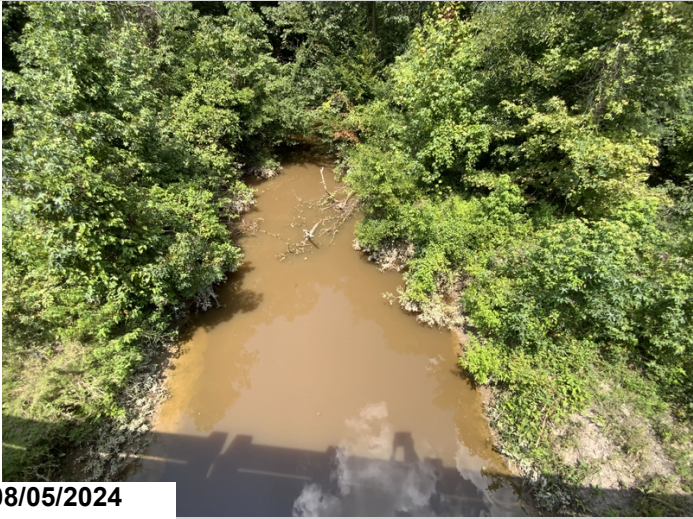
Channel upstream overview left side.

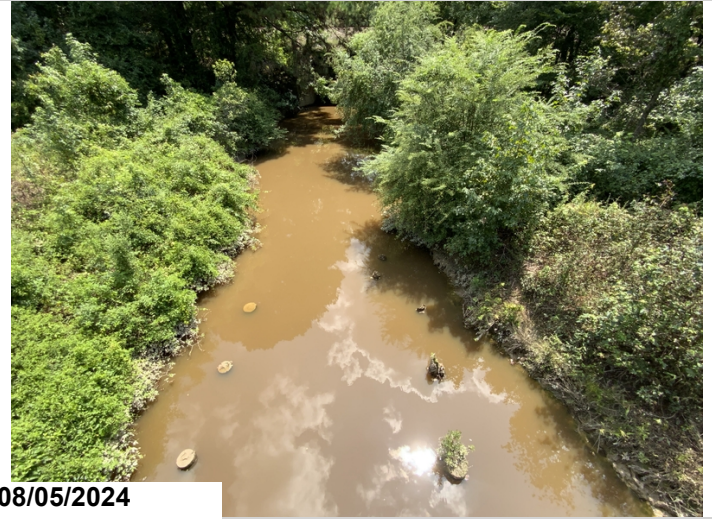
Channel downstream overview right side

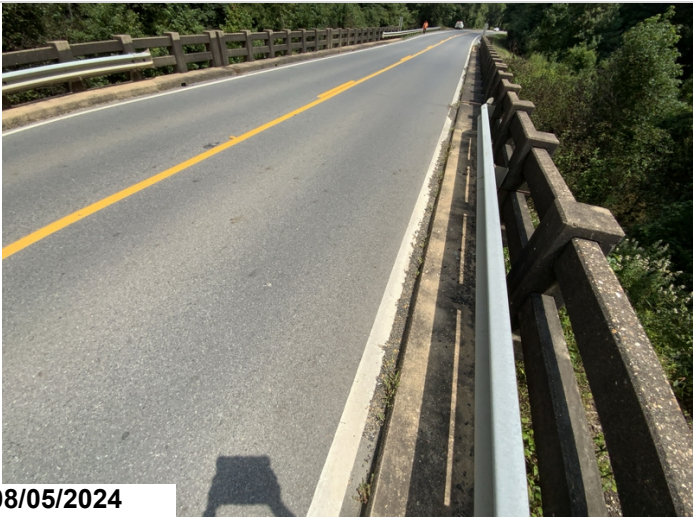
Good condition - Normal wear, overlay with cracks over the joints.

Deck overview

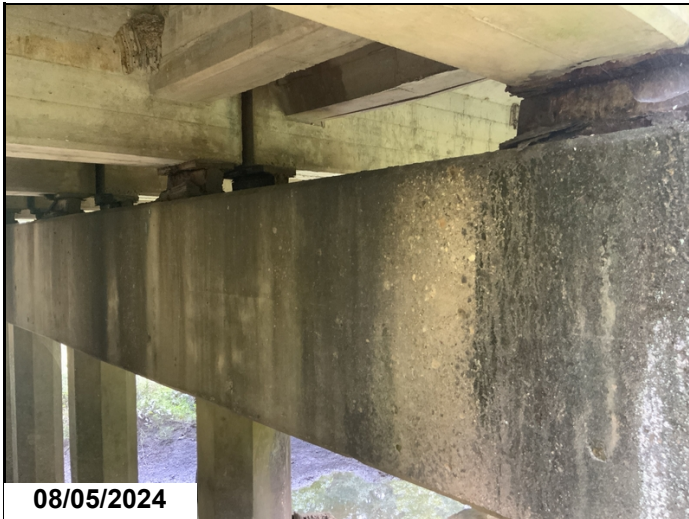
All bearings and masonry plates have paint failure and pack rust. All moveable bearings are rocked ahd. Bearings # 2, 3, & 4 masonry plates have heavy pack rust with some section loss, on all spans. Bearings # 1 & 5 have some rust with pitting & minor pack rust to masonry plates.

Bent 2 bearings active corrosion common all bents

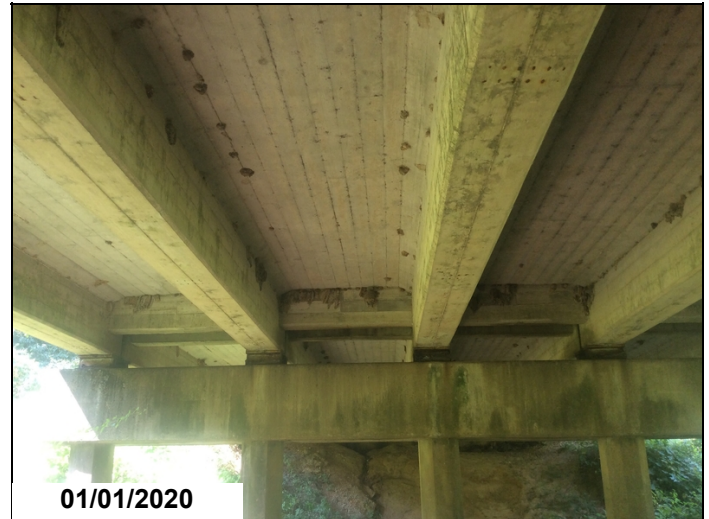
Bent 3, bearings and plates.

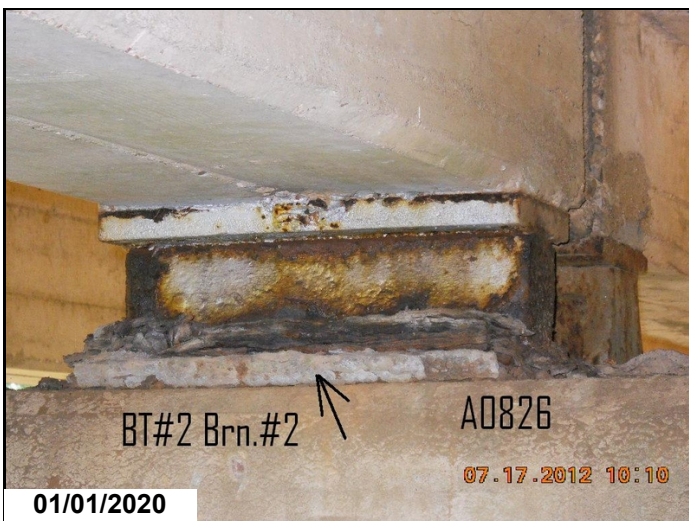
02356 BT 2 bearings and plates

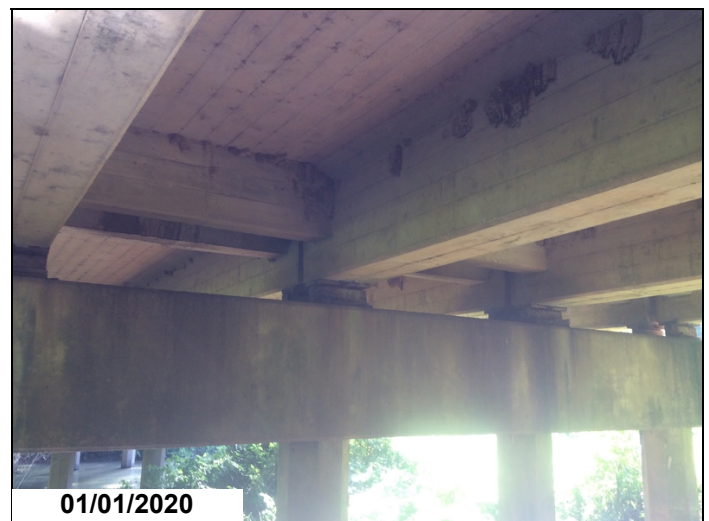
02356 BT 2 bearings and plates

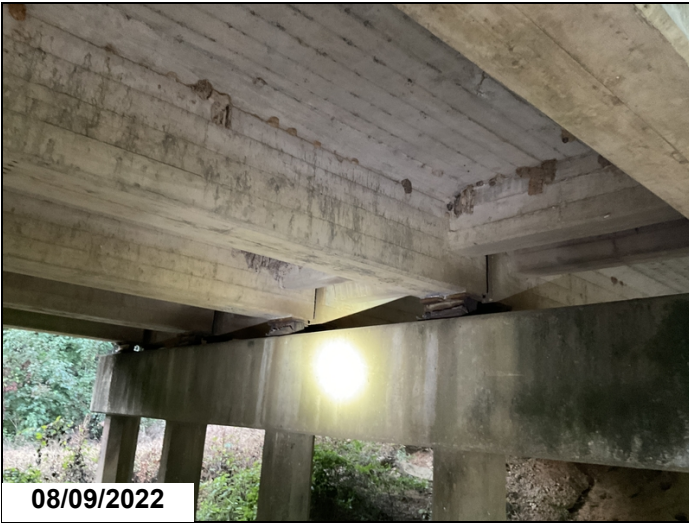
Bt. 2, bearing masonry plates have layering rust, all bearings have corrosion.

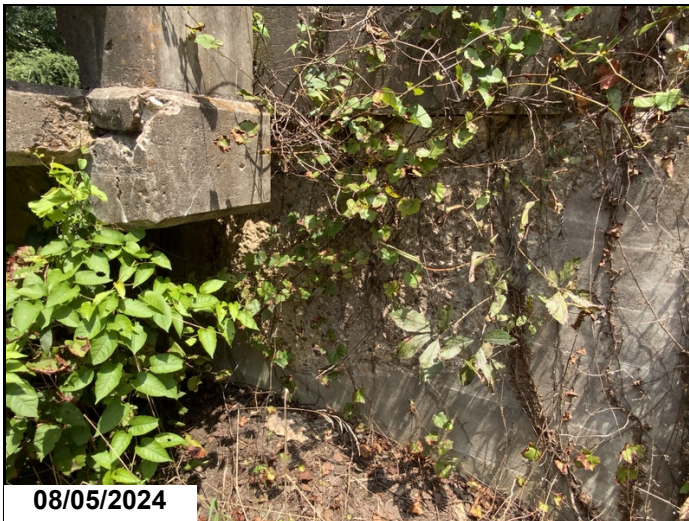
Bt. 5, the right end of the abutment has large spall with exposed rebar, from collision damage.

Abutment 2 right side large spall from impact damage.

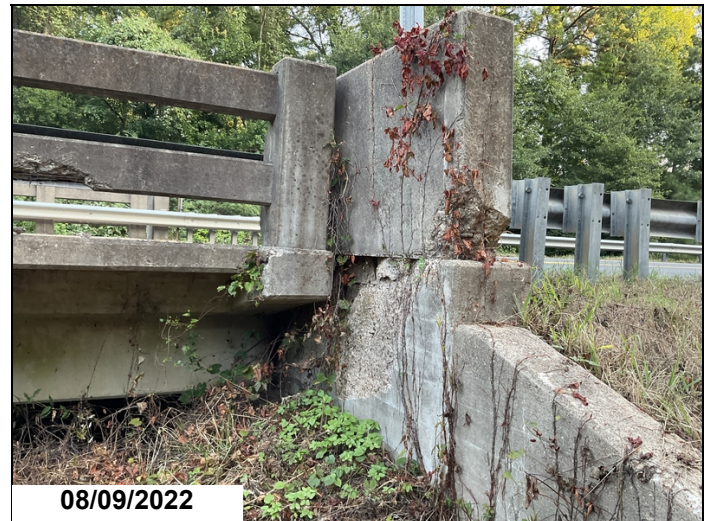
Bt. 5, right end of the abutment damage.
