## Bridge A0826 Inspection Report

**Asset #A0826**(Routine, Underwater type 2)

**US 79 S-3 LM .410 over GREEN LAKE**

**Team Lead: Rickie Bratton Inspection Date: 08/05/2024**

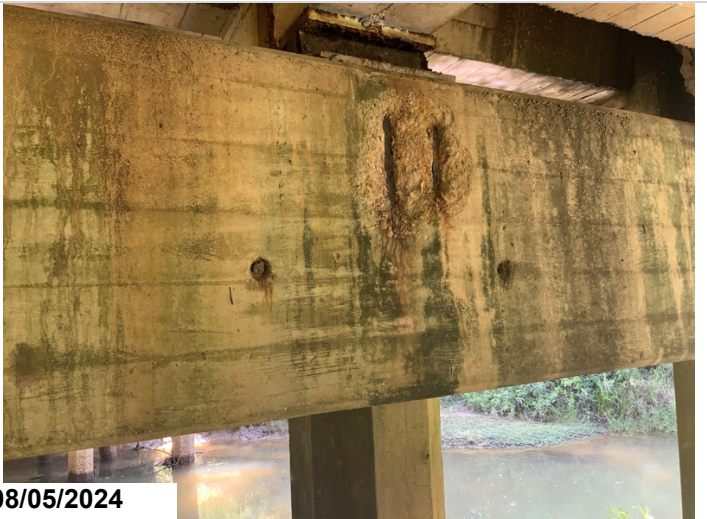
cap has spalls with exposed rebar.

Bent 3 cap back exposed rebar

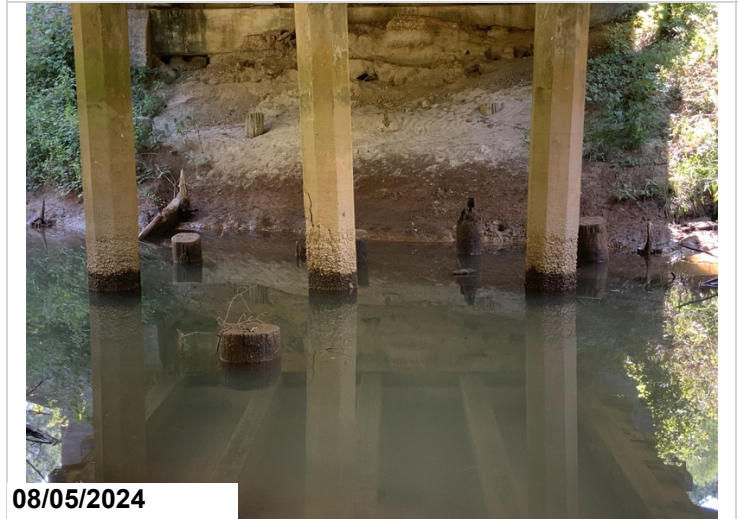
Piles with moderate abrasion with 1 delam.

Bent 3 pile 3 delam.

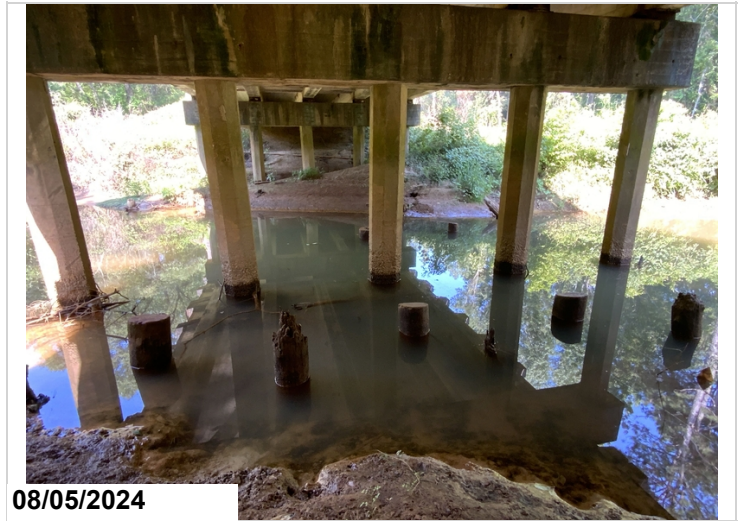
Bent 3 abrasion to piles.

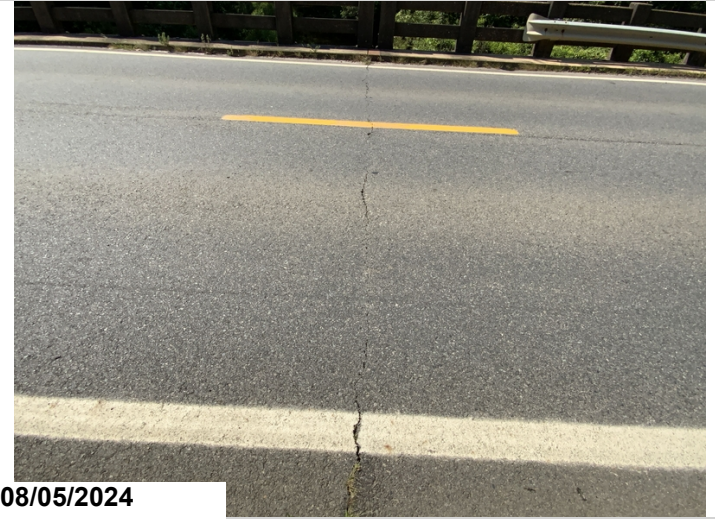
Normal wear on overlay, cracks over joints.

Cracks over joints in wearing surface

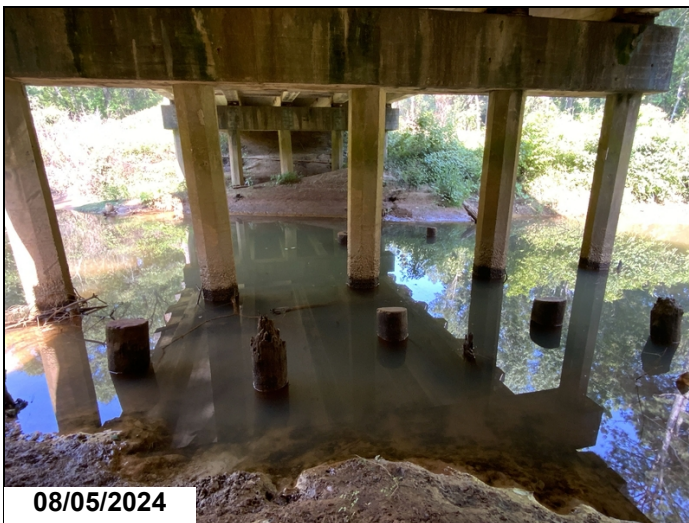
Bent 3 columns are pitted with some loss of section. Column 3 is the worst with large cracks. 07/26/2018 JPR -- this creek is in the oil fields and these piling have been exposed to salt water thus causing the deterioration at water line.

Bent 3 abrasion to piles.

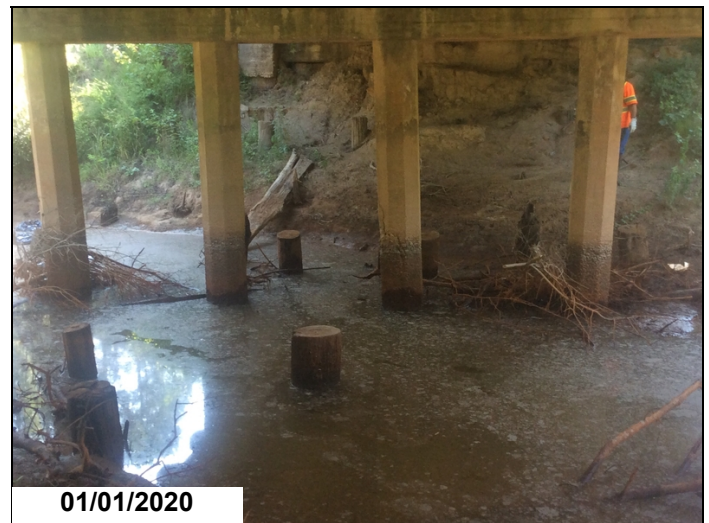
Bent 3 piles abrasion and wear pile 3 has a crack

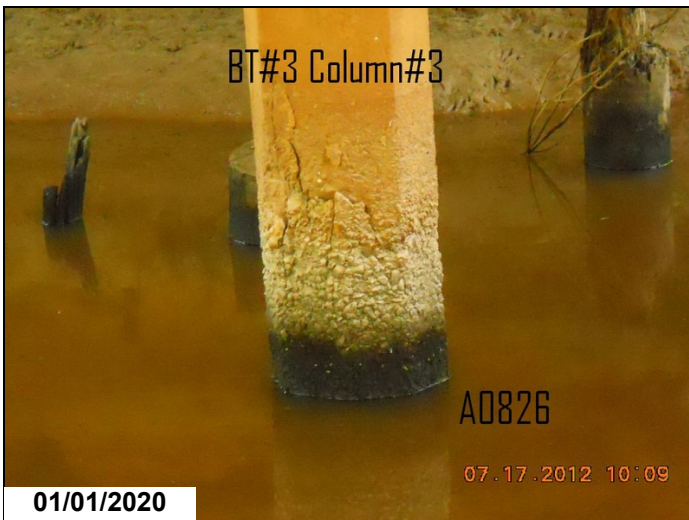
(227) Column 3 bt 3 has a large spall and several cracks. See picture. Other columns have moderate "pebbling" and loss of outer surface at and below high waterline. Bent 3 is the worst as it is the most exposed bent. 07/26/2018 JPR -- This creek is in oil fields and therefore have been exposed to high concentrations of salt water.							
234	Reinforced Concrete Pier Cap	LF	62	60	0	2	0
1090	Exposed Rebar	LF	2	0	0	2	0
305	Assembly Joint without Seal	LF	62	62	0	0	0
311	Movable Bearing	EA	15	0	0	15	0
1000	Corrosion	EA	15	0	0	15	0

Bent 3 column 3 has significant cracking and delamination @ waterline along with heavy abrasion and wear to the face of the pile.

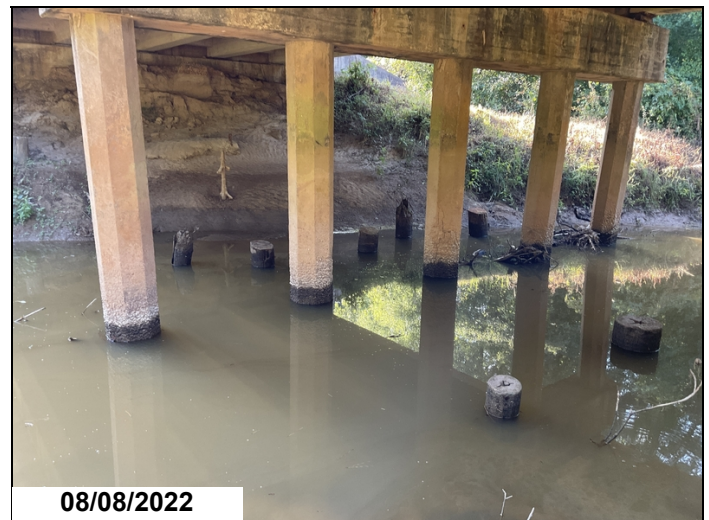
Bt. 3, looking ahead, abrasion to the piles & pile 3 has cracks & delams.

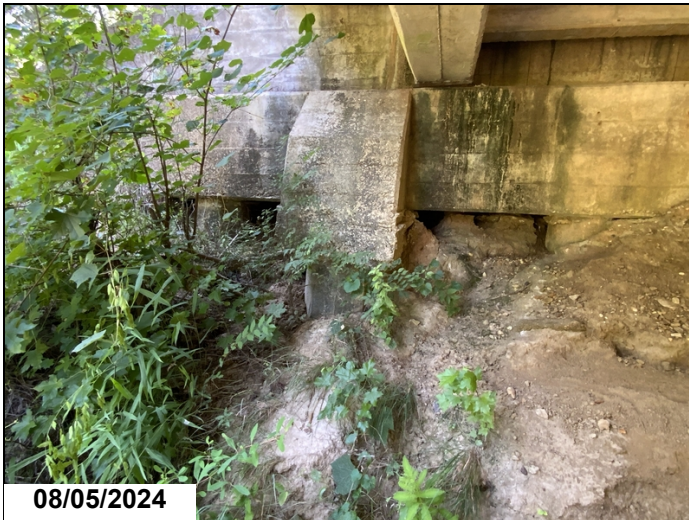
Bent 2 abutment left side scour

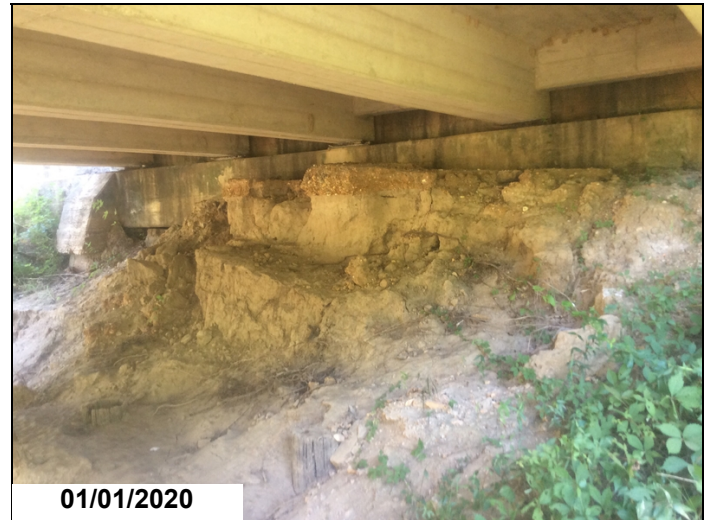
Abutment 2 Lt. side there is a large scour hole that goes back under the abutment cap from edge of wingwall & goes Rt. Just past girder 1. Abutment 2 slope has significant scouring & lateral stream migration towards abutment 2.

Abutment 2 slope has significant scouring & lateral stream migration.

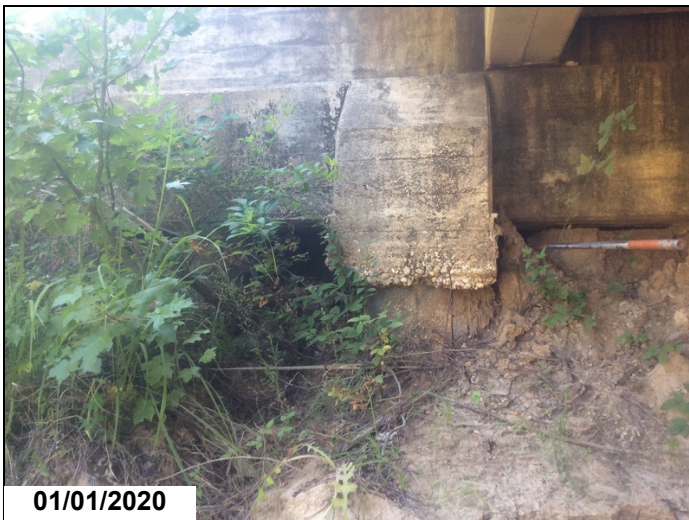
(215) Roadway settlement. 07/26/2018 JPR -- There is a new AC/inlay over the bridge at this time and there are no new signs visible now at BR ends, there is significant scouring of abutment 2 slope and under and below the bottom of the abutment 2 cap.							
227	Reinforced Concrete Pile	EA	12	2	5	5	0
1080	Delamination/Spall/Patched Area	EA	1	0	0	1	0
1190	Abrasion/Wear (PSC/RC)	EA	9	0	5	4	0

Abutment 2 Lt. side there is a large scour hole that goes back under the abutment cap from edge of wingwall & goes Rt. Just past girder 1.

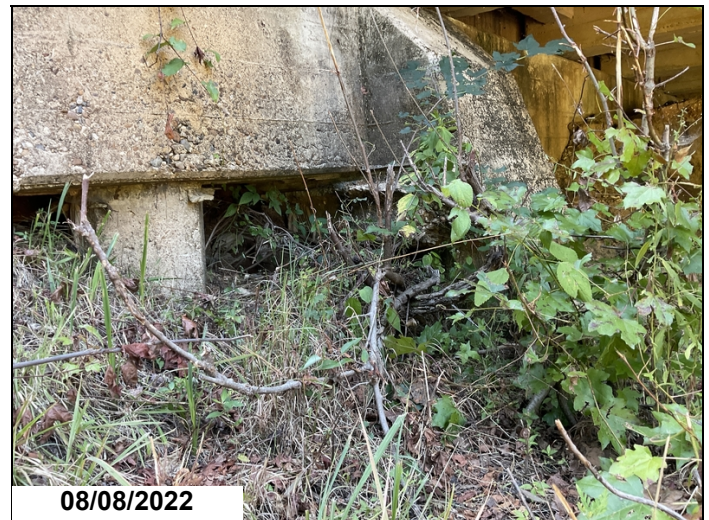
Bt. 4, left side of the abutment, erosion below the cap of the abutment.

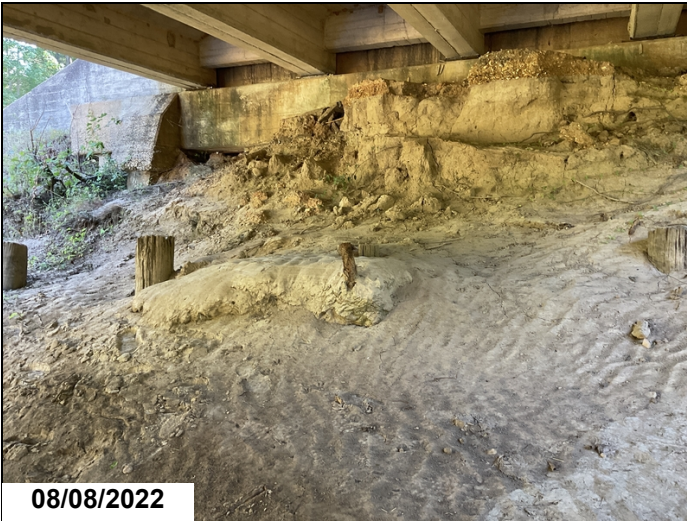
Bt. 4, abutment, scour action from the stream is removing the embankment.

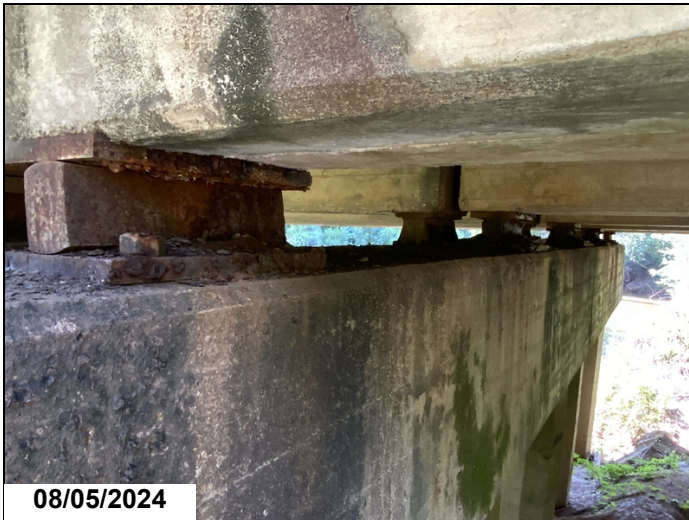
All bearings and pads have paint failure and moderate pack rust with section loss to masonry plates, all movable bearing are rocked ahead.

Active corrosion with some pack rust to bearings and pads all bents.

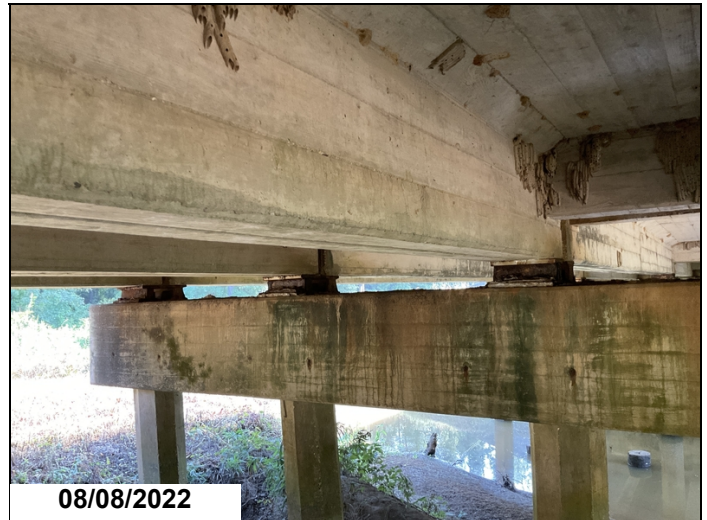
Masonry plates and rockers have severe corrosion.
