Bridge M1451 Inspection Report

Asset #M1451(Routine)

US 79 S-3 LM 3.18 over DESARC BAYOU RELIEF

Team Lead: John Parks Inspection Date: 07/10/2025

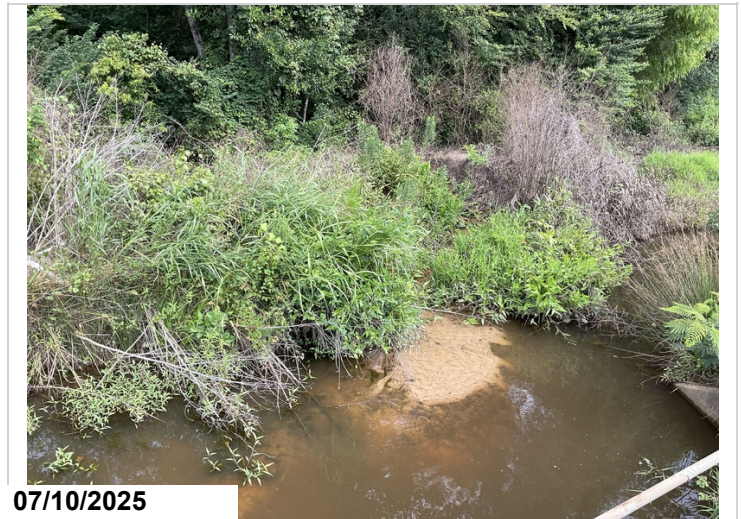
61 - Channel/Channel Protection (6 - Bank is beginning to slump. River control devices and embankment protection have widespread minor damage. There is minor stream bed movement evident. Debris is restricting the channel slightly.) Channel is rated 6 due to pipes across stream causing sediment to build up in the culvert.

Channel left side upstream

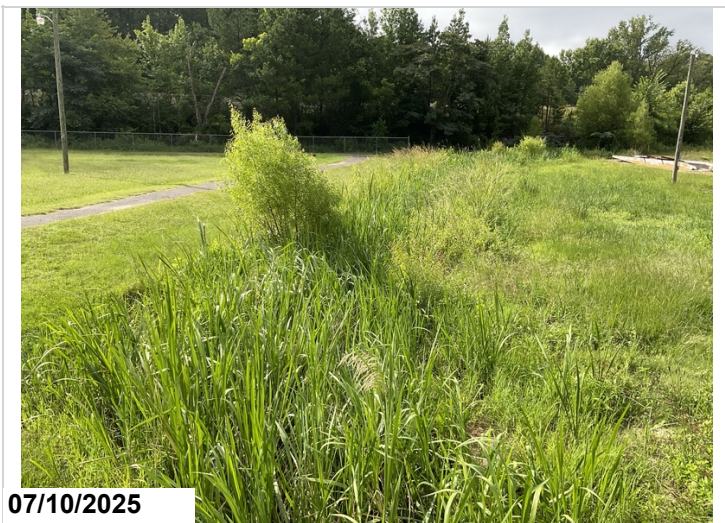
Channel right side downstream

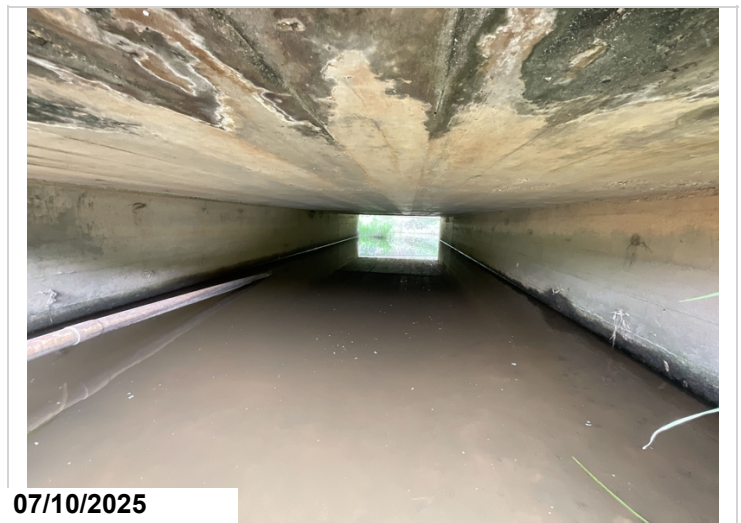
62 - Culverts (7 - Shrinkage cracks, light scaling and insignificant spalling which does not expose reinforcing steel. Insignificant damage caused by drift with no misalignment and not requiring corrective action. Some minor scouring has occurred near curtain walls, wingwalls or pipes. Metal culverts have a smooth symmetrical curvature with superficial corrosion and no pitting.) Culvert rated 7 due to being in good condition with minor abrasion.

Typical culvert

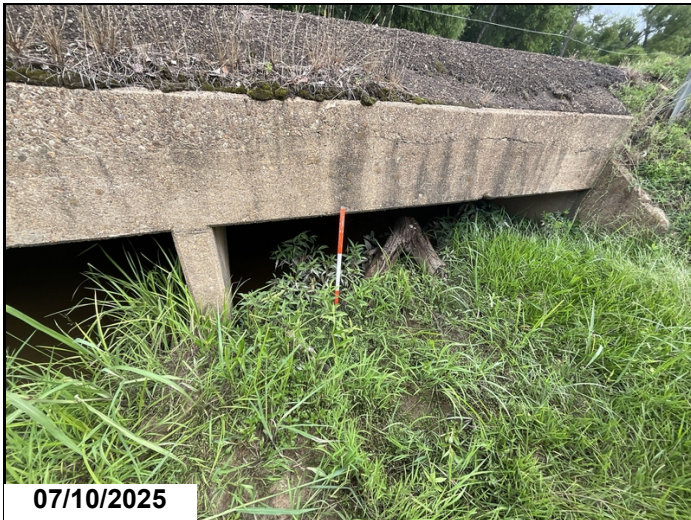
Barrel 2, upto 2' of sediment built up.

07/10/2025
Barrel 2, sediment built up to 1'-6" deep in the bottom of the culvert.

Type of Work: Channel Work/Drift Removal
