Bridge 05724 Inspection Report

Asset #05724(Routine, Underwater type 2)

SH 160 S-9 over SNAKE CREEK

Team Lead: John Parks Inspection Date: 10/15/2024

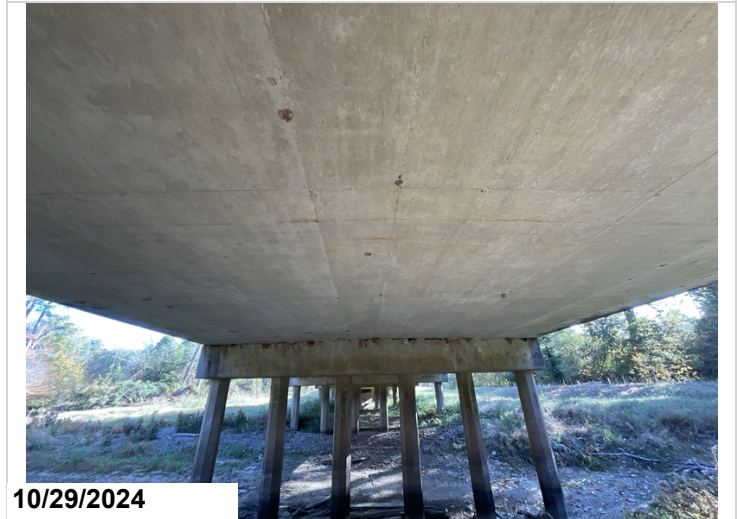
The superstructure is rated 6 due to the under surface of the slab having scattered spalls and spalls with exposed rebar. The edges of the slabs vertical cracks and minor spalls above the edges of the caps.

Typical view of the slab under surface.

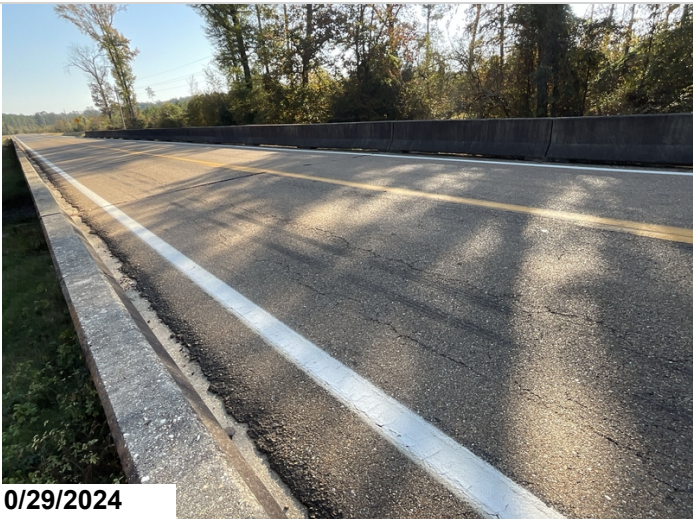
Deck is rated 7 due to the top surface of the slab being in good condition with no defects reflecting through the asphalt wearing surface. The asphalt wearing surface has minor cracking.

Typical view of the slab top surface.

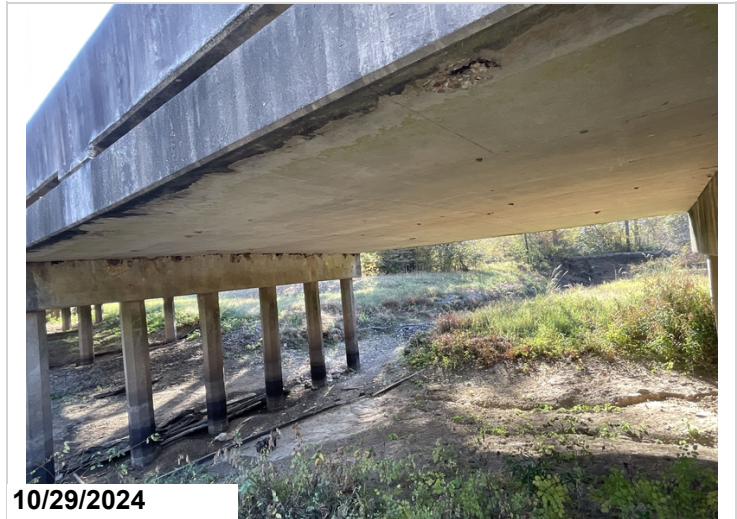
Typical superstructure

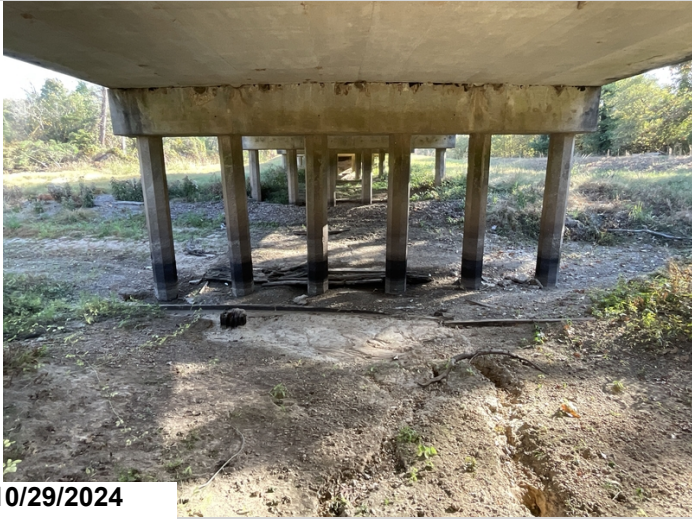
Typical substructure

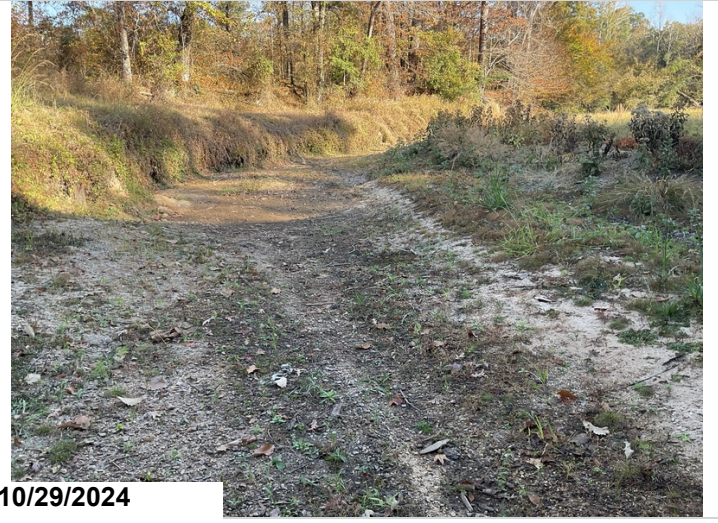
The channel is rated 6 due to the banks slumping and debris in the creek.

Channel left side upstream

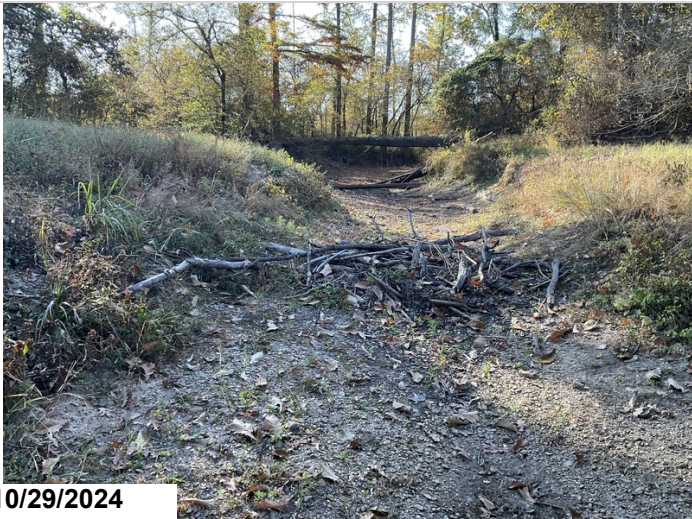
Channel right side downstream

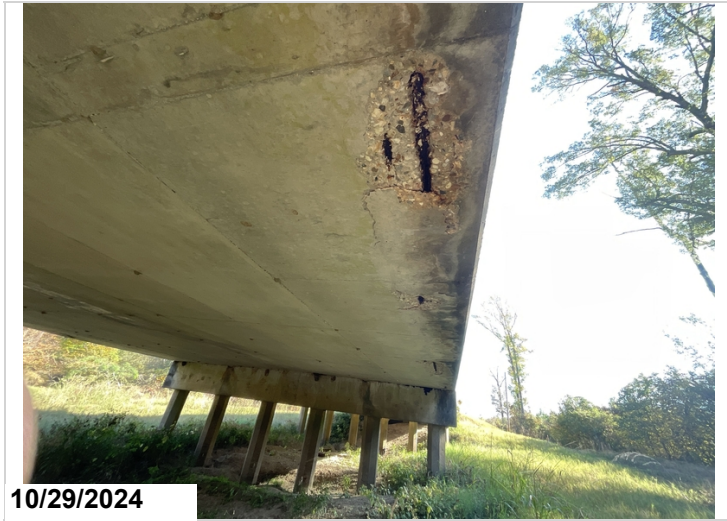
Span 5: Top surface, no defects reflecting through asphalt wearing surface. Under surface, left side, 1SF spall CS3, 10SF spall CS2. Right side, 10SF spall CS3. Left edge, at Bent 5 and Bent 6, vertical cracks. 2SF cracking CS2. Right edge, at Bent 5 and Bent 6, vertical cracks. 2SF cracking CS2.							
Span 6: Top surface, no defects reflecting through asphalt wearing surface. Under surface, right side, 3SF spall CS3, 4SF spall CS2. Left edge, at Bent 6 and Bent 7, vertical cracks. 2SF cracking CS2. Right edge, at Bent 6 and Bent 7, vertical cracks. 2SF cracking CS2.							
Span 7: Top surface, no defects reflecting through asphalt wearing surface. Under surface, left and right side have minor spalls. 3SF spall CS2. Left edge, at Bent 6 and Bent 7, vertical cracks. 2SF cracking CS2. Center, 1SF spall CS2. Right edge, at Bent 6 and Bent 7, vertical cracks. 2SF cracking CS2.							
Span 8:

Span 5 under surface, right side, 12SF spall CS3.

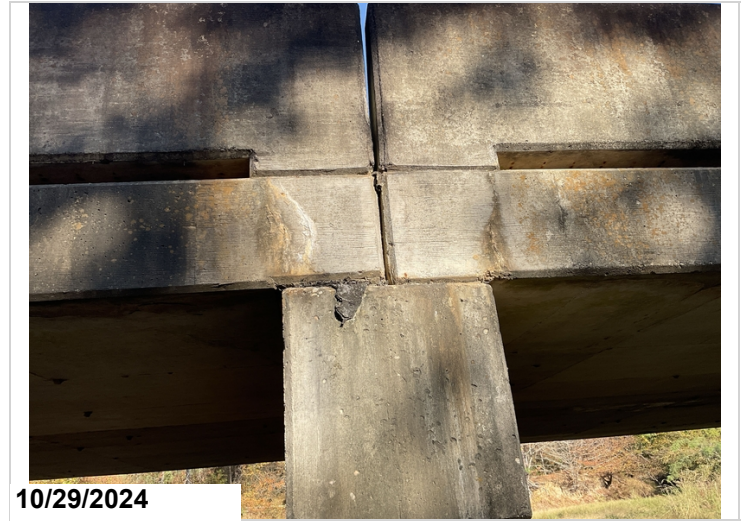
Span 4 & 5, right edge, at Bent 5. 1SF cracking CS2.

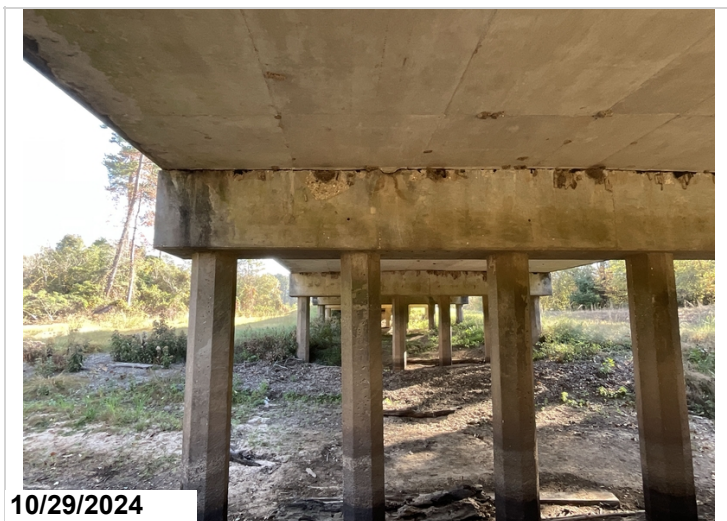
234	Reinforced Concrete Pier Cap	LF	202	163	37	2	0
1080	Delamination/Spall/Patched Area	LF	38	0	36	2	0
1120	Efflorescence/Rust Staining	LF	1	0	1	0	0
	(234) Bent 2: Back side at keyway 2LF spall CS2. Ahead left corner, 1LF efflorescence CS2. Bent 3: Backside, scattered along the top edge, 12LF spall CS2. Bent 4: Backside, scattered along the top edge, 7LF spall CS2. Above Pile 2, 2LF spall CS3

Bent 4, cap, back side above Pile 2, 2LF spall CS3

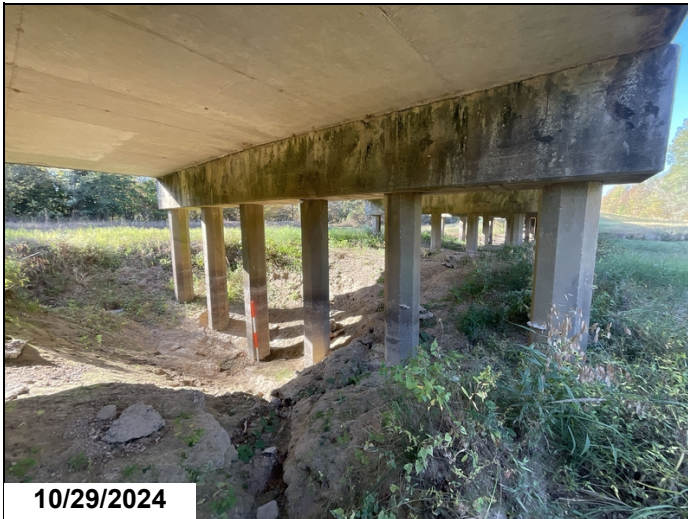
The scour condition is rated 6 due to embankment at the abutments having erosion and local scour that is 4' deep at Bent 7.

Embankment below Spans 1 and 2 have reel erosion.
Bent 7, local scour at Piles 3 - 6. Scour hole is 20' in diameter and 4' deep.
There is no riprap protecting the embankment at this bridge.

Bent 7, piles 3 - 6 have local scour 4' deep.

Type of Work: Channel Work/Drift Removal

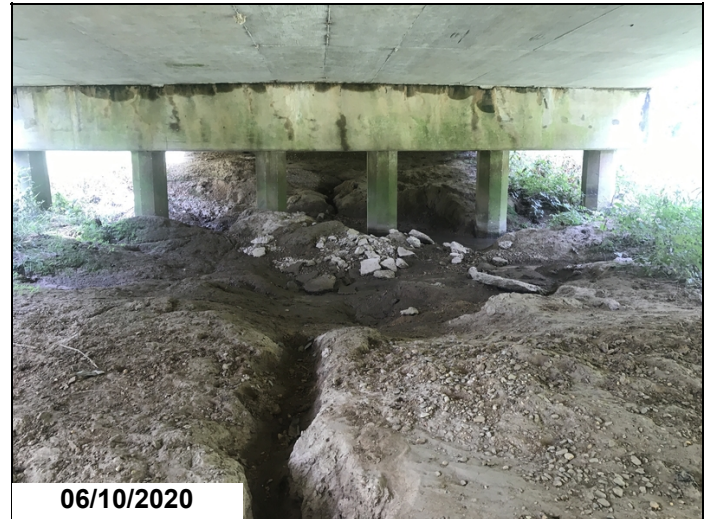
Bent 2 has minor erosion.
