Bridge 07475 Inspection Report

Asset #07475(Routine)
Ar Hwy 160 over Halfway Creek
Location: 9.9 MI E HERMITAGE

Team Lead: Rickie Bratton Inspection Date: 04/09/2025

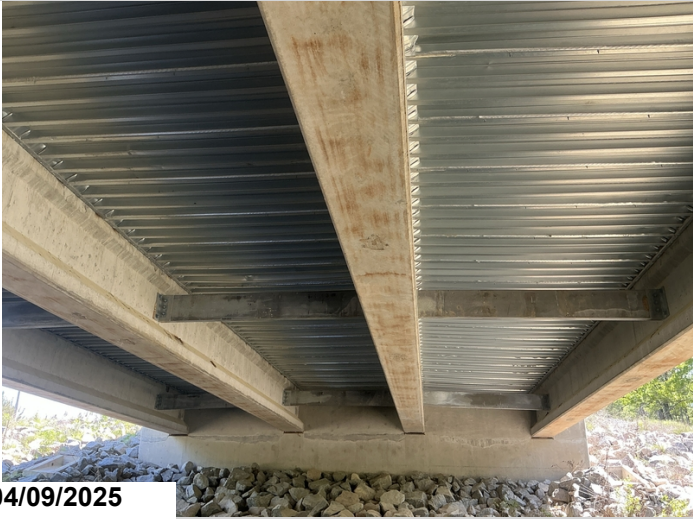
- LT overhang efflorescence 2' CS2

- RT overhang efflorescence 1' CS2

Span 3 under surface overview

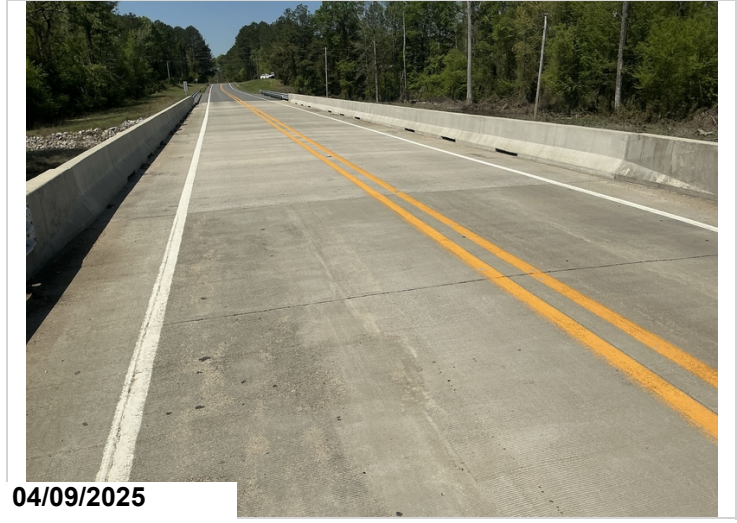
Overall, the deck is in good condition, scattered hairline cracks, with efflorescence on the undersurface.

Deck has scattered hairline transverse and longitudinal cracks 80' CS2

Deck overview

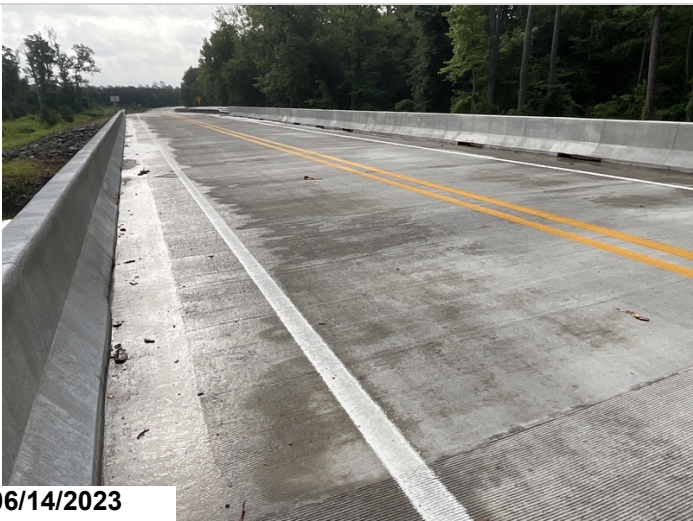
Deck overview

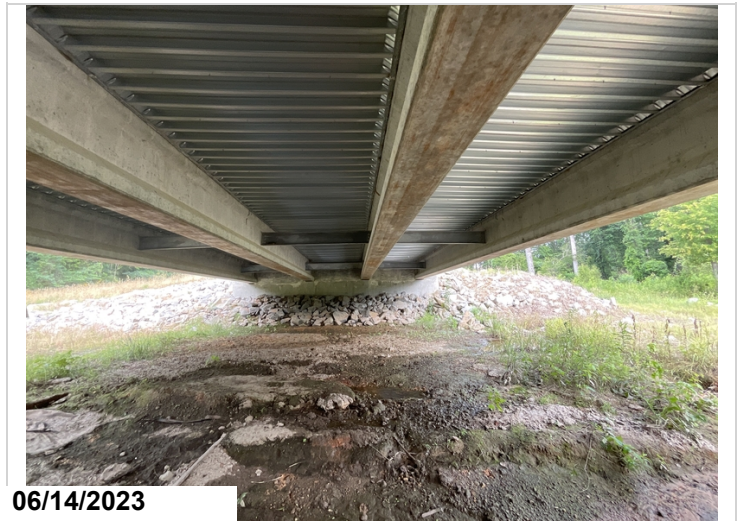
Deck Underview

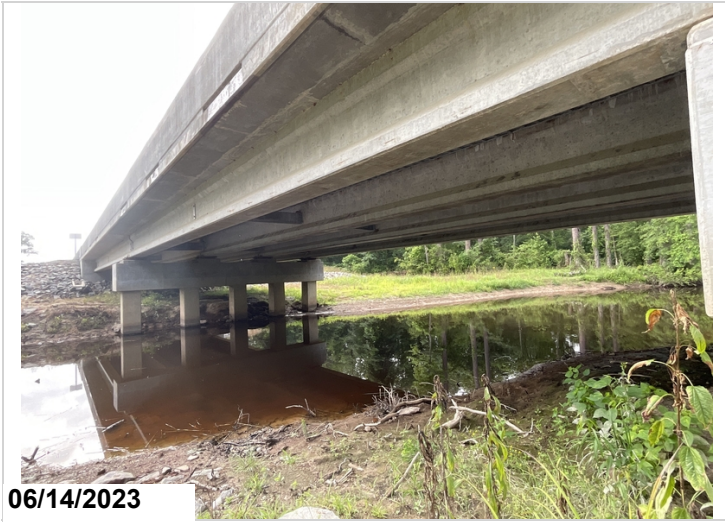
Overall, the superstructure is in very good condition. No problems noted.

Typical superstructure

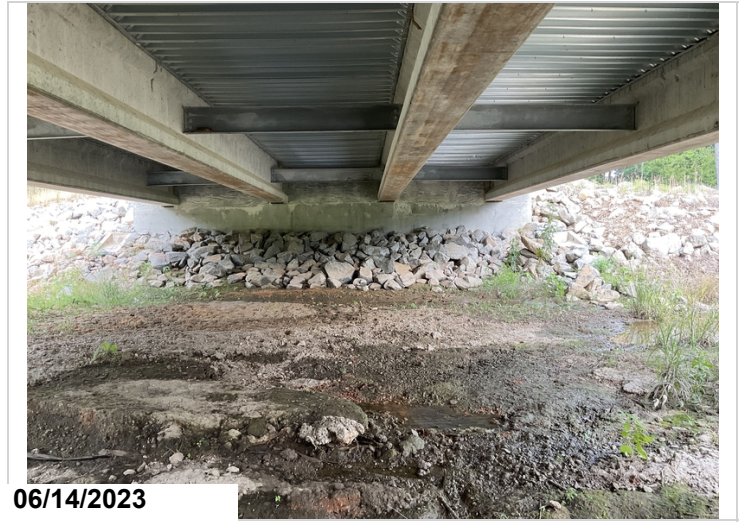
Overall, the substructure is in very good condition. No problems noted.

Typical substructure

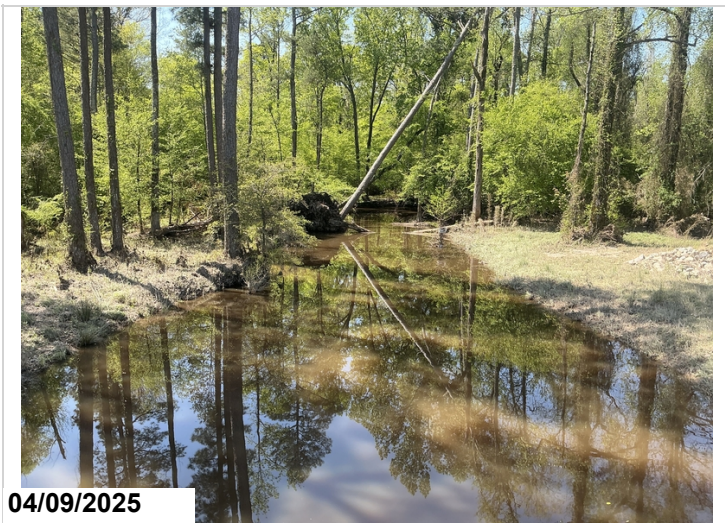
Channel has some gravel in the bottom and banks are vegetated.

Downstream channel overview right side

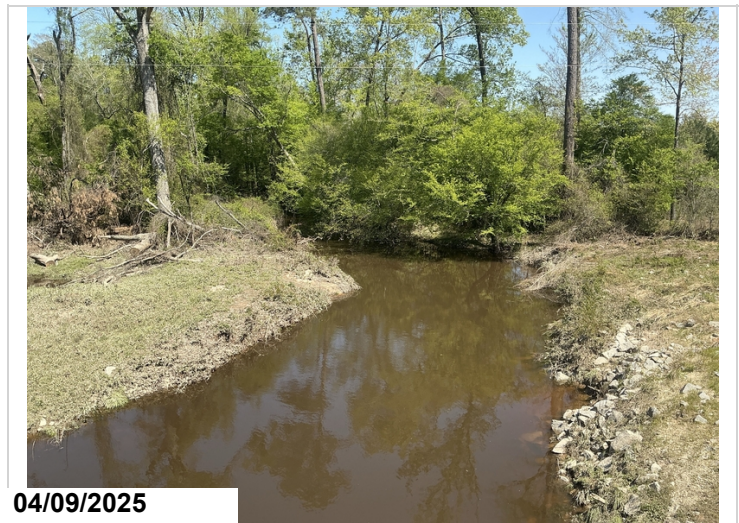
Upstream channel overview left side

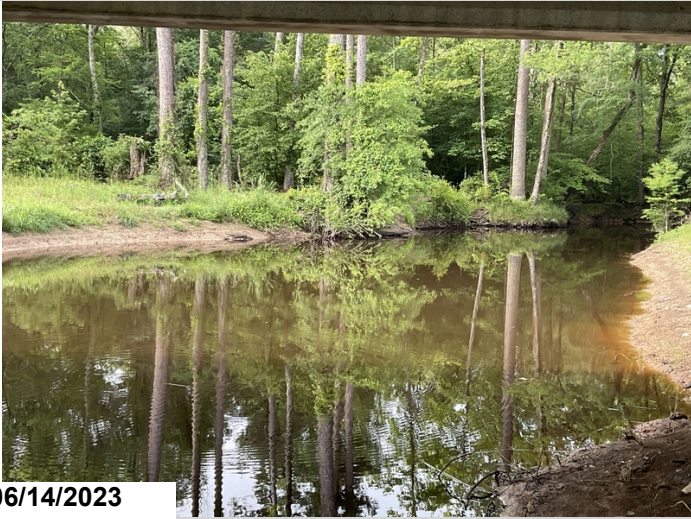
Channel has little to no scour visible.

Channel right side

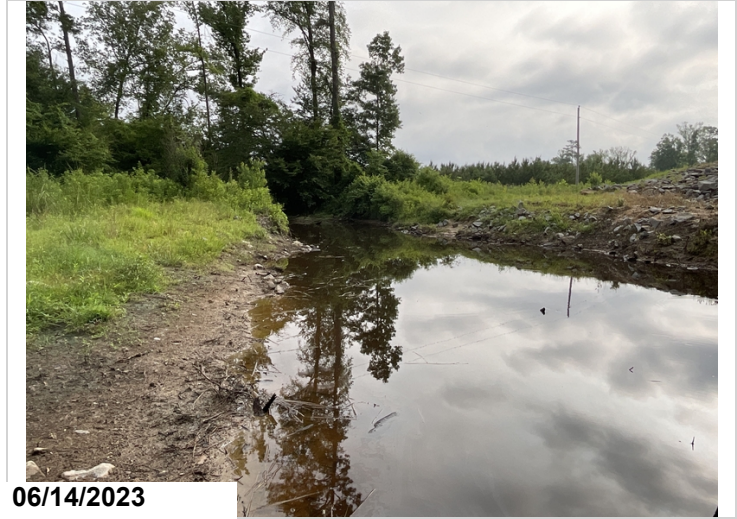
Channel left side

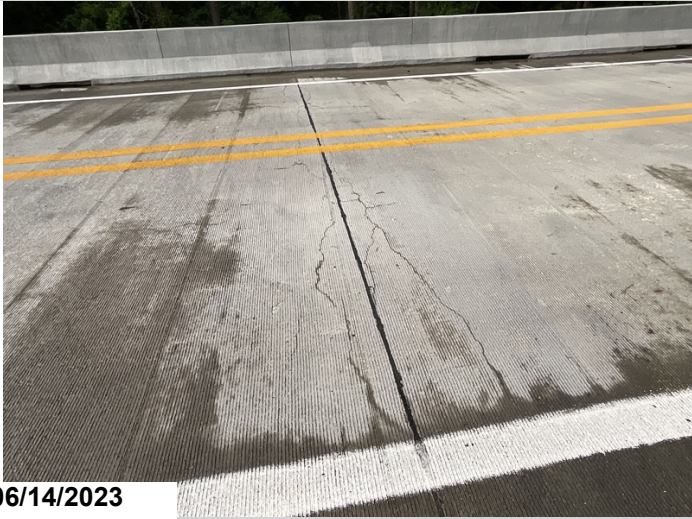
(12) All spans have transverse cracking up to 0.015", these cracks are 1' either side of Bent 2 & 3 joints. (1120-12) Under surface Span 1 - RT overhang efflorescence 4' CS2 - LT overhang efflorescence 4' CS2 Span 2 -LT overhang efflorescence 6' CS2 - RT overhang NONE Span 3 - LT overhang efflorescence 2' CS2 - RT overhang efflorescence 1' CS2							
109	Prestressed Concrete Open Girder/Beam	LF	658	658	0	0	0
215	Reinforced Concrete Abutment	LF	86	86	0	0	0
226	Prestressed concrete piles	EA	10	10	0	0	0
234	Reinforced Concrete Pier Cap	LF	62	62	0	0	0
301	Pourable Joint Seal	LF	133	133	0	0	0
310	Elastomeric Bearing	EA	16	16	0	0	0
321	Reinforced Concrete Approach Slab	SF	1320	1296	24	0	0
1130	Cracking (RC and Other)	SF	24	0	24	0	0

Deck cracks at bent 3 joint

A-54 - Sealable Deck Cracks (Yes)

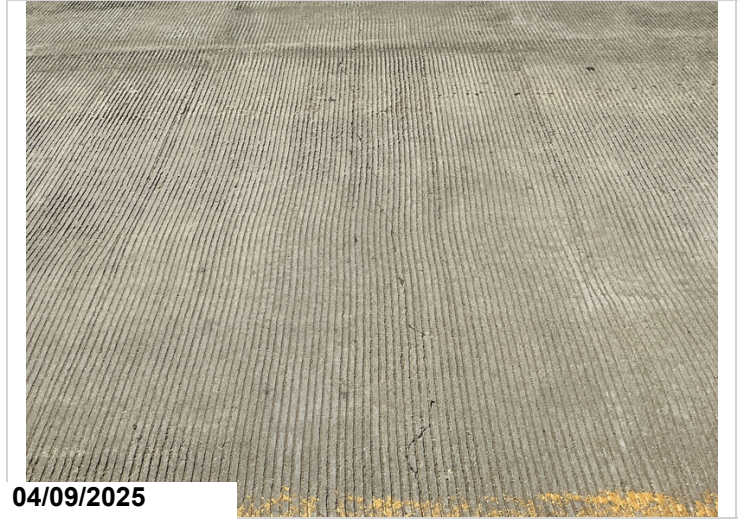
East Approach slab cracking 24' CS2

(321) Bent 1 Approach Slab -Transverse cracks. (1130-321) East Approach slab cracking 24' CS2							
331	Reinforced Concrete Bridge Railing	LF	329	329	0	0	0

East approach slab cracking 24' CS2
