Bridge M2114 Inspection Report

Asset #M2114(Routine, Underwater type 2)

SH 160 / S-9 over GRASSY POND CREEK

Team Lead: John Parks Inspection Date: 09/30/2024

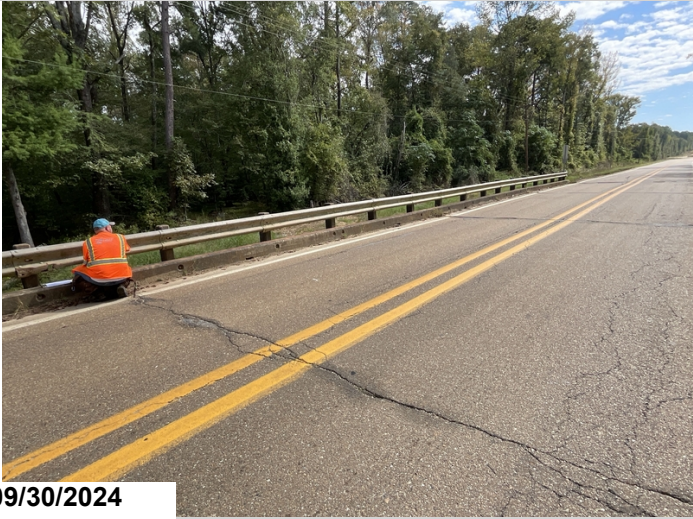
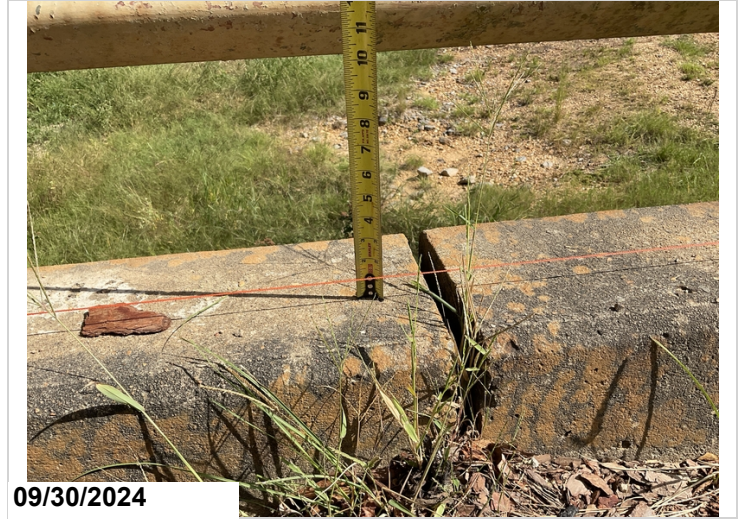
Substructure is rated 5 due to Bent 3 cap has dropped previously causing the cap to crack. Supplemental bents are in place to support Spans 2 and 3 at Bent 3. Other caps have minor cracks and spalls. Most of the timber piles have been repaired by concrete splice collars.

Bent 3 left side, previously cap has dropped causing 1 1/4" sag in curb.

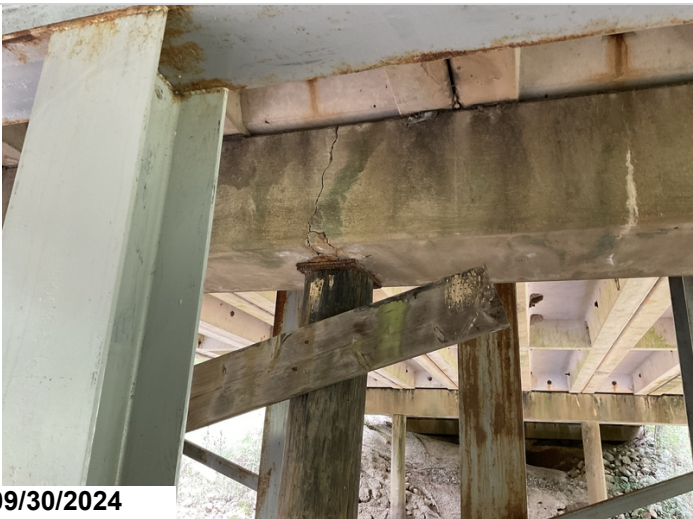
(234) Bent 2: Back side, above Pile, 2LF efflorescence CS2.							
Bent 3: Center, all the way around, 1/8" crack. 1LF crack CS3. Ahead side, 3' left of center and above Pile 4. 2LF efflorescence CS2. Under surface, scattered spalls. 10LF spalls CS2.							
Bent 4: Under surface, from Pile 2 through Pile 4. 4LF spall CS3, 2LF cracking CS2.							
330	Metal Bridge Railing	LF	248	0	248	0	0
1000	Corrosion	LF	248	0	248	0	0
515	Steel Protective Coating	SF	496	0	0	496	0
3440	Effectiveness (Steel Protective Coatings)	SF	496	0	0	496	0

Bent 3 cap cracked over pile 3

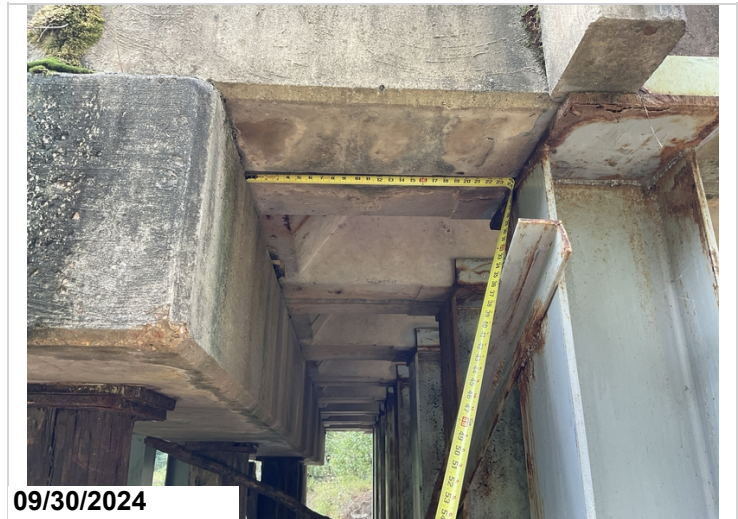
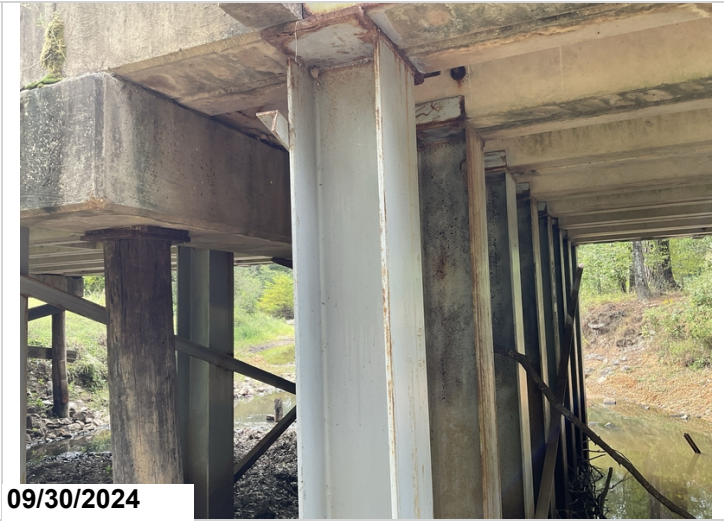
(202) Span 2 supplemental bent:							
Column 1, 1Each corrosion CS2.							
Column 2, 1Each corrosion CS2.							
Column 3, 1Each corrosion CS2.							
Column 4, 1Each corrosion CS2.							
Column 5, 1Each corrosion CS2.							
Column 6, 1Each corrosion CS2.							
Column 7, 1Each corrosion CS2.							
Column 8, 1Each corrosion CS2.							
Span 3 supplemental bent:

Span 2, supplemental Bent, 2' 0" back of Bent 3. Steel columns with steel saddles under the channel unit legs.

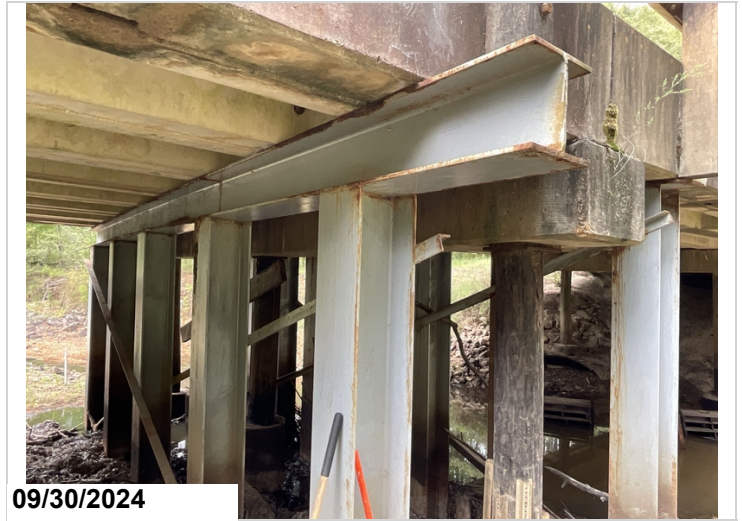
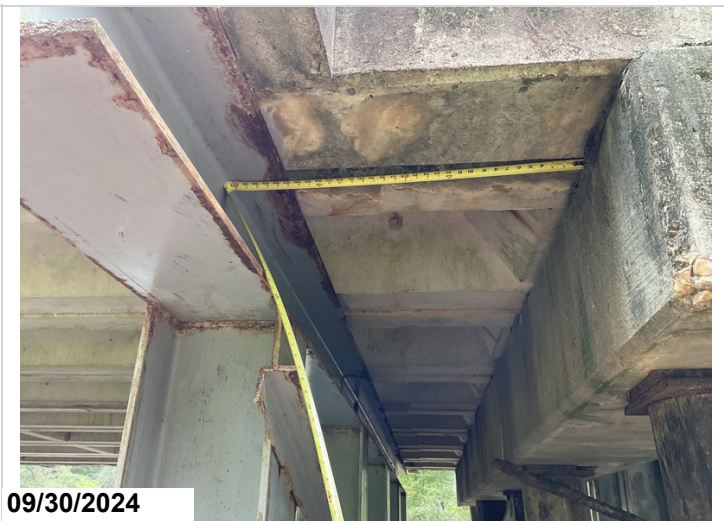
(231) Span 3 supplemental bent: Entire length corrosion. 29LF corrosion CS2.

Span 3, supplemental Bent, 2' 3" ahead of Bent 3. Steel columns and steel cap.

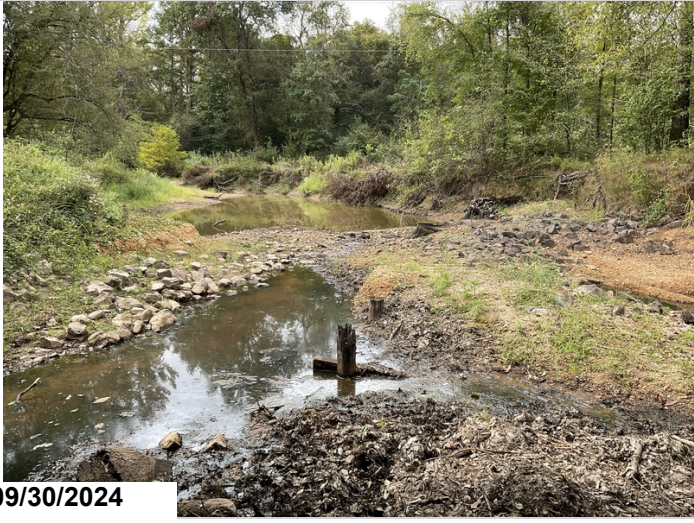
Channel is rated 6 due to banks are slumping and debris in the stream.

Channel right side downstream

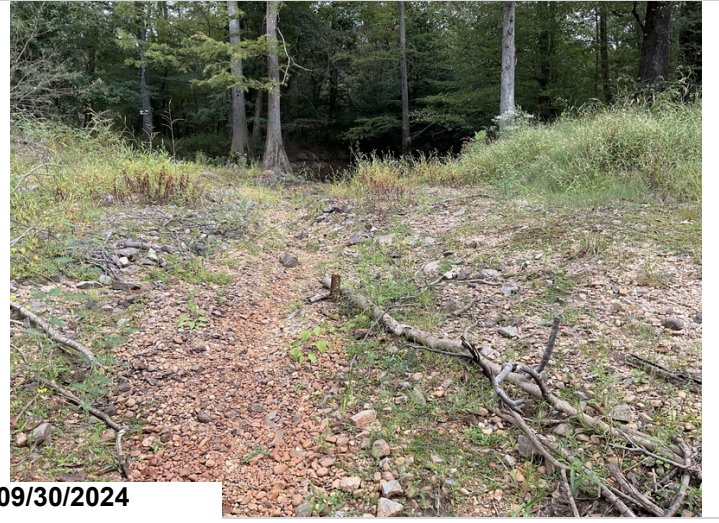
Channel left side upstream

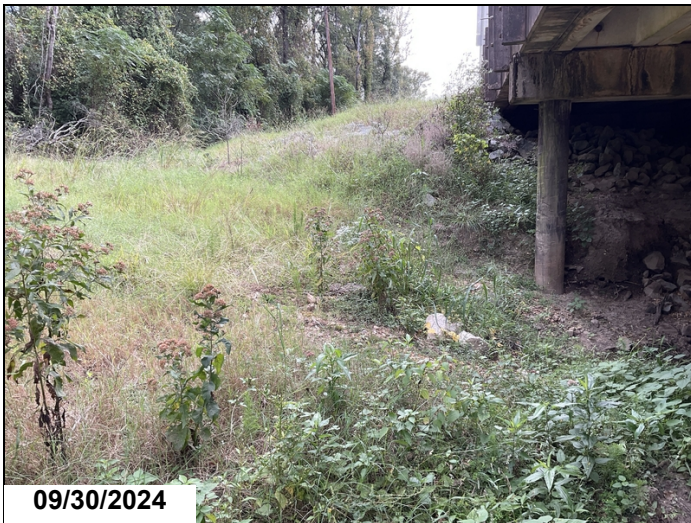
Right side of spans 3 and 4 has active scour

Bent 4 and 5, scour repairs have been made.

Bent 4 and 5, scour repairs have been made.

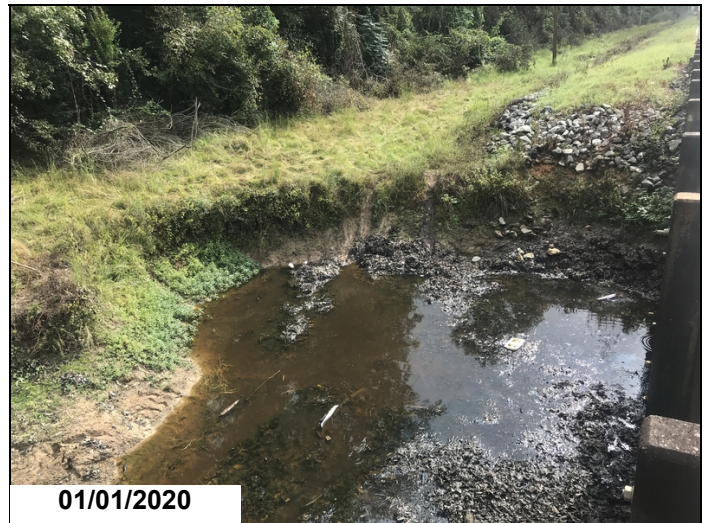
Left side spans 3 and 4, erosion to slope and ditch line.

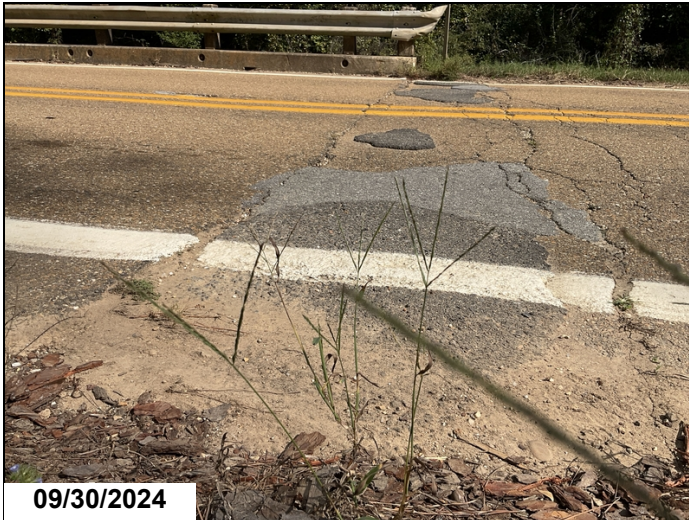
10' of the center, embankment has been eroded 1' below the stub. 10LF scour CS2. Road way is settling due to erosion of embankment below the abutment stub.

Bent 5 end, road way is settling due to erosion of embankment below the abutment stub.

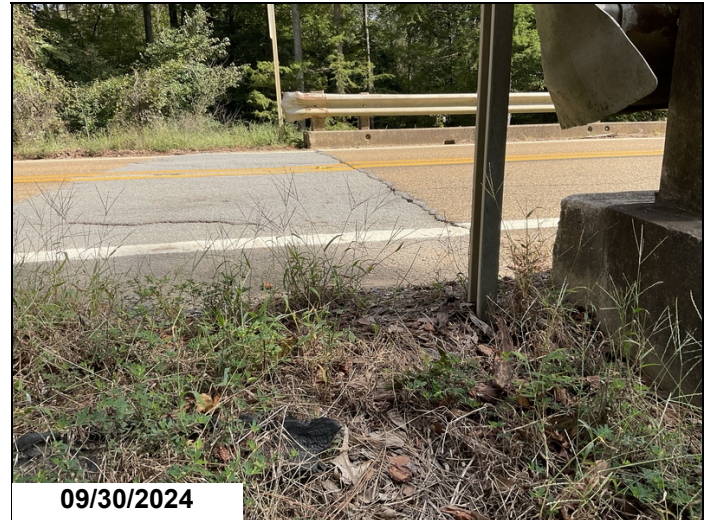
Starting 1' from both ends, the embankment has settled 1' below the stub. 24LF scour CS2. Road way is settling due to erosion of embankment below the abutment stub.

Bent 1 end, road way is settling due to erosion of embankment below the abutment stub.

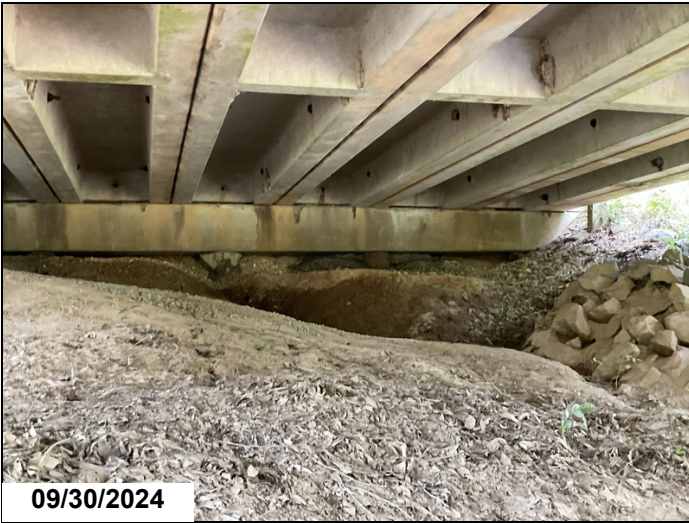
Bent 1:

Starting 1' from both ends, the embankment has settled
1' below the stub. 24LF scour CS2.

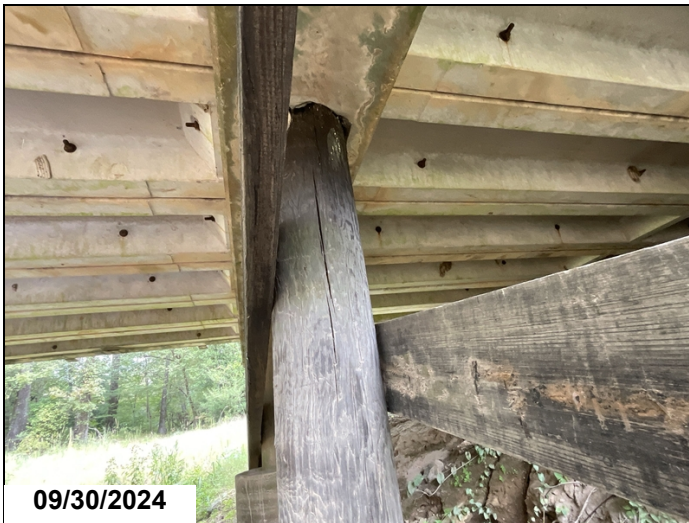
Bent 4, Pile 2 & 4, moderate vertical crack.

Bent 4 pile 4, minor vertical cracks.
