Bridge M2115 Inspection Report

Asset #M2115(Routine, Underwater type 2)

SH 160 S-9 LM6.87 over CANEY BRANCH

Team Lead: Jermy Purifoy Inspection Date: 09/03/2024

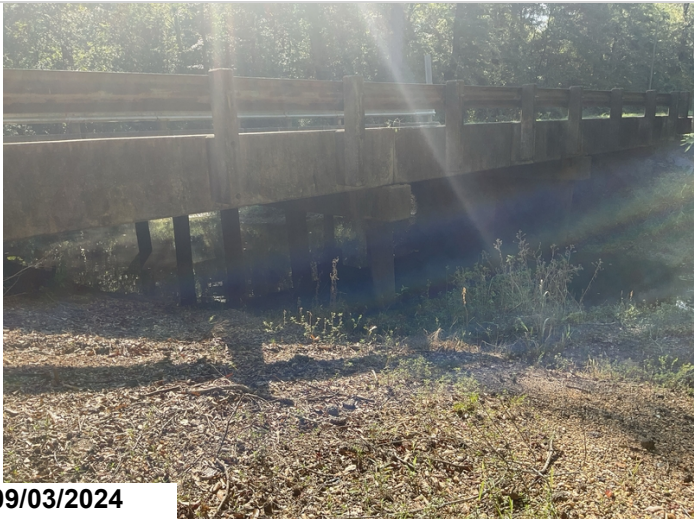
Elevation

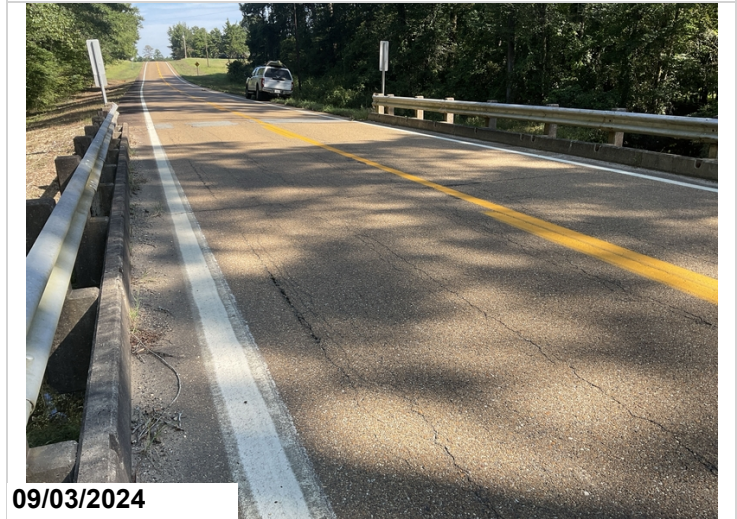
Deck overview

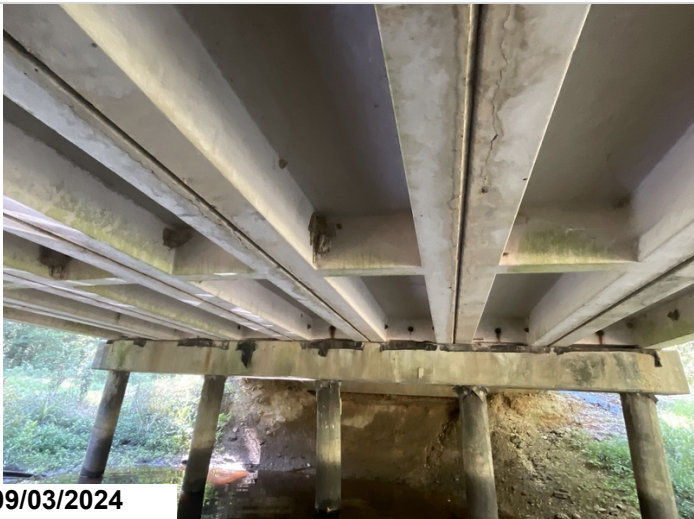
Under surface of top flange

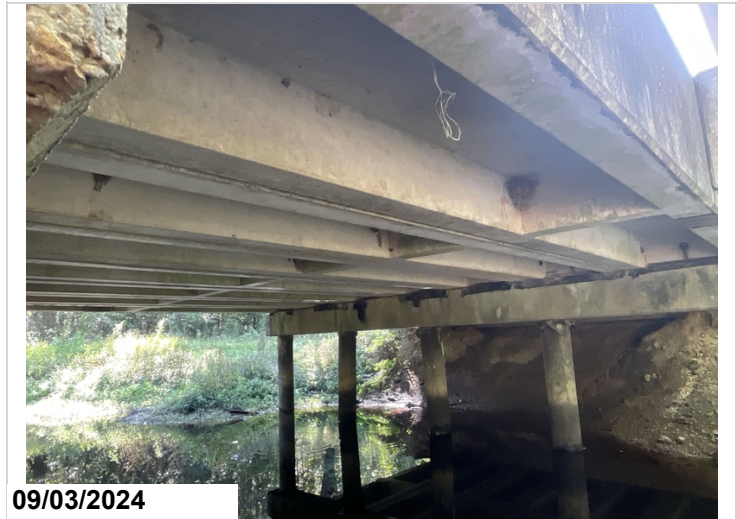
Superstructure is rated 7 due to minor cracks in unit legs.

Typical superstructure

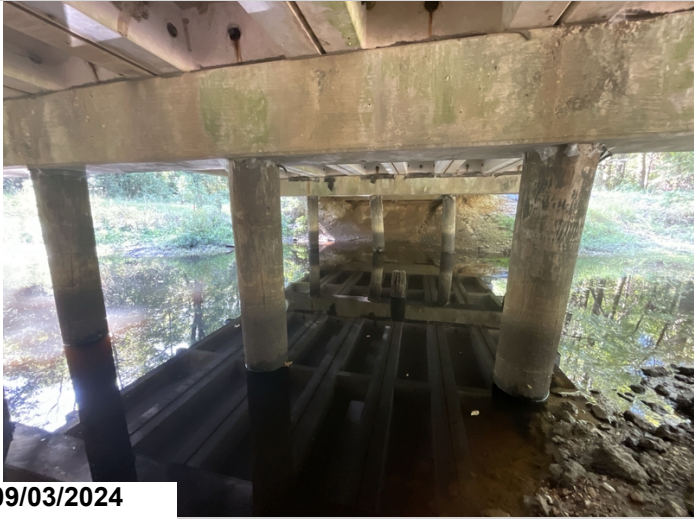
Substructure is rated 6 due to one pile having minor decay and caps having minor spalls.

Typical substructure

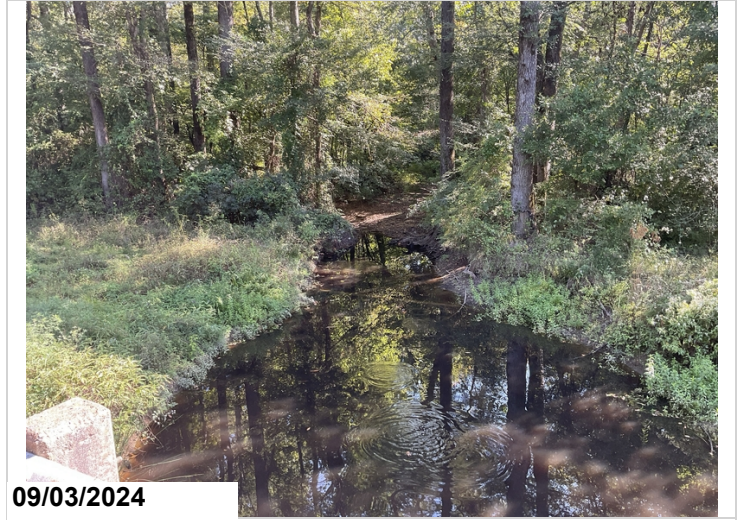
Channel is rated 6 due to some minor bank slumping.

Channel left side upstream

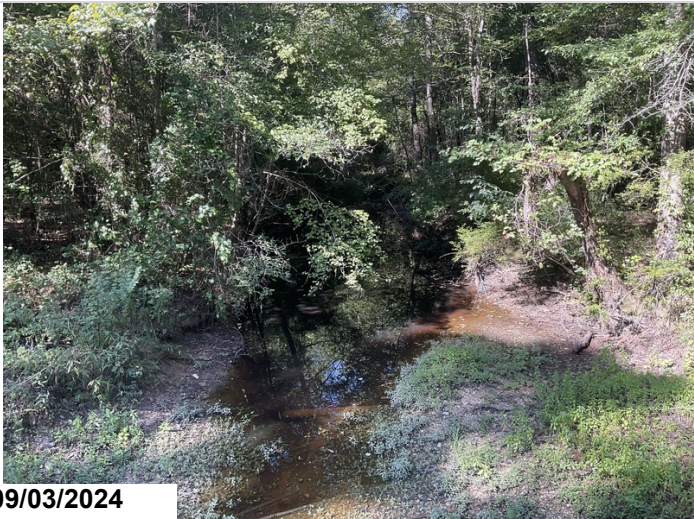
Channel right side downstream

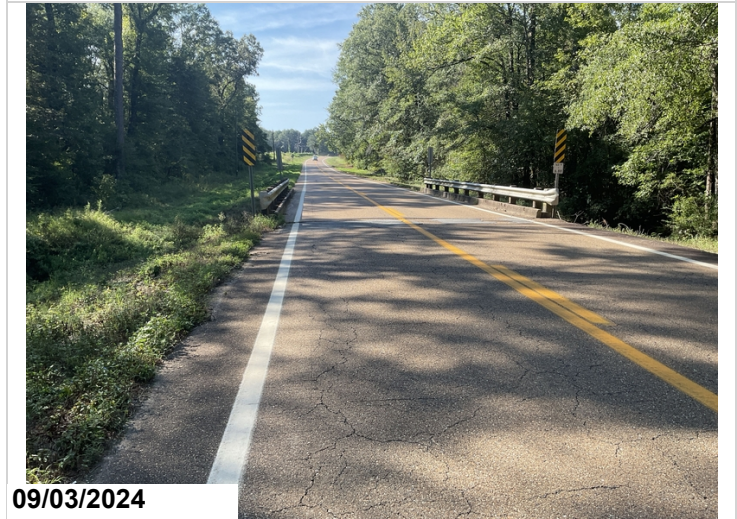
Approach

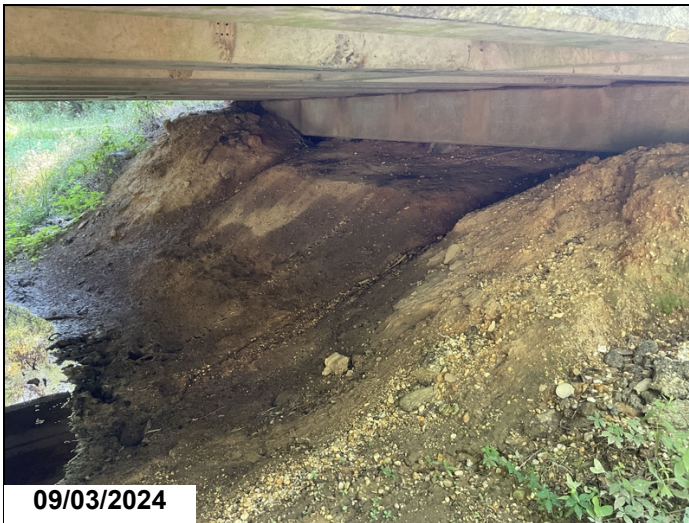
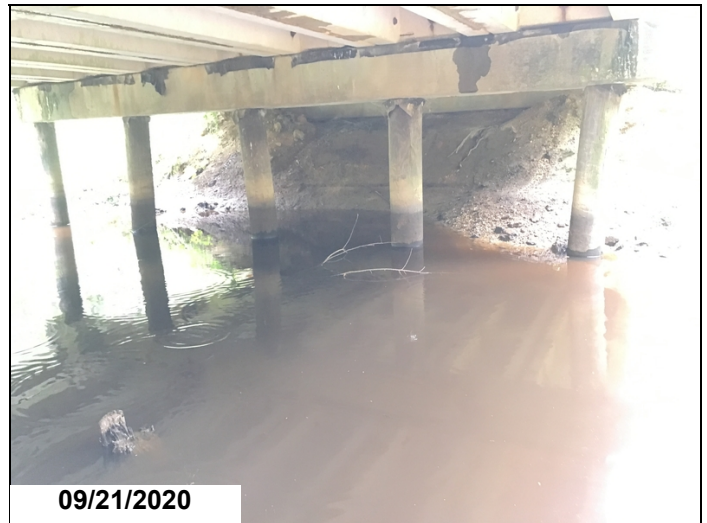
215	Reinforced Concrete Abutment	LF	56	31	25	0	0
6000	Scour	LF	25	0	25	0	0
(215) Bent 1: Scour 10" below cap left end for 10' CS2. Bent 4: Scour hole from pile 2-4 for 15' CS2.							
228	Timber Pile	EA	12	11	1	0	0
1140	Decay/Section Loss	EA	1	0	1	0	0

Abutments 2 slope has a large scour hole from pile 2 - 4, this scour is beginning to encroach upon the abutment cap.

Abutments 2 slope has a large scour hole from pile 2 - 4.

Type of Work: Repair (General)
