Bridge M2647 Inspection Report

Asset #M2647(Routine)

SH 274 S-3 LM10.53 over DITCH

Team Lead: John Parks Inspection Date: 08/27/2024

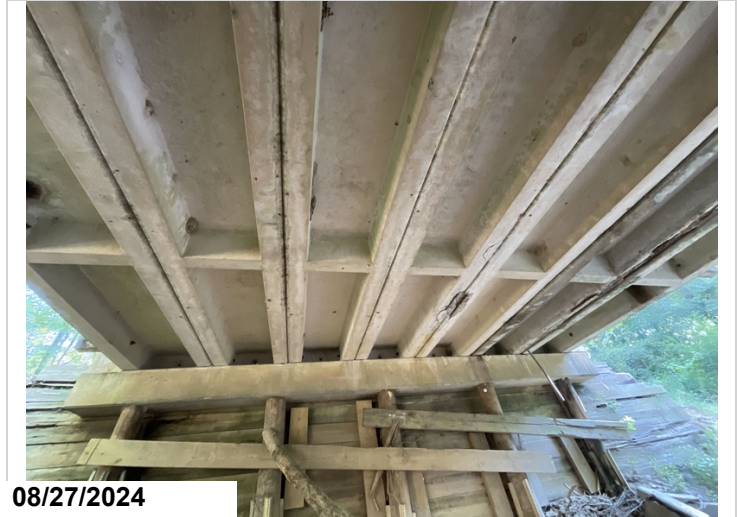
Under surface of top flange

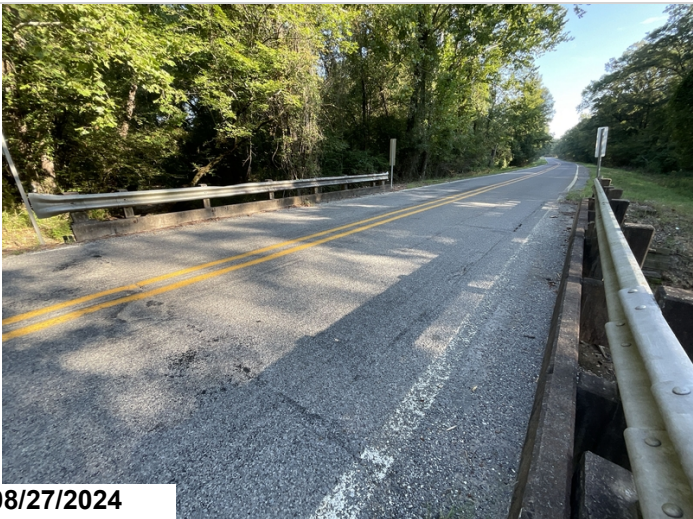
Deck is rated 6 due to spalls in the top surface of the top flange and grout missing in the keyways.

Deck overview

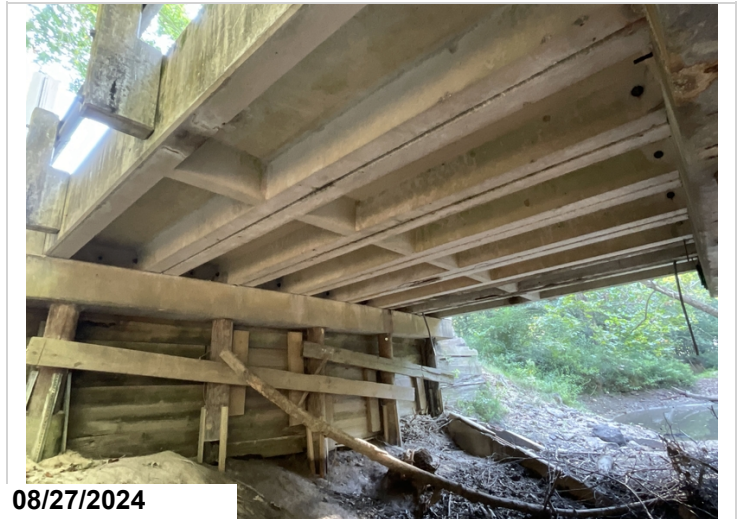
Superstructure is rated 6 due to channel unit legs having moderate spalls, cracks, and cracks with exposed rebar.

Typical superstructure

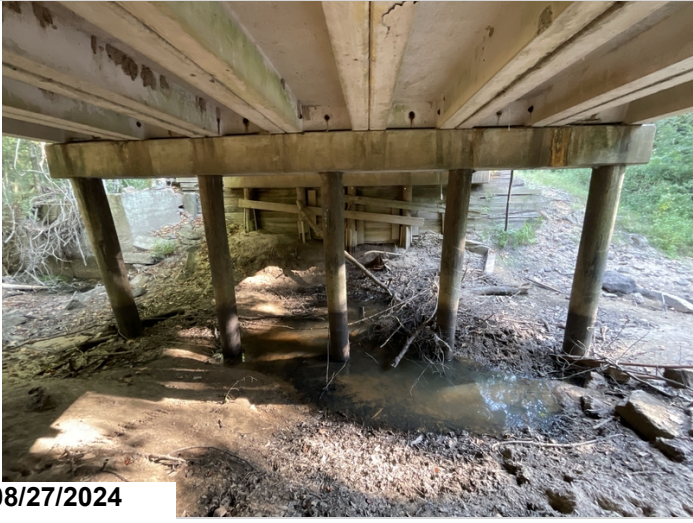
Substructure is rated 6 due to multiple piles being repaired and caps having minor spalls and exposed rebar.

Typical substructure

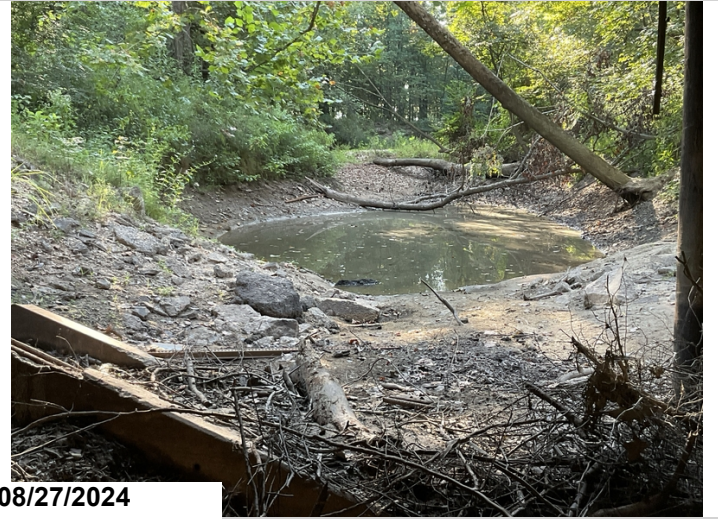
The channel is rated 6 due to debris in the stream and banks slumping.

Channel right side downstream

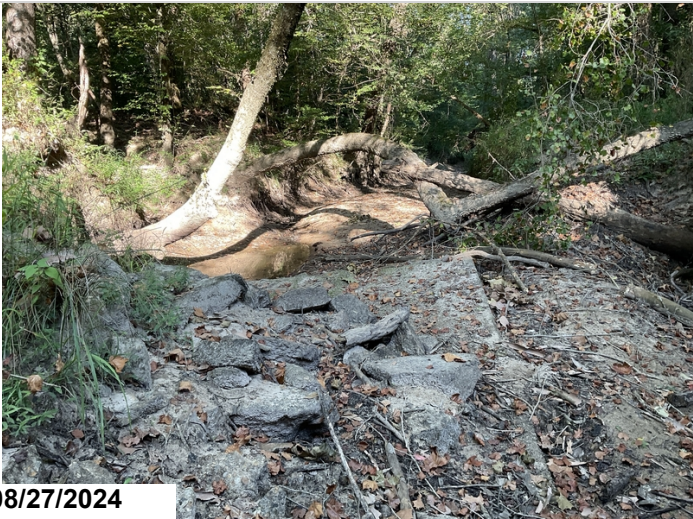
Channel left side upstream

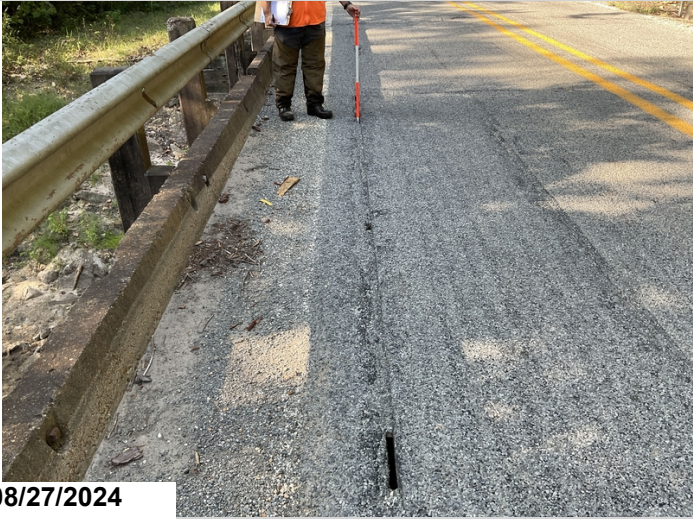
Grout missing between units 6 and 7

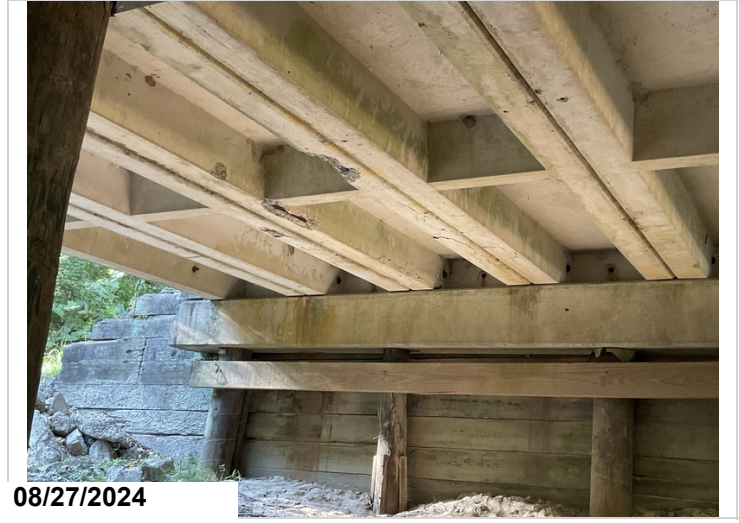
Span 1 units 5 and 6 cracks in legs and spalls with exposed rebar

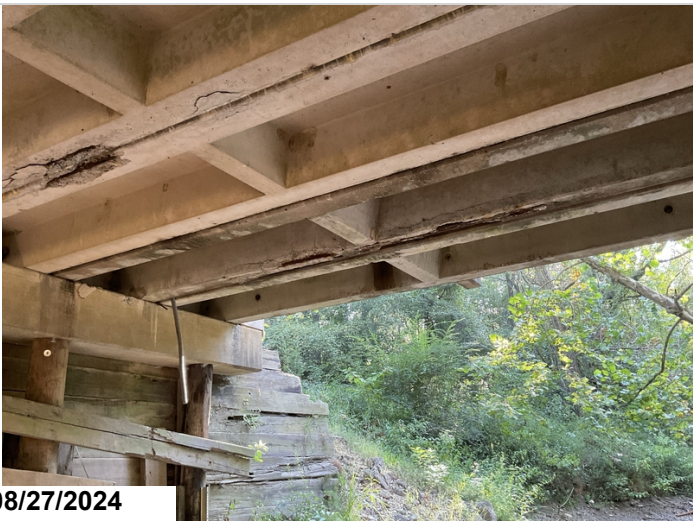
Span 2 unit 6 right leg spall with exposed rebar

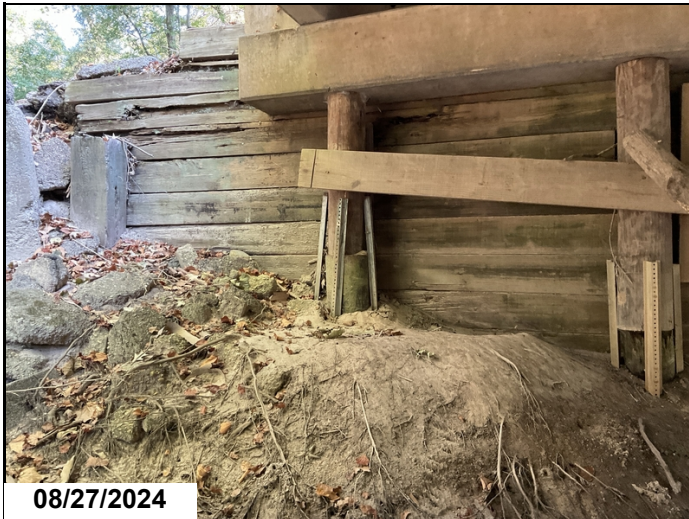
Bent 3 pile 1 has been repaired

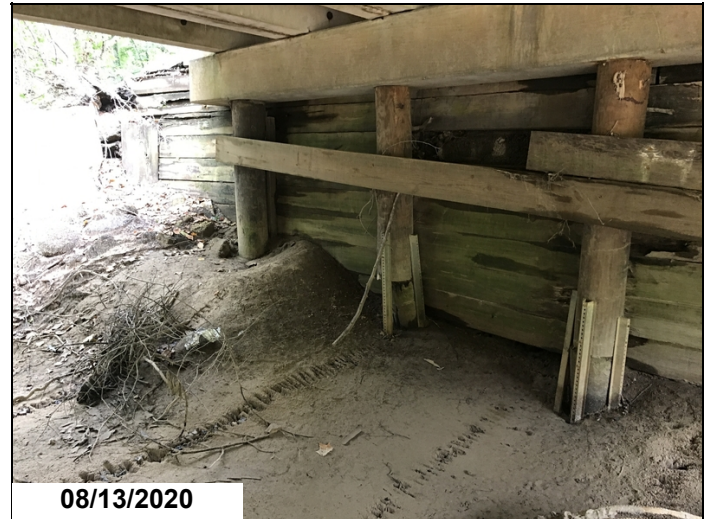
Abutment 2 pile 1 inside decay

Abutment 2 pile 1 has not been repaired

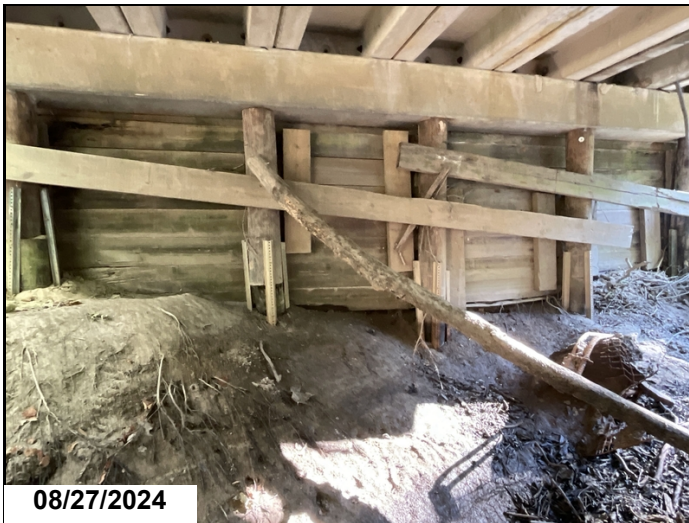
08/27/2024

Bent 3 backwall, has some rotten boards allowing dirt and silt thru.

Backwall has been repaired

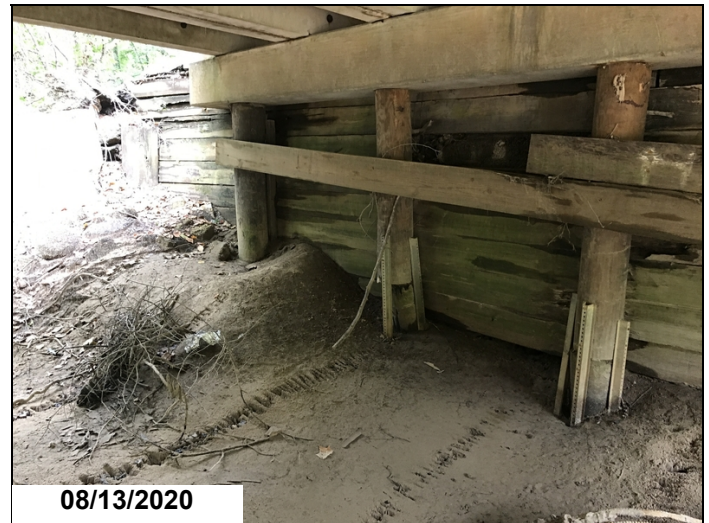
08/13/2020

Abutment 2 backwall has not been repaired, numerous backwall boards are rotten allowing dirt from behind the backwall to silt through the holes, there is some minor roadway settlement.
