Bridge M2648 Inspection Report

Asset #M2648(Routine, Underwater type 2)

SH 274 S-3 LM11.77 over WHITE WATER CREEK

Team Lead: John Parks Inspection Date: 08/27/2024

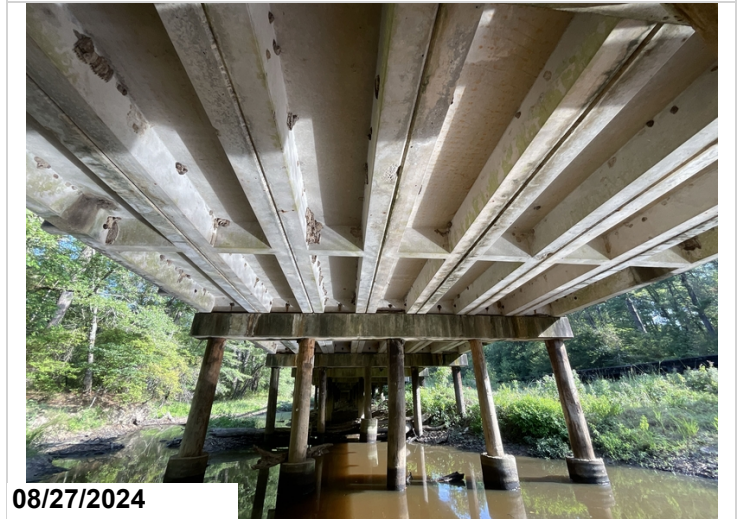
Deck is rated 6 due to the top flange having scattered spalls through out the top and under surface.

Under surface of top flange

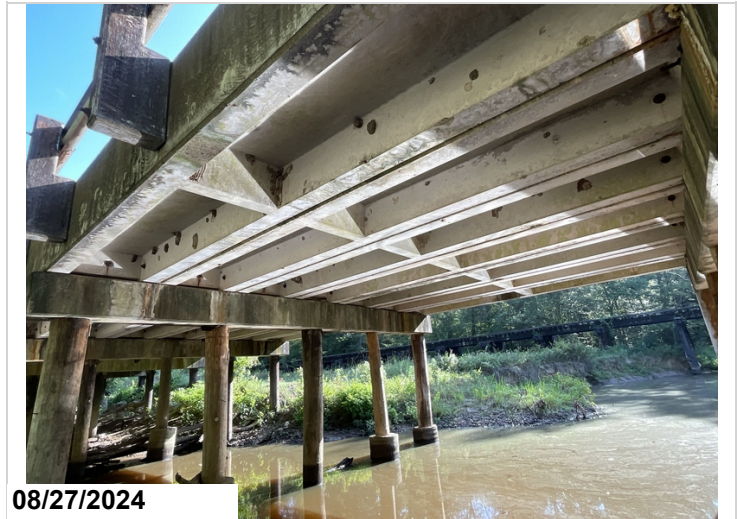
Typical superstructure

The superstructure is rated 6 due to the channel unit legs having scattered spalls, spalls with exposed rebar, and cracking through out the bridge.

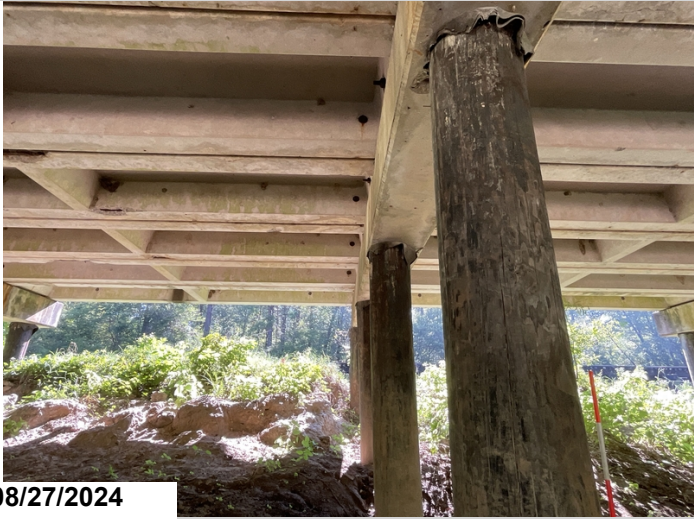
Bent 5, right end, Pile 5 is ahead of center of the cap, the units are centered on the cap. Piles 2 - 5 get progressively farther ahead of center of the cap the further you look right. Bent 6, 7, and 8 are similar.

Bent 5, ahead side, Piles 2 - 5 get progressively farther ahead of center of the cap the further you look right.

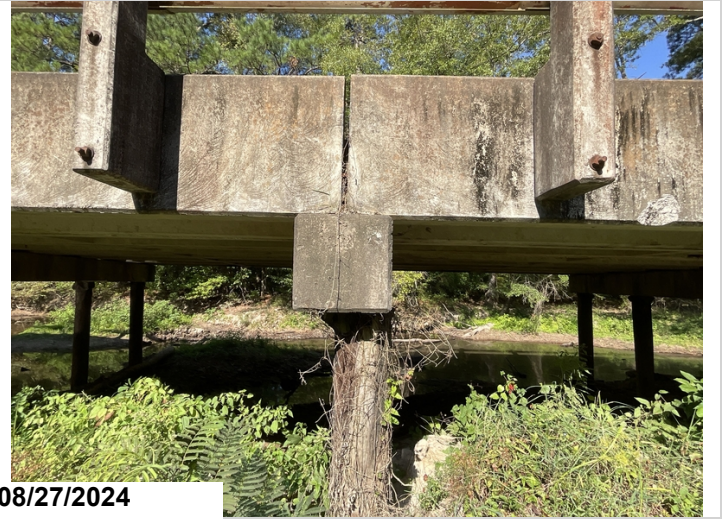
Bent 5, right end, Pile 5 is ahead of center of the cap, the units are centered on the cap.
Bent 6, 7, and 8 are similar.

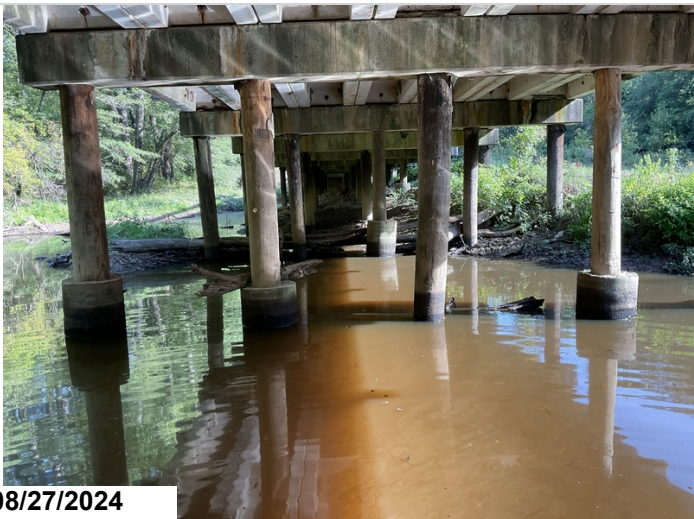
Typical substructure

The substructure is rated 6 due to spalls on the caps, timber piles having minor cracks and several piles have been spliced.

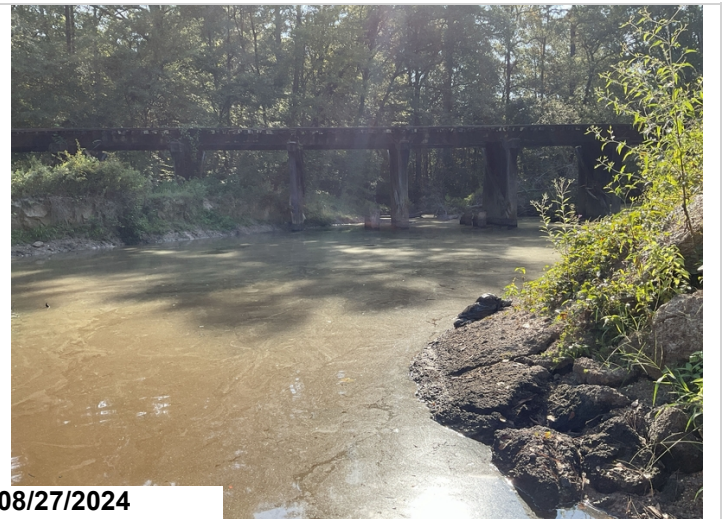
Channel right side downstream

The channel is rated 5 due to the stream alignment, banks slumping, and debris in the creek. The channel approaches the bridge near the left side of Bent 11, runs down the left side of the bridge, and exits the bridge at Bent 3.

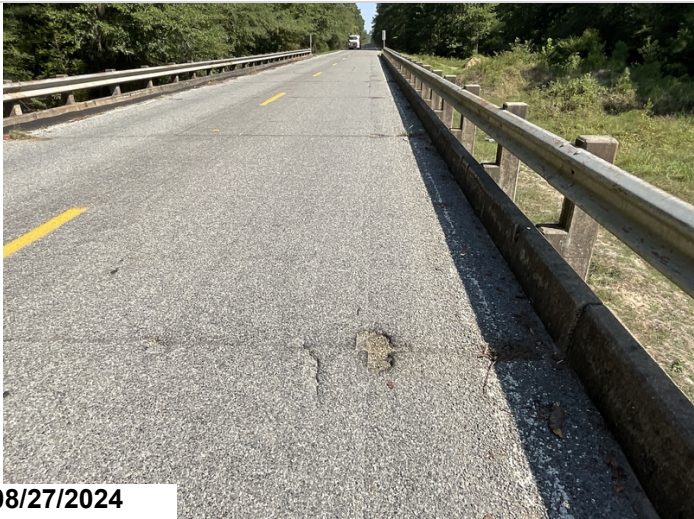
Right side several spans have spalls in the top flange.

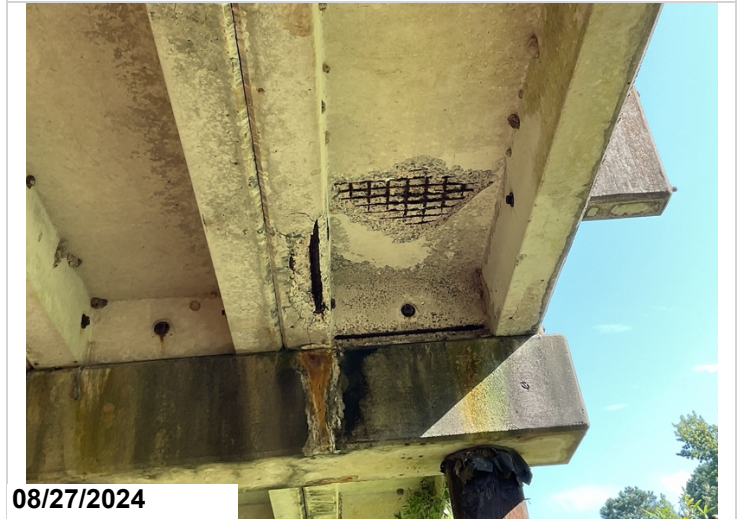
Span 3 Unit 7, under surface back of Bent 4, 2SF exposed rebar CS3.

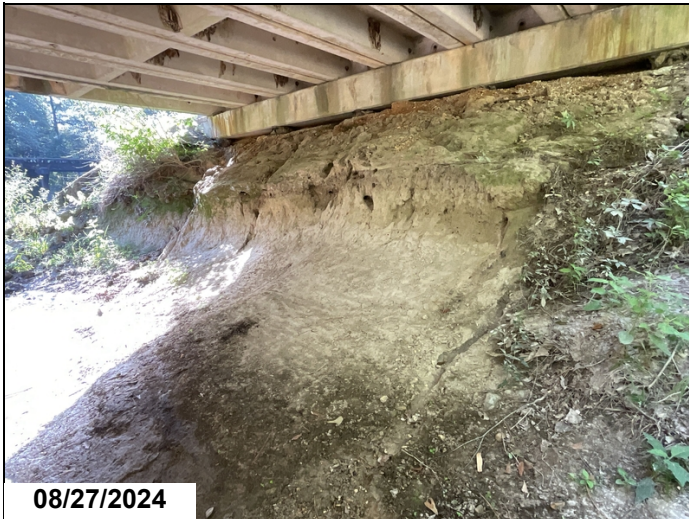
(215) Bent 1:							
Below Unit 1, 1LF spall CS3. Right end, 2LF spall CS3.							
Entire length embankment has settled 10" below the stub. 25LF scour CS2							
Bent 13:							
Entire length embankment has settled 10" below the stub. 28LF scour CS2							
228	Timber Pile	EA	55	19	33	3	0
1160	Crack (Timber)	EA	36	0	33	3	0

Bent 1, Embankment has settled 10" below the abutment allow erosion to cause the void behind the abutment.

Type of Work: Approach Leveling/Maintenance

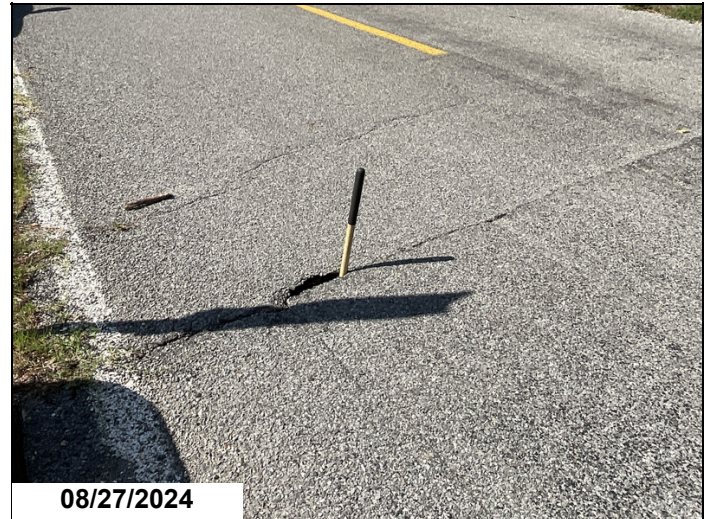
Roadway embankment at Bent 1, right lane, right wheel path, void in the embankment at the backside of the abutment below the asphalt. The void is 4' deep x 1' long x 2' wide. Embankment has settled 10" below the abutment allow erosion to cause the void behind the abutment.

Roadway embankment at Bent 1, right lane, right wheel path, void in the embankment at the backside of the abutment below the asphalt. The void is 4' deep x 1' long x 2' wide.

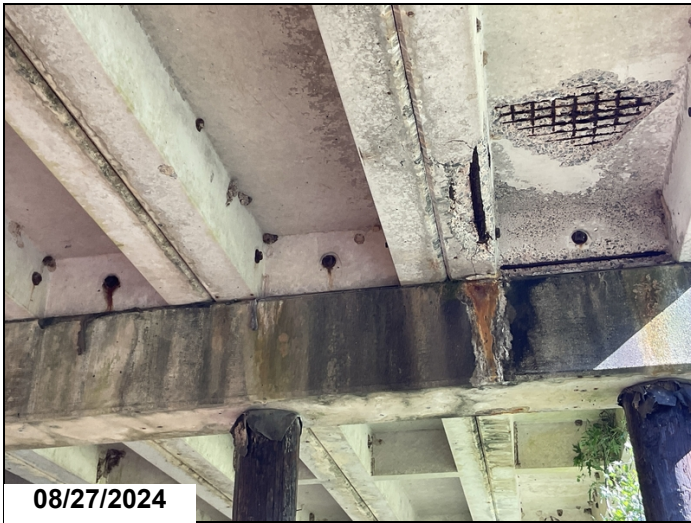
Unit 7 Left leg, back of Bent 4, 3LF exposed rebar CS3

Span 3 Unit 7 back of Bent 4, 3LF exposed rebar CS3.

Type of Work: Superstructure Repair
