## Bridge M2649 Inspection Report

IDENTIFICATION	
(1) State Names	5 - Arkansas
(8) Structure Number	M2649
(5) Inventory Route	1
(2) Highway Agency District	07 - District 07
(3) County Code	13 - Calhoun County

Team Lead: John Parks, Inspection Date: 08/27/2024

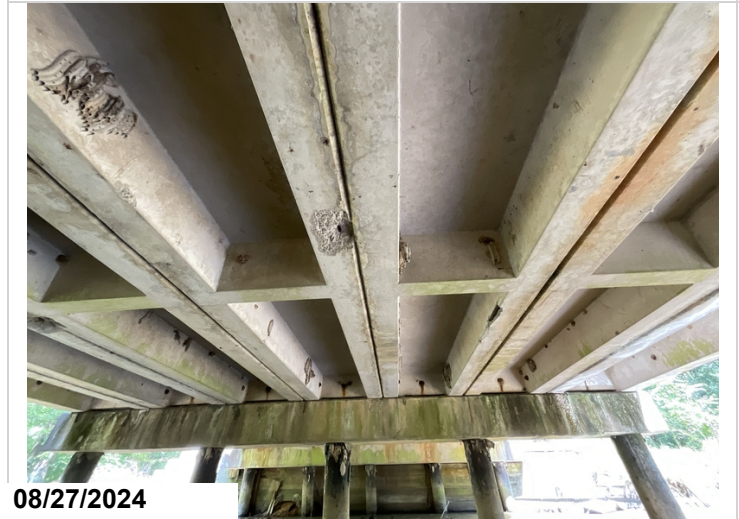
Deck is rated 6 due to the top surface of the top flange having scattered moderate spalls and spalls in the grout keyways.

Typical view of top flange under surface.

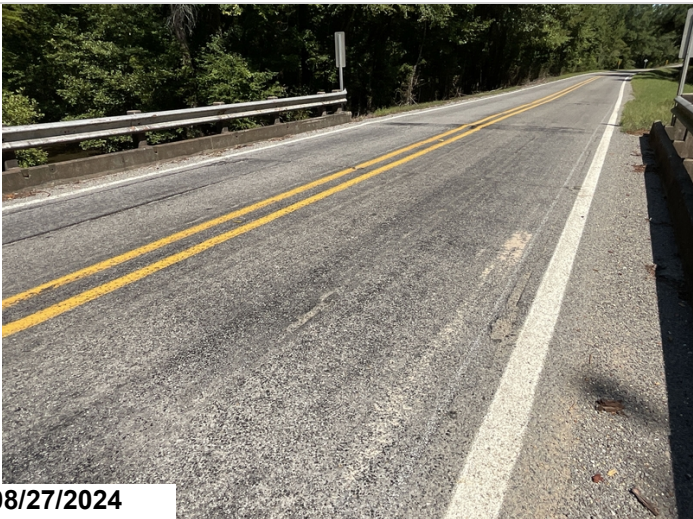
Typical view of top flange top surface.

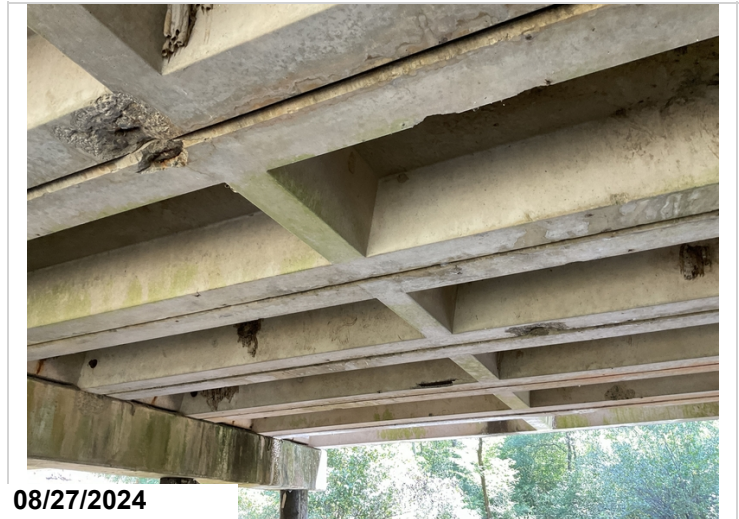
The superstructure is rated 5 due to channel unit legs having spalls with exposed rebar, spalls, and cracking.

Typical view of the superstructure.

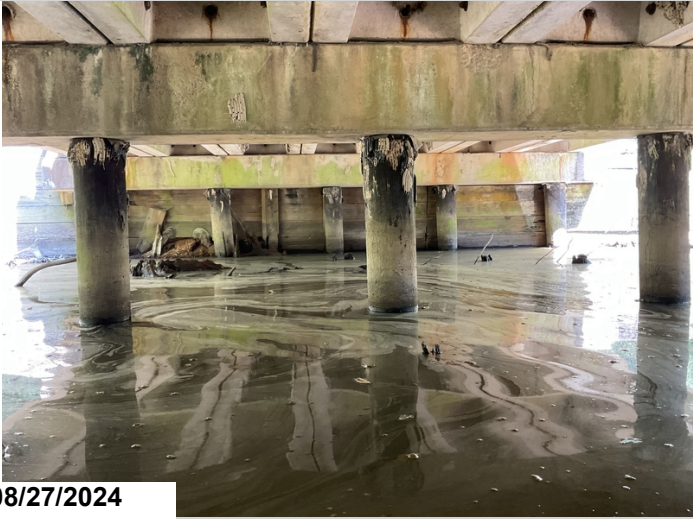
The substructure is rated 5 due to spalls at the abutments and 1 pile having moderate decay. The are timber backwalls allowing scour.

Typical view of the substructure.

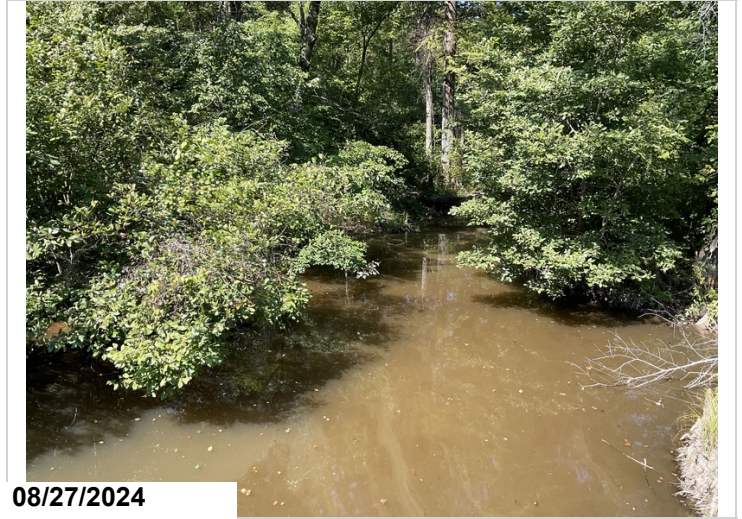
The channel is rated 6 due to debris in the stream, the banks slumping up and downstream.

Channel left side upstream

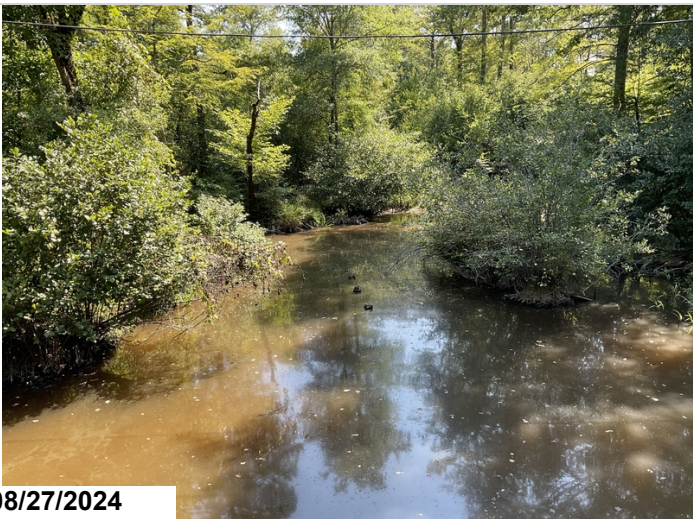
Channel right side downstream

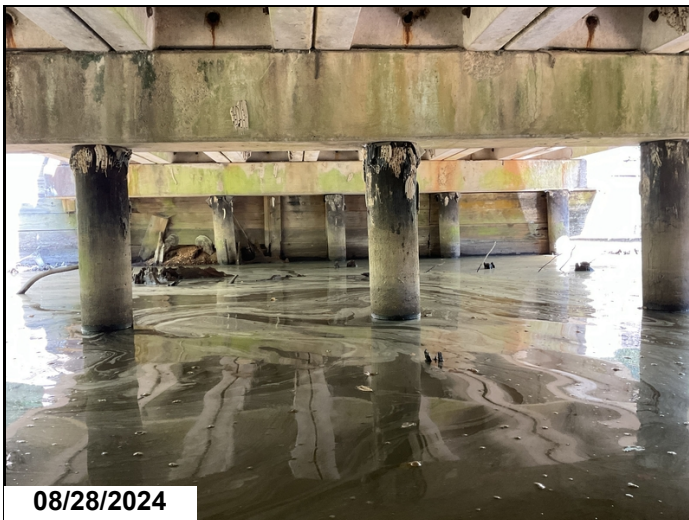
Bent 3:

3' left of center. Section of timber backwall missing allowing embankment to flow through. 3LF scour CS3.

Type of Work: Substructure Repair

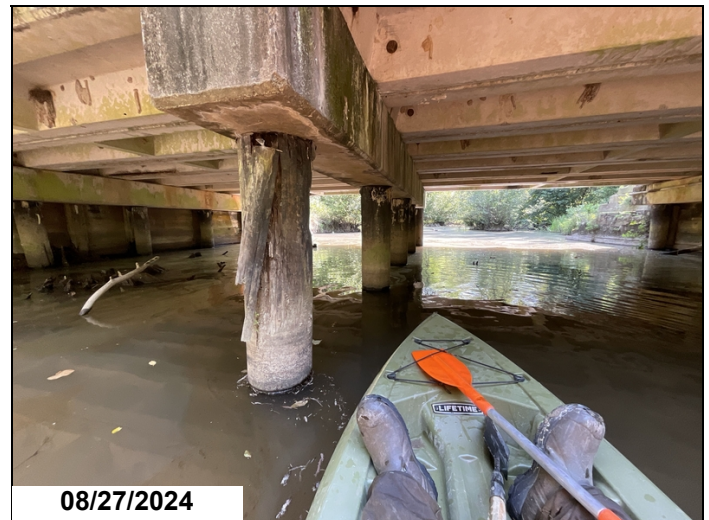
Pile 1, 1Each decay CS3.

Bent 2 Pile 1, 1Each decay CS3.

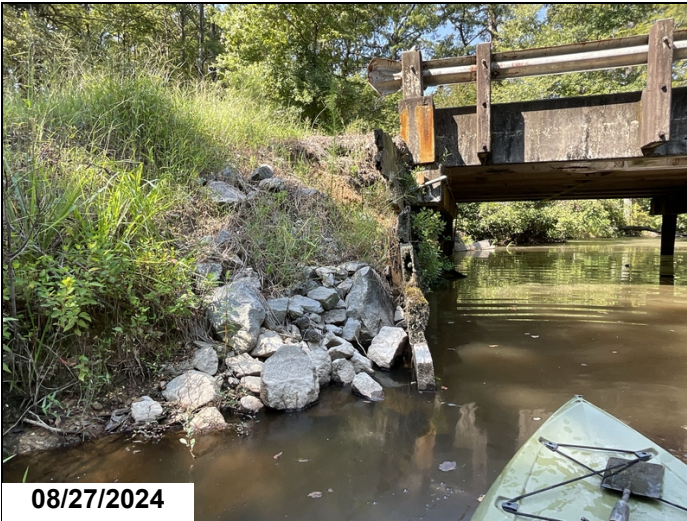
10' of the right end, scour of embankment behind the backwall causing timbers to be bowed ahead in to the channel. 10LF scour CS3.

Bent 1, 10' of the right end, scour of embankment behind the backwall causing timbers to be bowed ahead in to the channel. 10LF scour CS3.

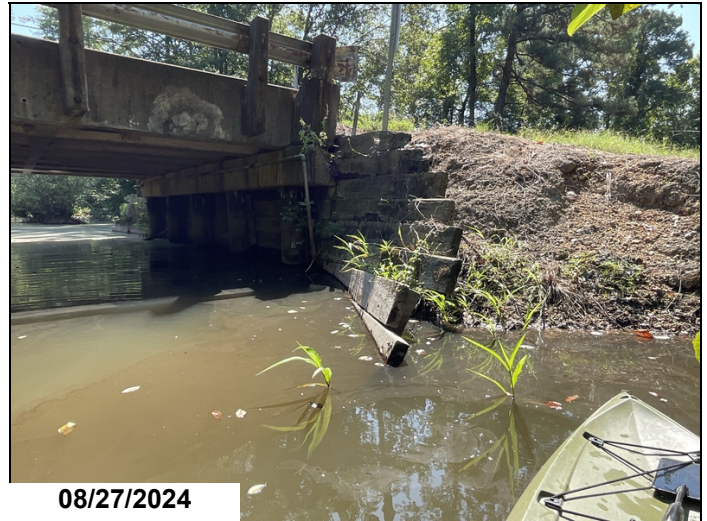
10' of the left end, scour of embankment behind the backwall causing timbers to be bowed ahead in to the channel. 10LF scour CS3.

Bent 1, 10' of the left end, scour of embankment behind the backwall causing timbers to be bowed ahead in to the channel. 10LF scour CS3.

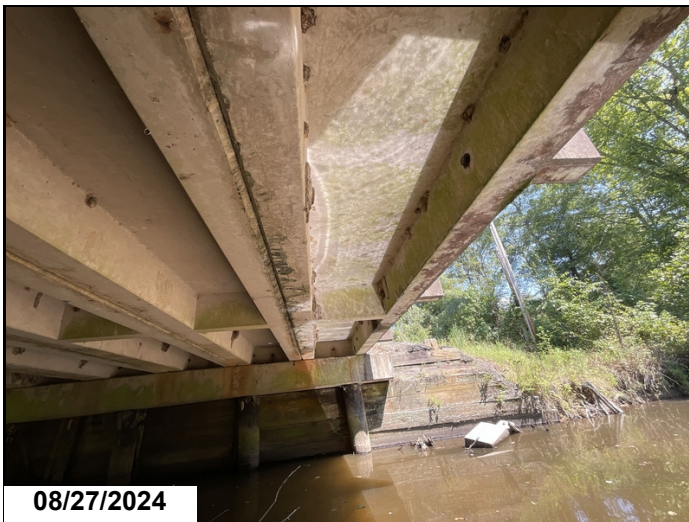
Unit 7 Left leg, ahead of Bent 2, 9LF cracking CS3.

Span 2, Unit 7 Left leg, ahead of Bent 2, 9LF cracking CS3. 2LF spall CS2.

**Type of Work:** Superstructure Repair

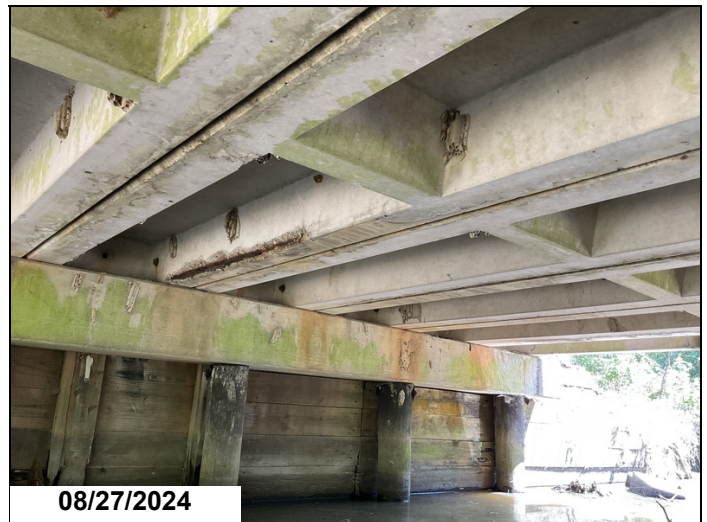
Unit 3 Right leg, ahead of mid span 3LF cracking CS3. Back of Bent 3, 5LF exposed rebar CS3.

Span 2, Unit 3, Right leg, ahead of mid span 3LF cracking CS3. Back of Bent 3, 5LF exposed rebar CS3.

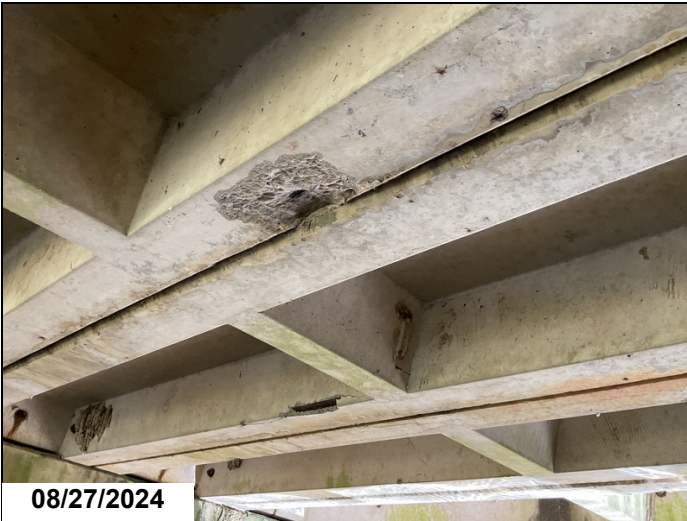
Unit 4 Right leg, 1' back of mid span, 1LF spall CS3.

Unit 5 Right leg, ahead of mid span, 2LF spall CS3.

Span 1, Unit 4, Right leg, 1' back of mid span, 1LF spall CS3.

Unit 5, Right leg, ahead of mid span, 2LF spall CS3.

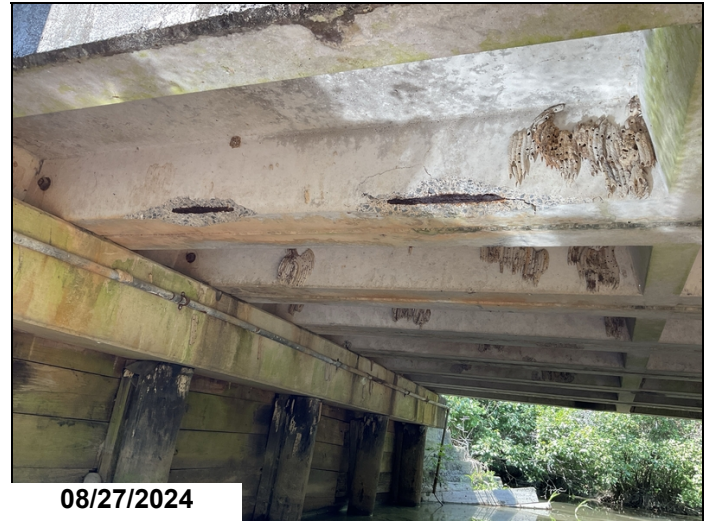
Unit 7 Left leg, 1' back of mid span, 2LF exposed rebar CS3. 2' ahead of Bent 1, 2LF exposed rebar CS3.

Span 1, Unit 7 Left leg, 1' back of mid span, 2LF exposed rebar CS3. 2' ahead of Bent 1, 2LF exposed rebar CS3.

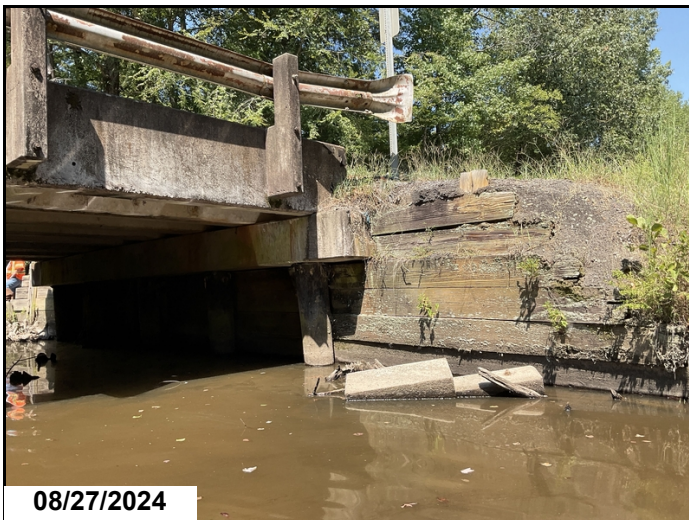
Left end, 1Lf spall CS3. Right end, 1LF spall CS3, bridge rail end post has broken off the end of the cap.

Bent 3, Right end, 1LF spall CS3, bridge rail end post has broken off the end of the cap.

**Type of Work:** Repair (General)

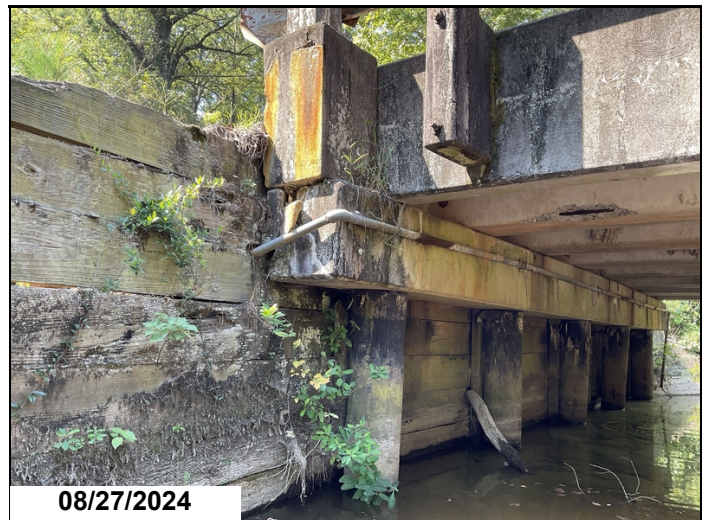
Left end, 1Lf spall CS3. Right end, 1LF spall CS3

Bent 1 Right end, 1LF spall CS3
