Bridge M2650 Inspection Report

Asset #M2650(Routine, Underwater type 2)

SH 274 S-3 LM20.49 over CANEY CREEK

Team Lead: Jermy Purifoy Inspection Date: 07/16/2024

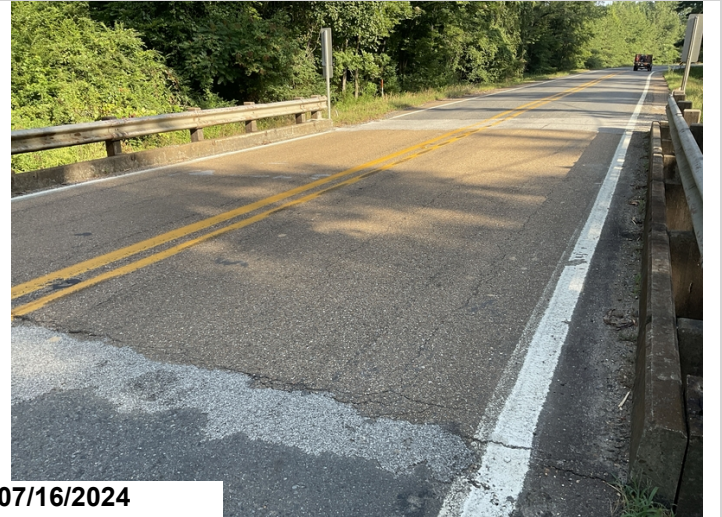
Deck overview

Deck is rated 7 due to some minor abrasion.

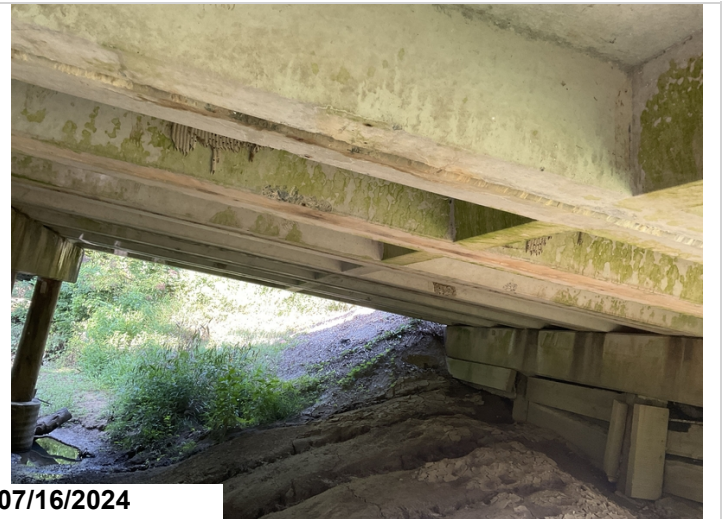
Typical superstructure

Superstructure is rated 6 due to some of the unit legs have minor spalls.

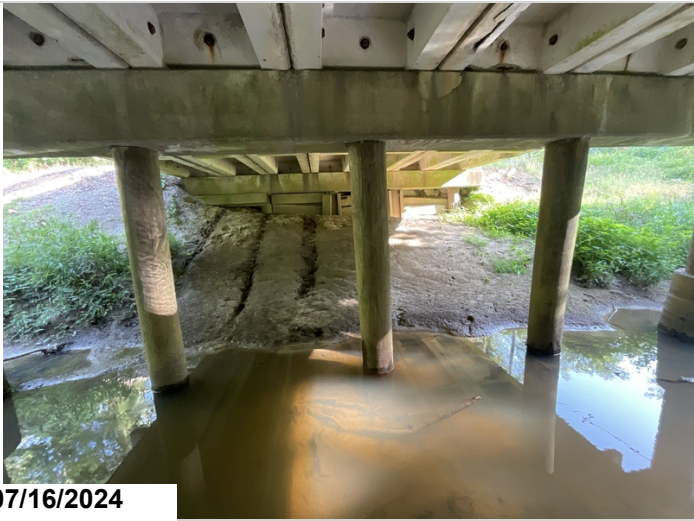
Typical substructure

Substructure is rated 6 due some spalls on caps and some minor piling decay.

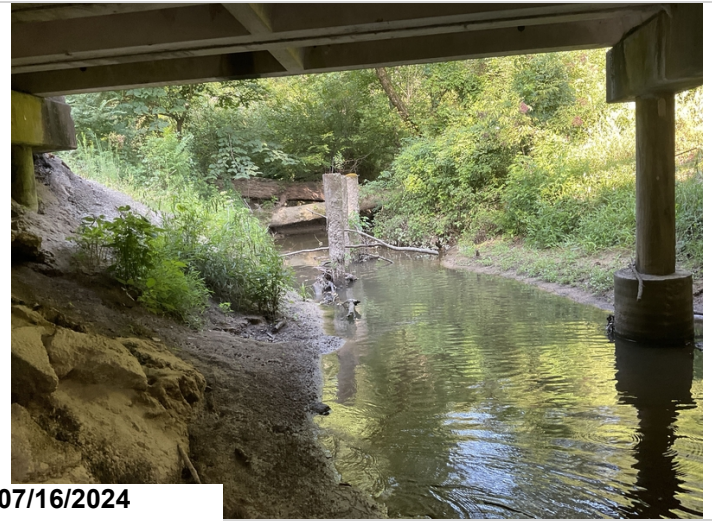
Channel left side upstream

Channel is rated 6 due to banks slumping and debris in the stream.

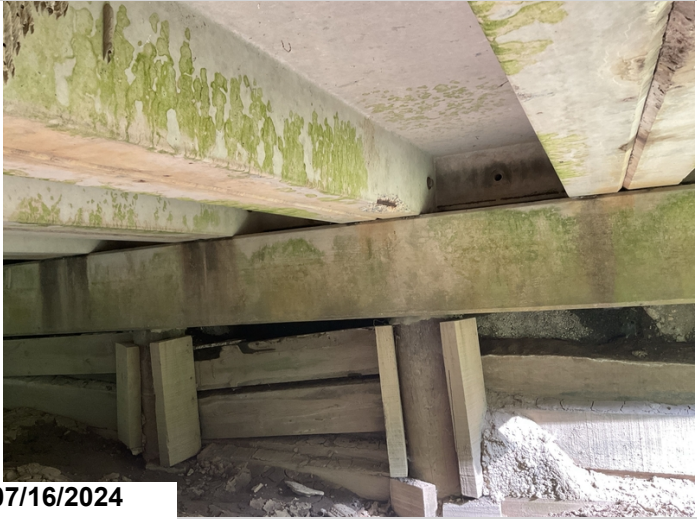
Span 2 unit 6 left leg spall 2LF CS3 at bent 3.

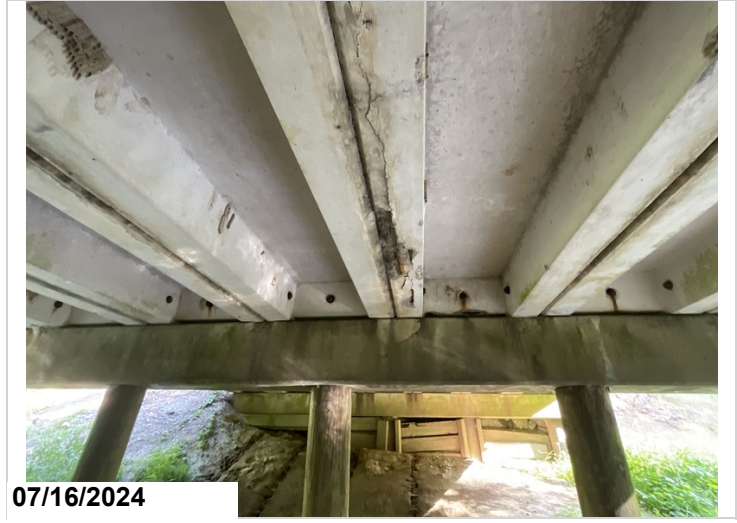
(110) Span 1 unit 5 left leg spall 8LF CS3 at bent 2. Span 2 unit 4 1' spall cs2							
228	Timber Pile	EA	13	12	1	0	0
1140	Decay/Section Loss	EA	1	0	1	0	0

Span 1 unit 5 left leg spall 8LF CS3 at bent 2.

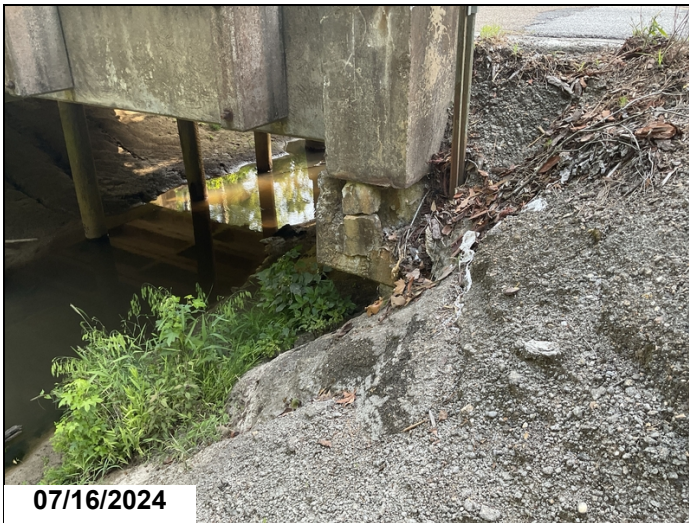
(234) Bent 1: 2LF spall left end CS3 Bent 2: 2LF spall between piles 3 and 4 CS3 1LF spall over pile 4 CS3 1LF spall on right side CS3 Bent 3: No defects observed							
304	Open Expansion Joint	LF	25	25	0	0	0
330	Metal Bridge Railing	LF	76	76	0	0	0

Bent 1 Lt. side, end of cap is spalled.

Bent 1 left side 2LF spall CS3
